GEOTECHNICAL ASSESSMENT

Client: Swanage Town Council

Swanage Seafront

Report No. 12660

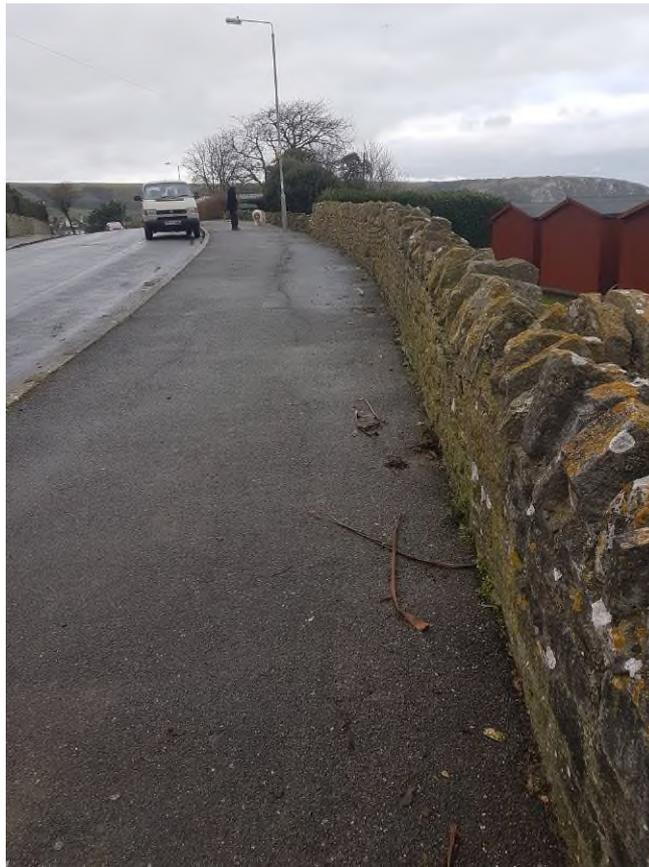
accommodate the holiday cabins with steps and small (1-2m) to medium (~2-3m) retaining walls. The entire section displays signs of slope instability with the stone wall along the western boundary is tilting down slope (as seen on photo 1.) Several of the retaining walls exhibit cracks with sections of blockwork repaired and rebuilt towards the south of this section (see photo 7.) There is significant seepages through the two large retaining walls towards the east of this section, with calcite deposition encountered <1.5m up the wall (as seen in photo 6.)

At the northern end of the site, on the footpath adjacent to De Moulham Road, a series of cracks (Photo 1) were noted in the tarmac to the rear of the stone boundary wall. The wall was noted to be tilting downslope.

Photo 1 – Leaning wall and cracks in pavement (looking north.)

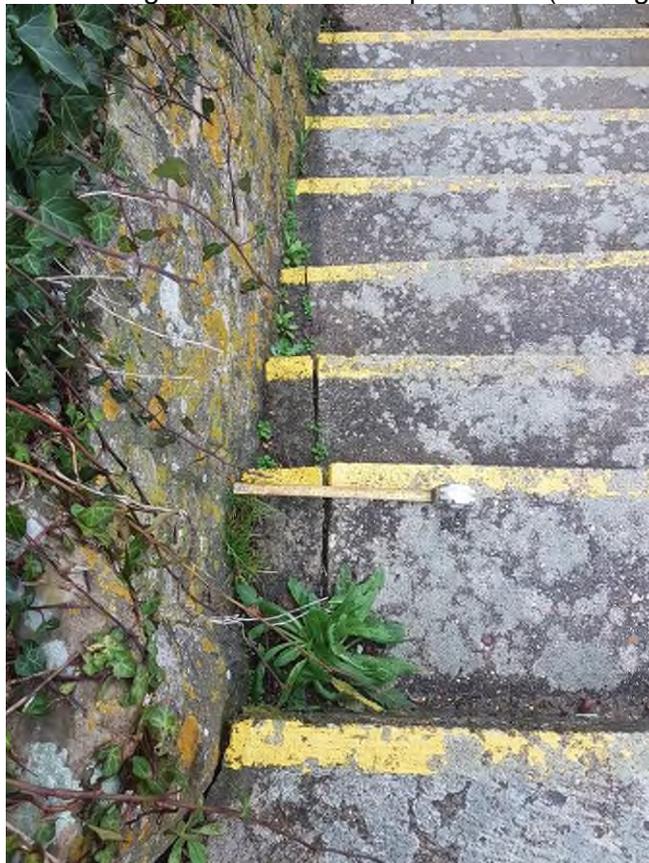
The northern most section comprises a gently then steeply sloping grass area (again, from west to east) with a combination of steps and retaining walls which work their way down to Shore Road below. The entire slope is showing signs of gradual instability, including cracks within the path (see photo 2) and tilting of paving stones (see photo 3)

Photo 2 – 10mm diameter cracks.

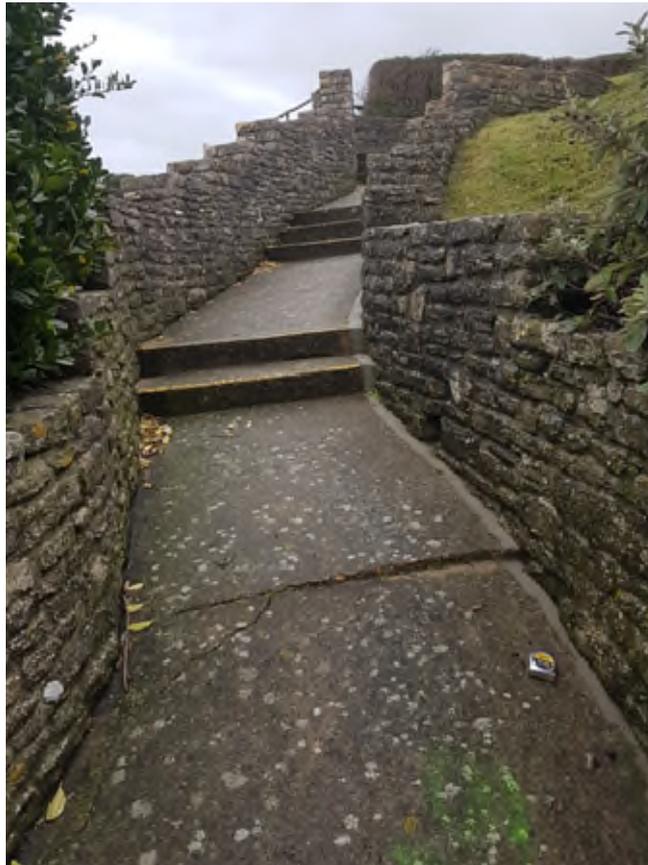
Photo 3 – Steps off camber (looking south west.)

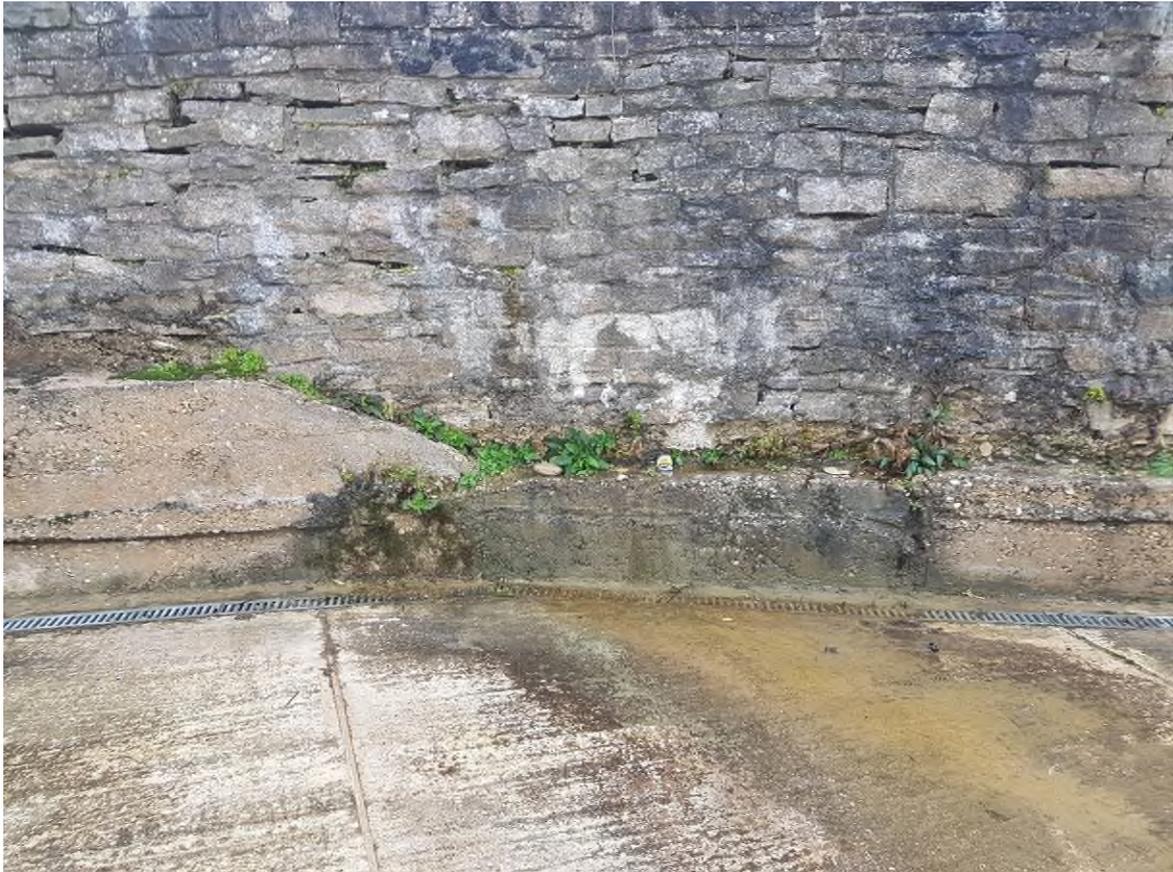
Photo 5 – Seepage through retaining wall and drain

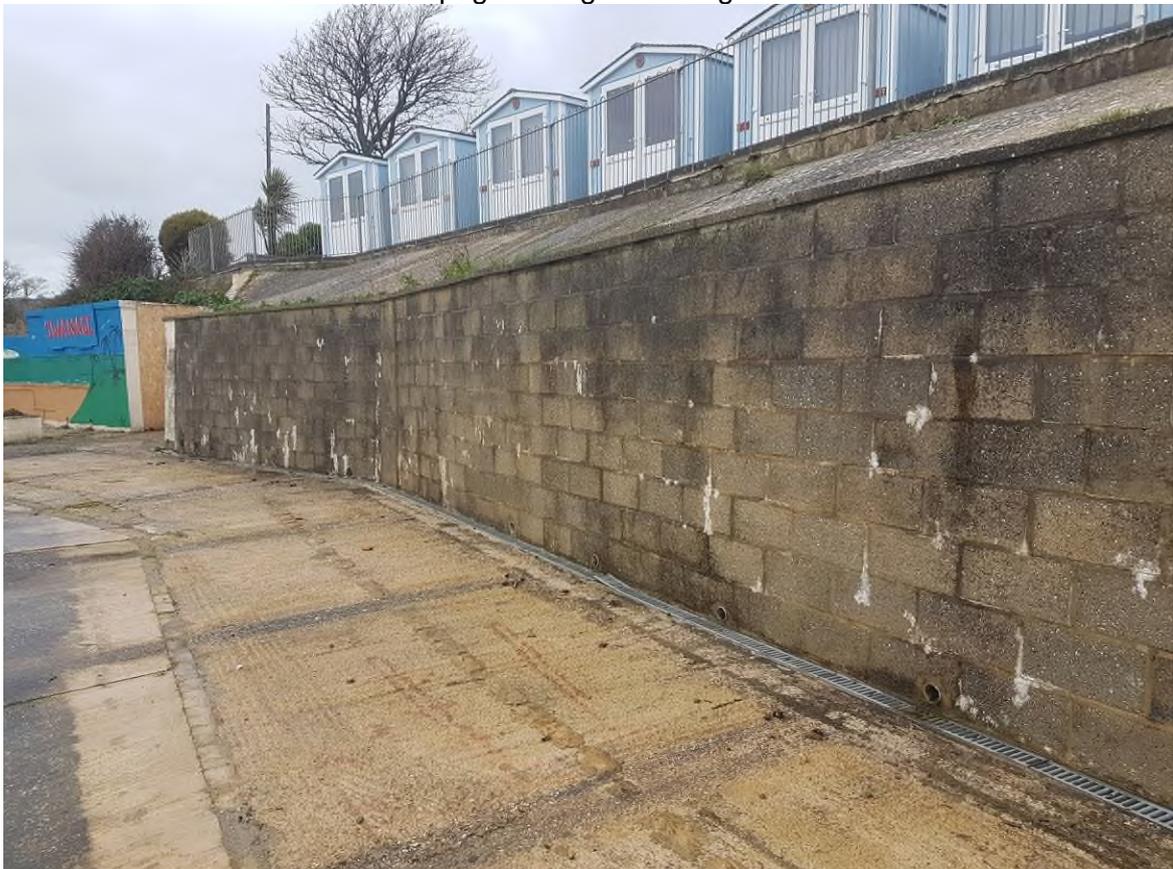
Photo 6 – Calcite deposition along retaining wall (looking south west)

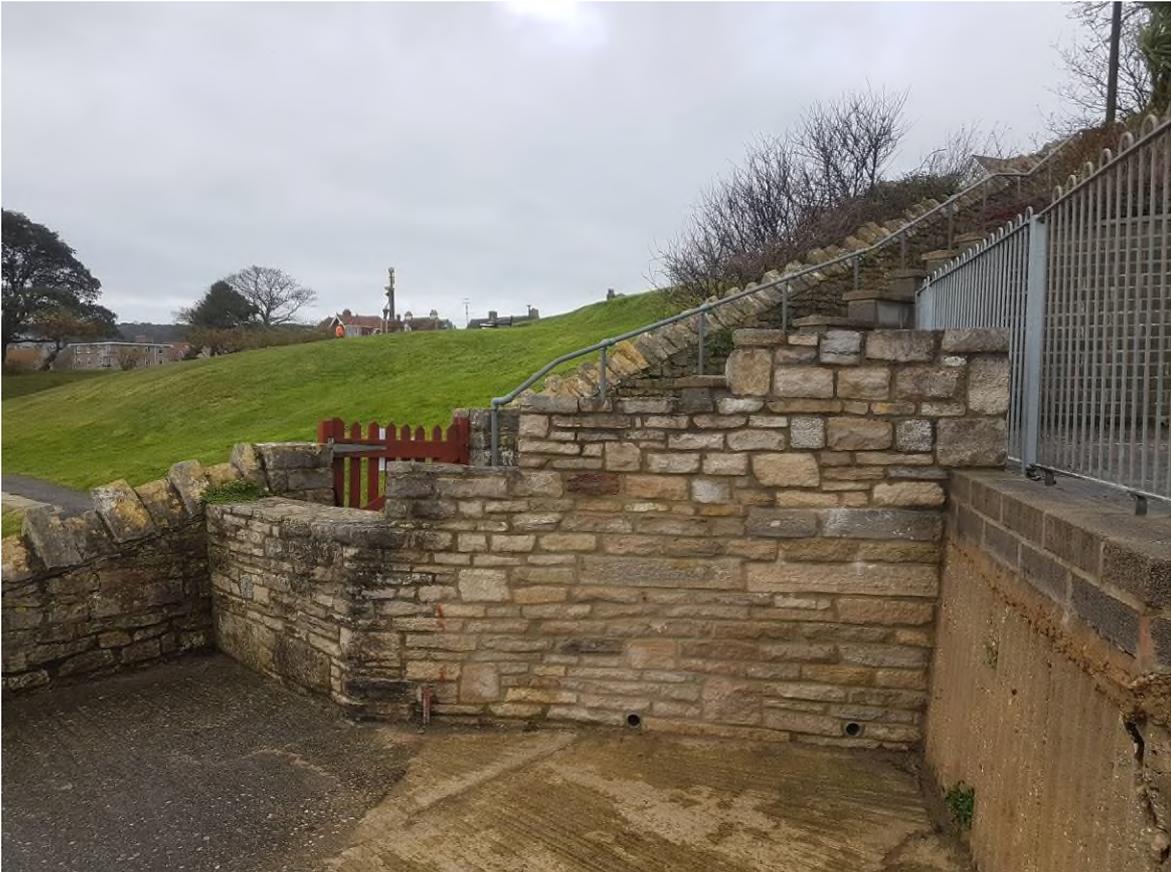
Photo 7 – Repaired wall (looking south west.)

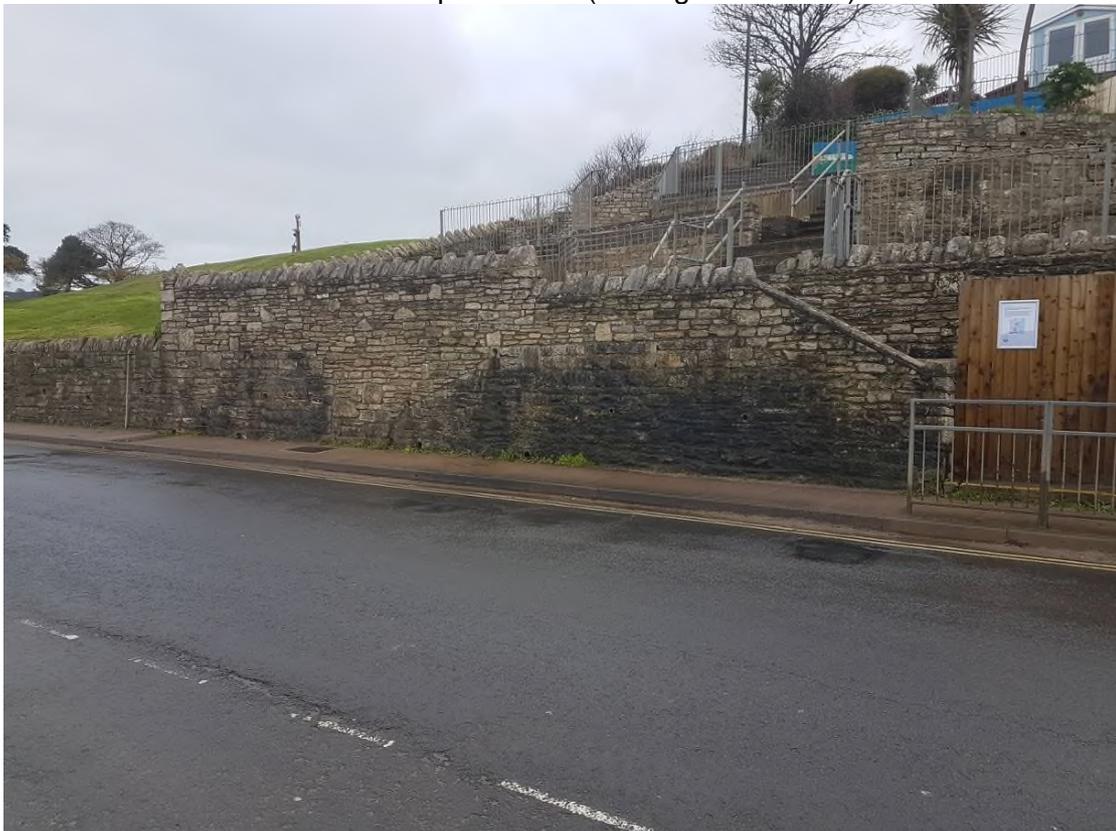
Photo 8 – Groundwater seepage through retaining wall, at 1.4m up wall (looking south west west.)

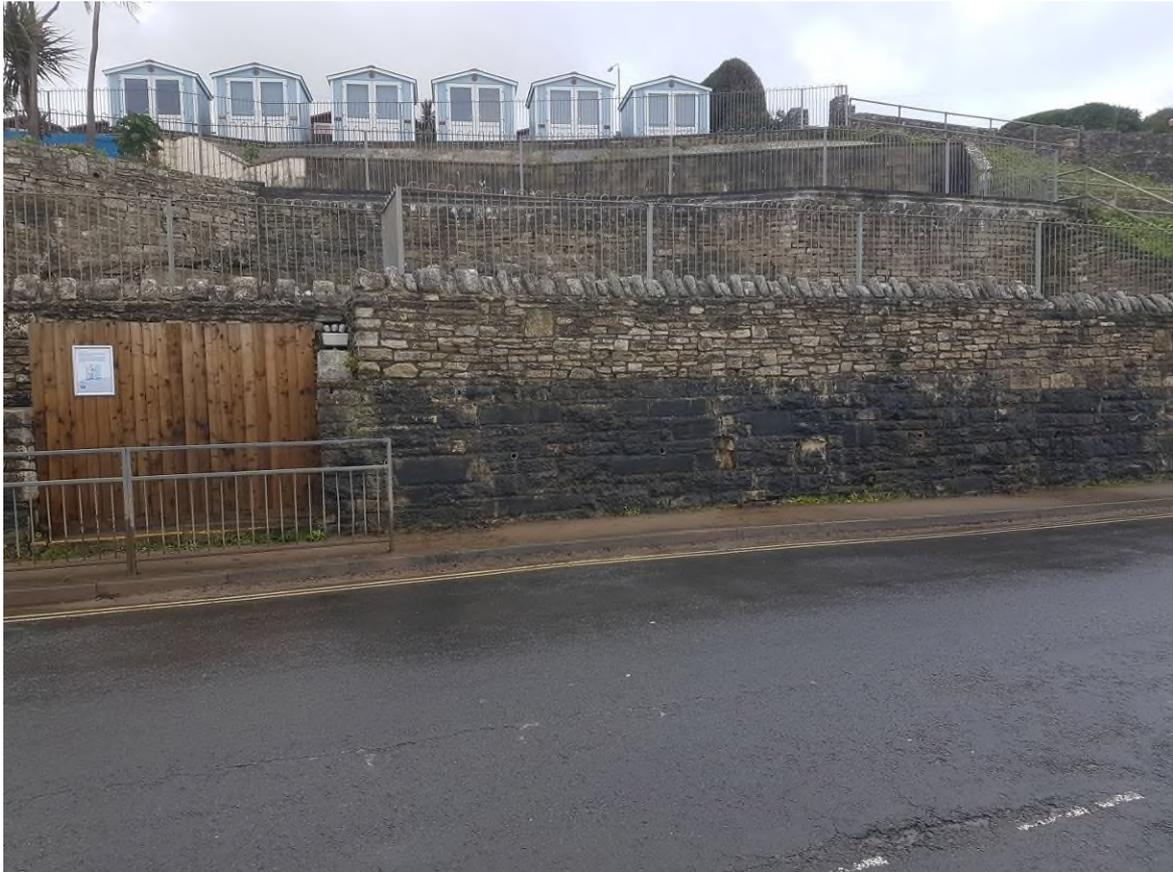
Photo 9 - Groundwater seepage through retaining wall at 1.4m up wall (looking west.)

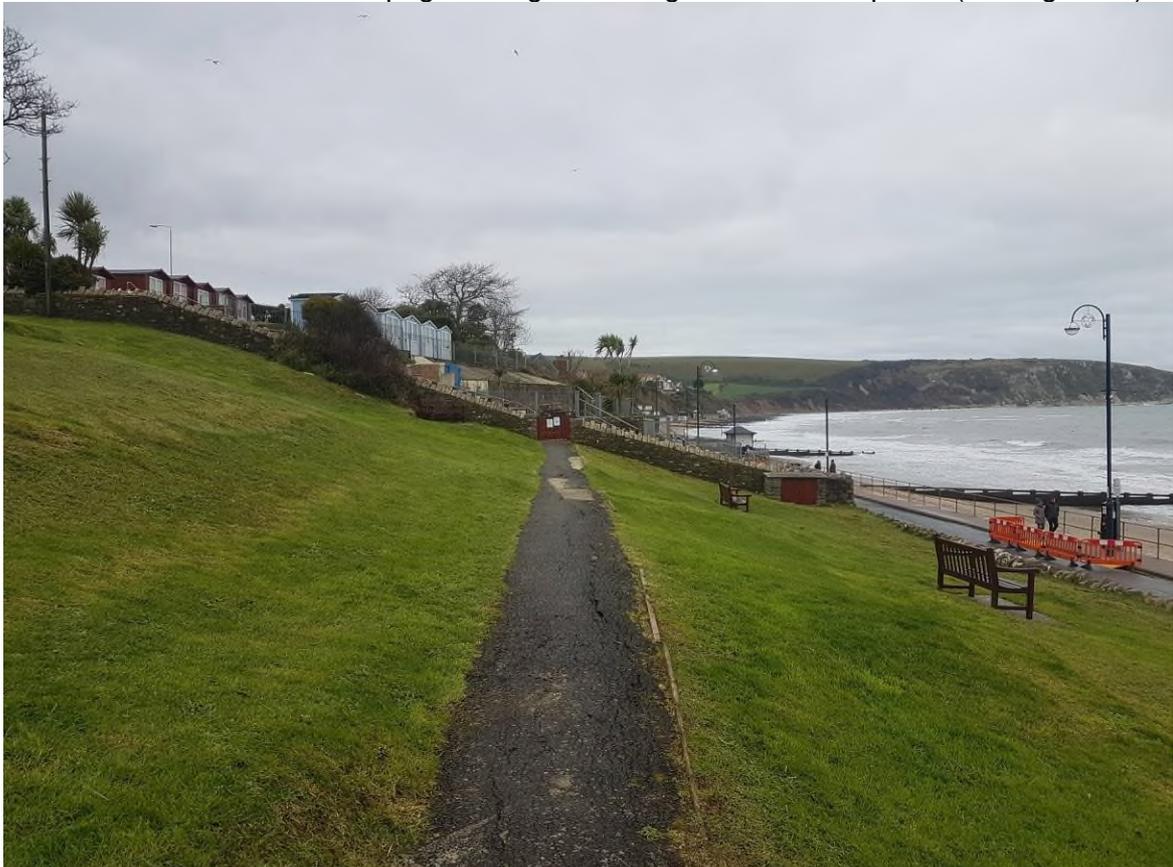
The southern-most part of the northern section is bordered to the south by Walrond Road, to the east by Shore Road and to the west by De Moulham Road. The northern boundary is defined by a stone wall with holiday cabins beyond (northern central section). It generally comprises a partly terraced grassed area that slopes gently down from the west to the east. The eastern boundary is defined by a ~2m high retaining that has seepages (see photo 11) and cracks (see picture 12) visible towards the south of the wall. A path runs north-south approximately ten metres from the eastern boundary on which park benches are placed. There are tension cracks along this path that have been filled in with concrete towards the north of the section (see picture 10.) A weather station is located in the south western corner.

Photo 10 – Hummocky terrain and concrete filled cracks in tarmac (Looking north.)

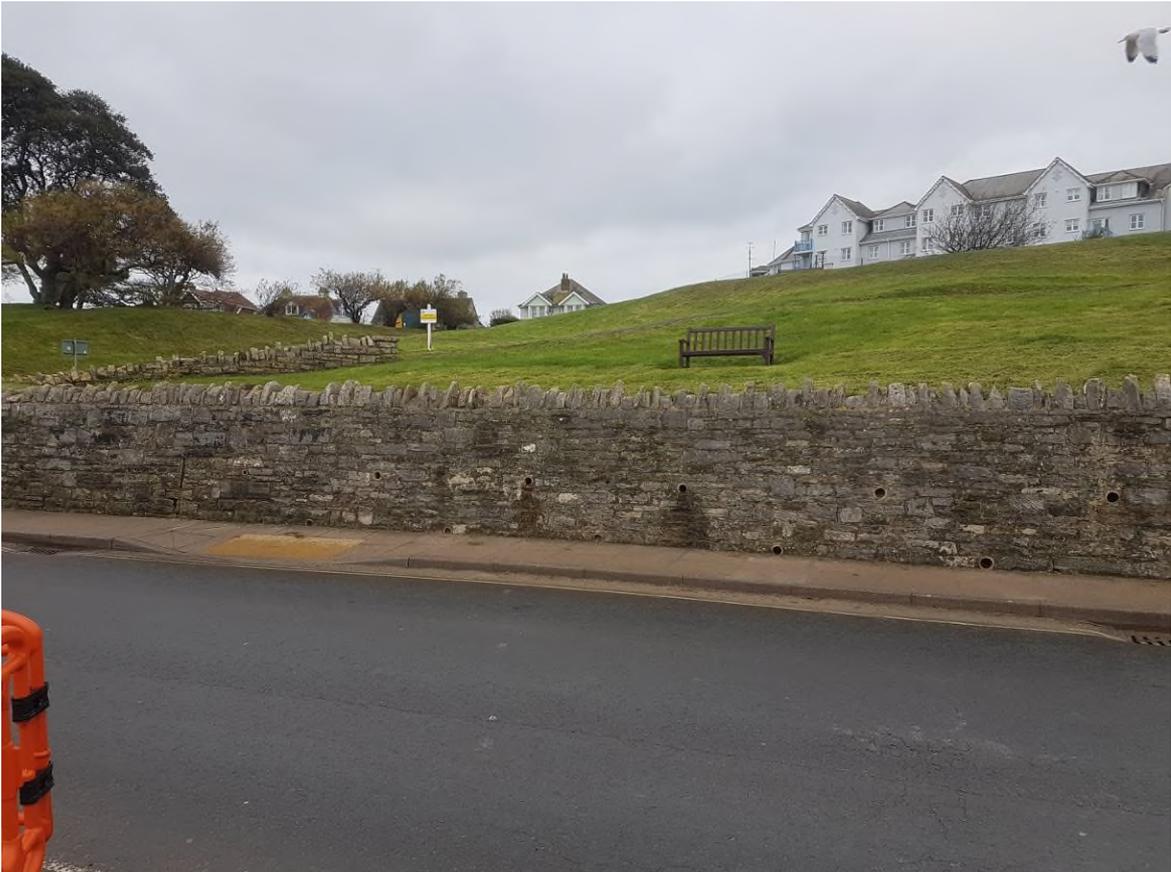
Photo 11 – Seepage from weep hole in the wall. (Looking south west west.)

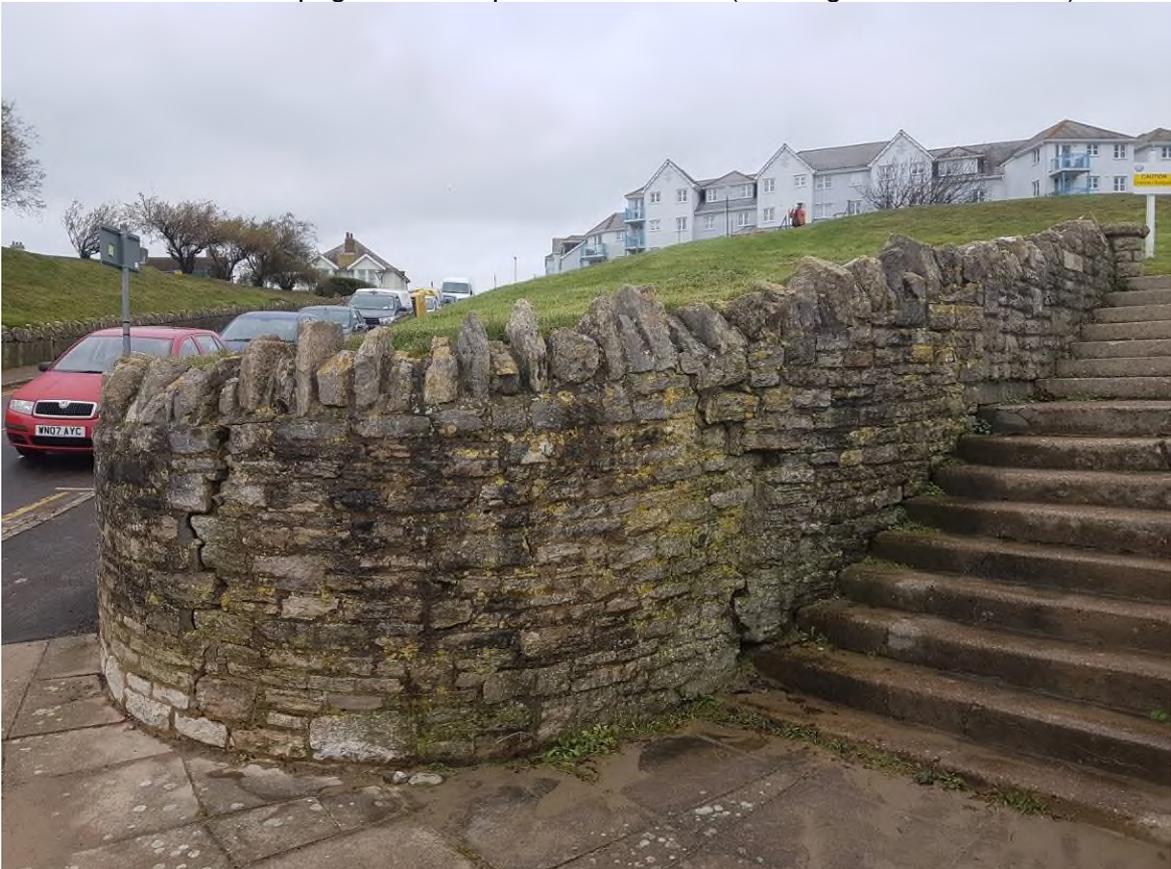
Photo 12 – Cracks in wall. Seepages through wall

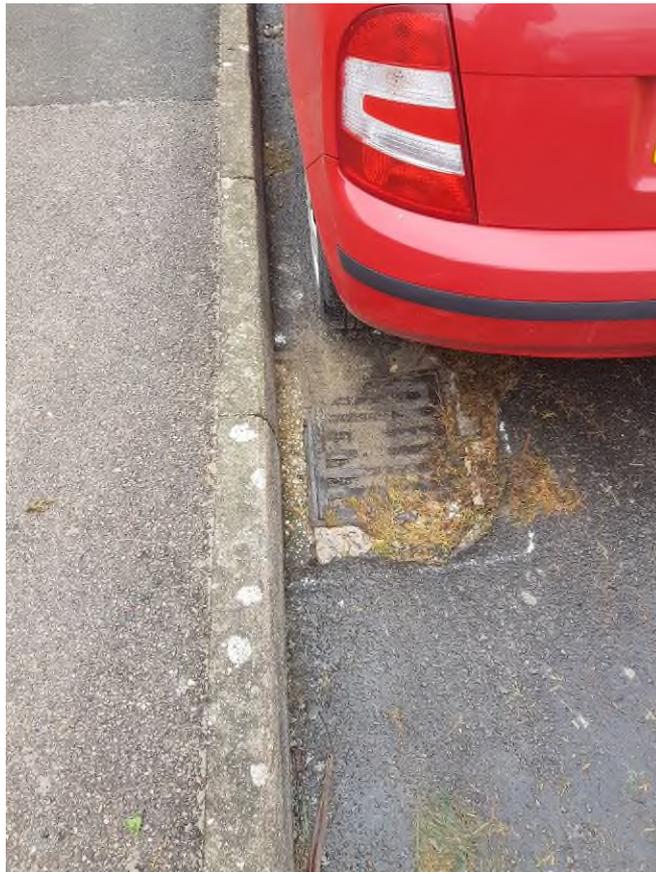
Photo 13 – Drain blockage

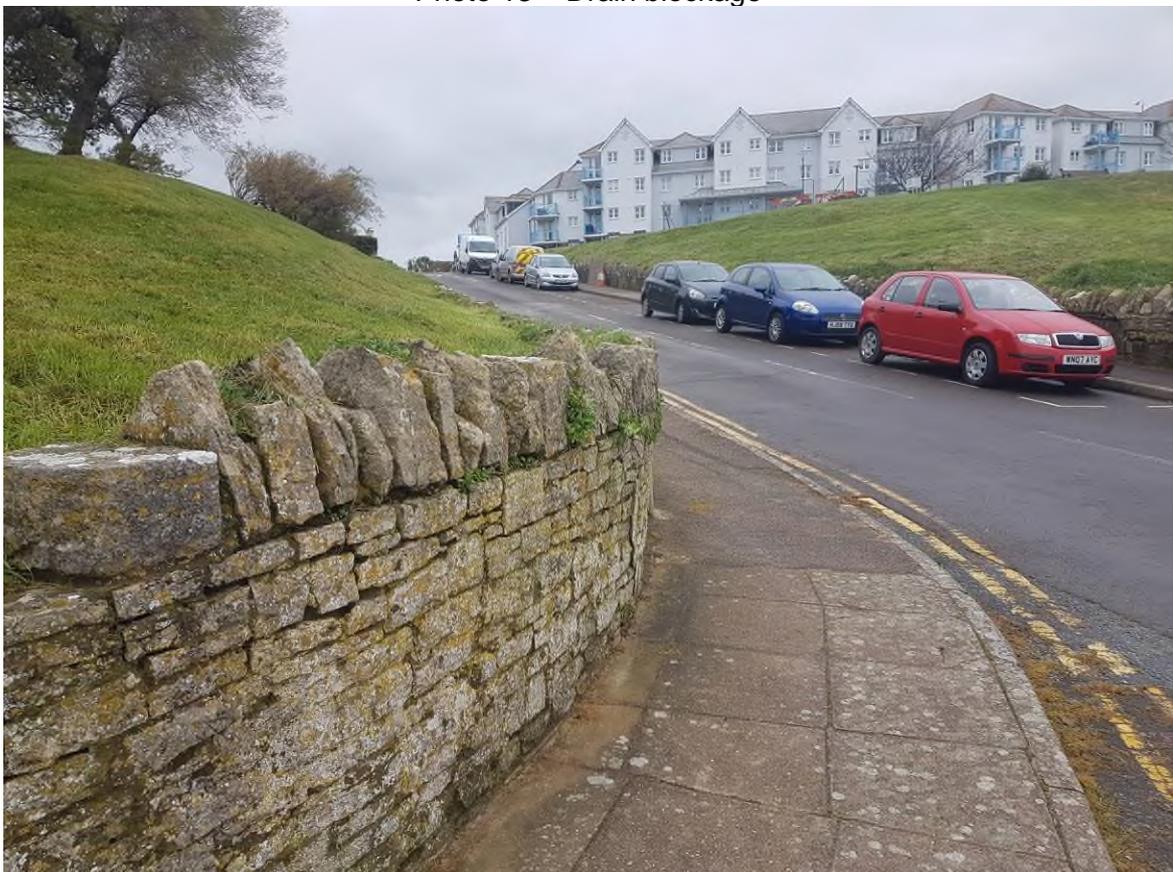
Photo 14 – Tension cracks (looking east.)

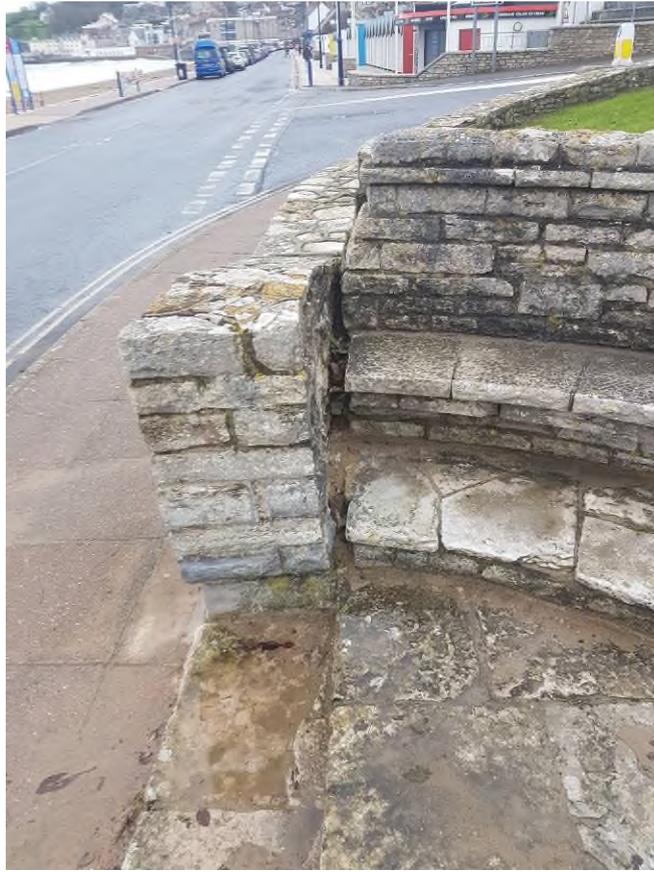
Photo 15 – Tilting wall. Looking south.

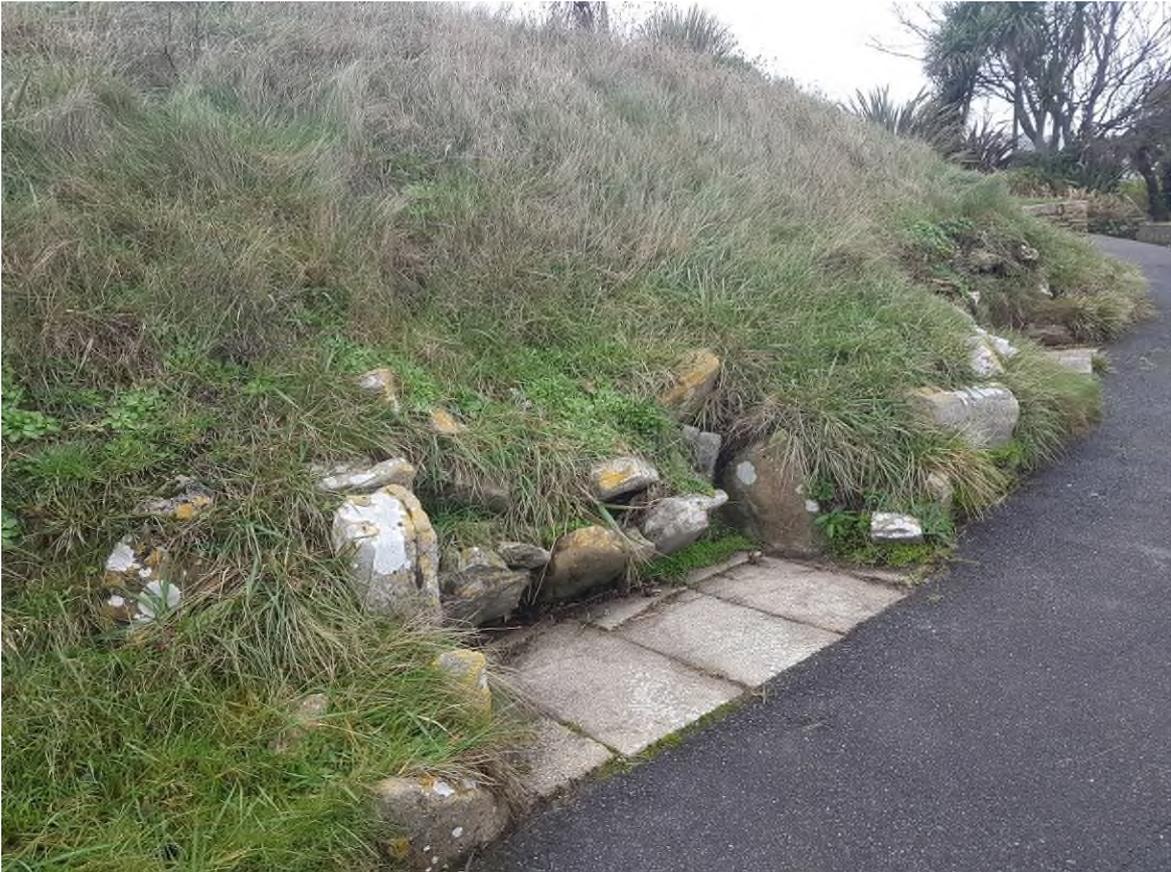
The slope is landscaped and maintained as a formal public garden with terraced grassed areas and formally planted beds that are tilting down slope towards shore road in areas (see photo 17 and 19.). Towards the middle to southern areas of this section, significant soil saturation was noted during the site works, with ponding water (see photo 21) and overland flow as the field slopes off towards the path in the south east of the section (see photo 22.)

Photo 17 – Tilting wall. (Looking north west.)

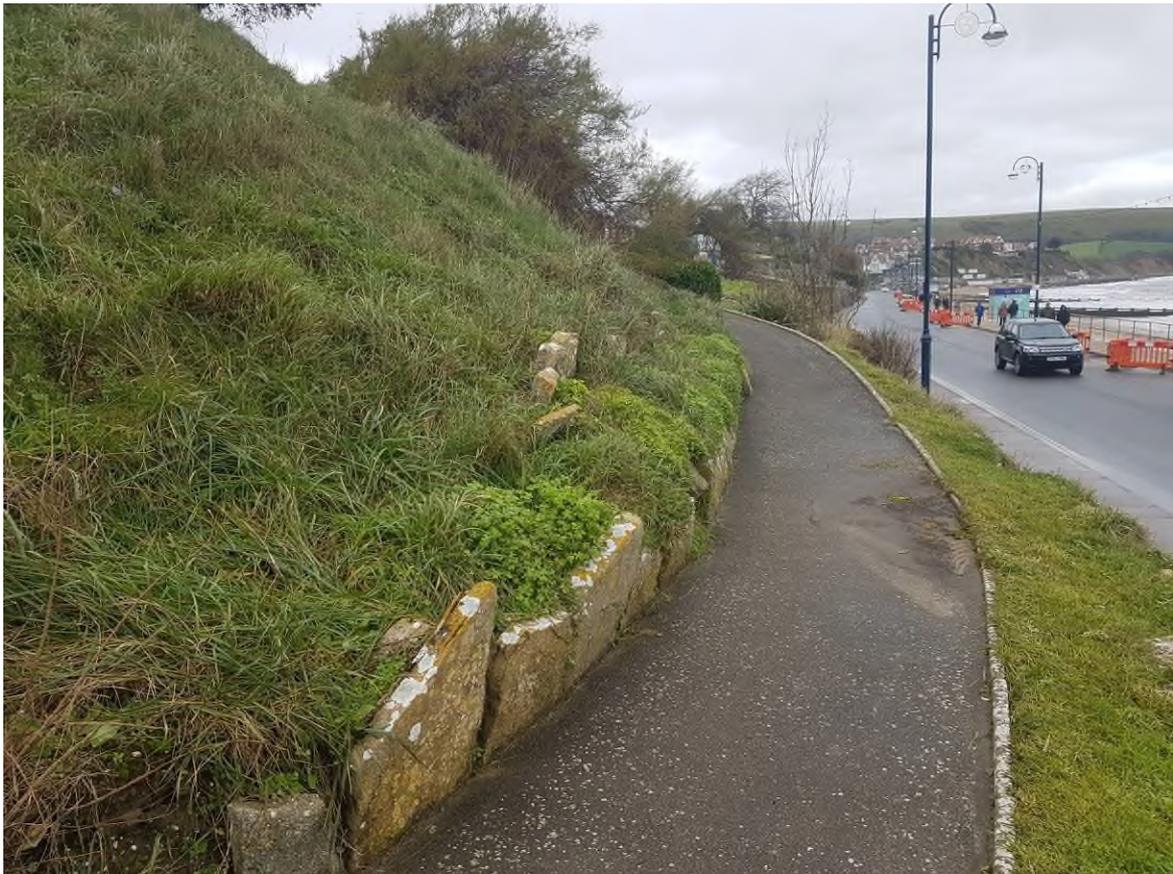
Photo 19 – tilting wall – Looking north.

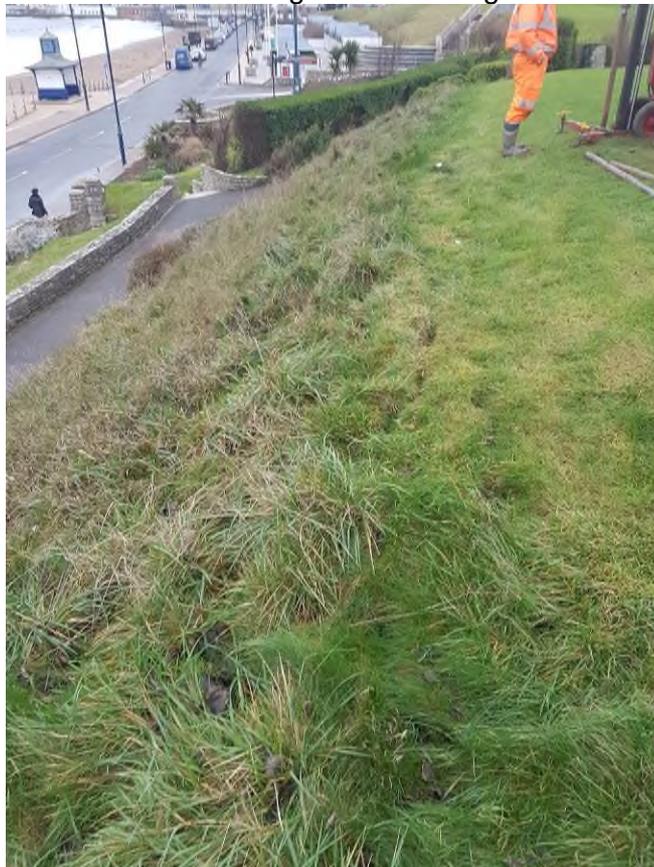
The southern section, known locally as Sandpit Field, is bordered to the south by the A351, to the east by Shore Road with the beach beyond, to the west by De Moulham Road and to the north by Walrond Road. The majority of this section comprises a generally flat, undeveloped grassy area. A bank, approximately + 9.0m above Shore Road to the east forms the eastern boundary of this section, The slope angle of this bank varies from 26 to 40 degrees measured from crest to toe. Tension cracks have been identified along some sections of this slope (see picture 20).

Photo 20 – Tension cracks.

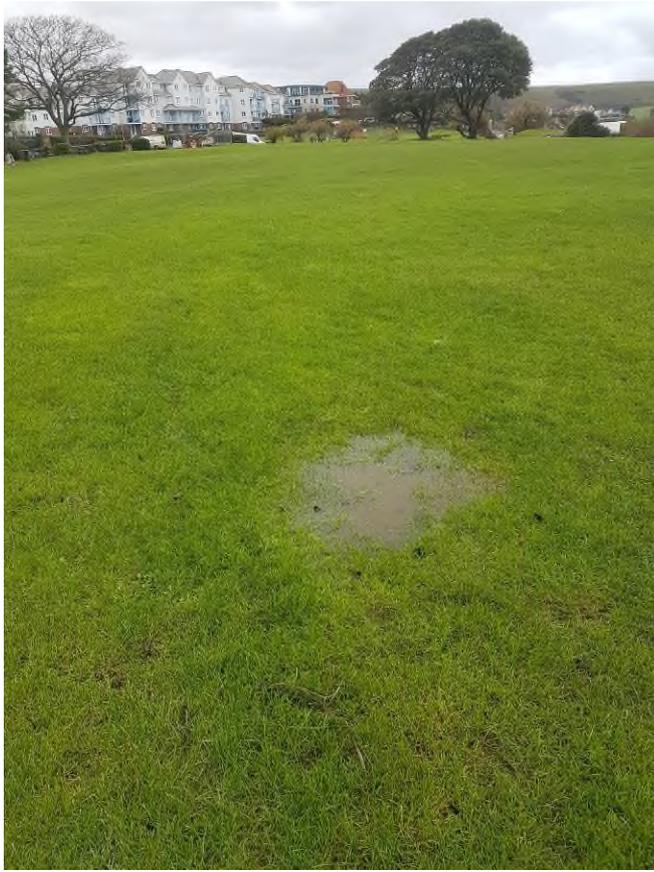
Photo 21 – Ponding water (looking north.)

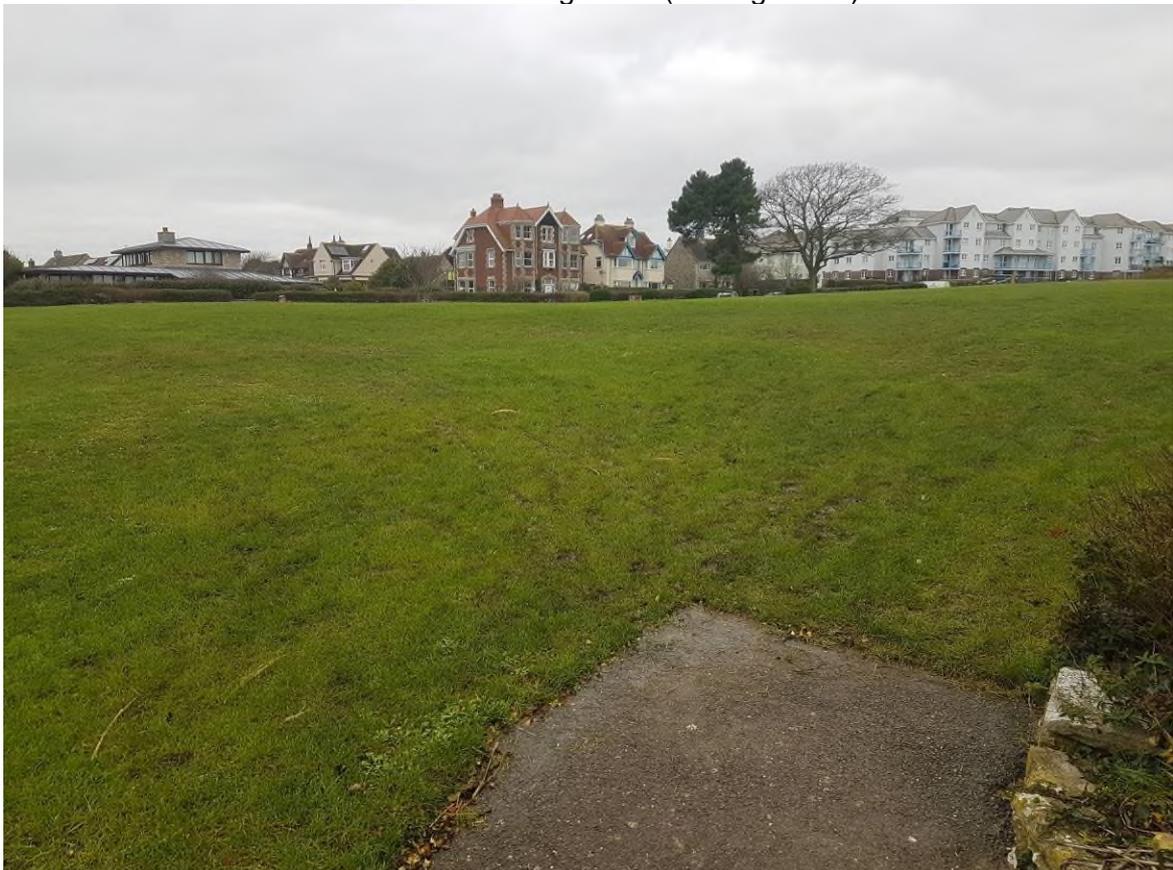
Photo 22 – Seepage through slope. (Looking north west.)

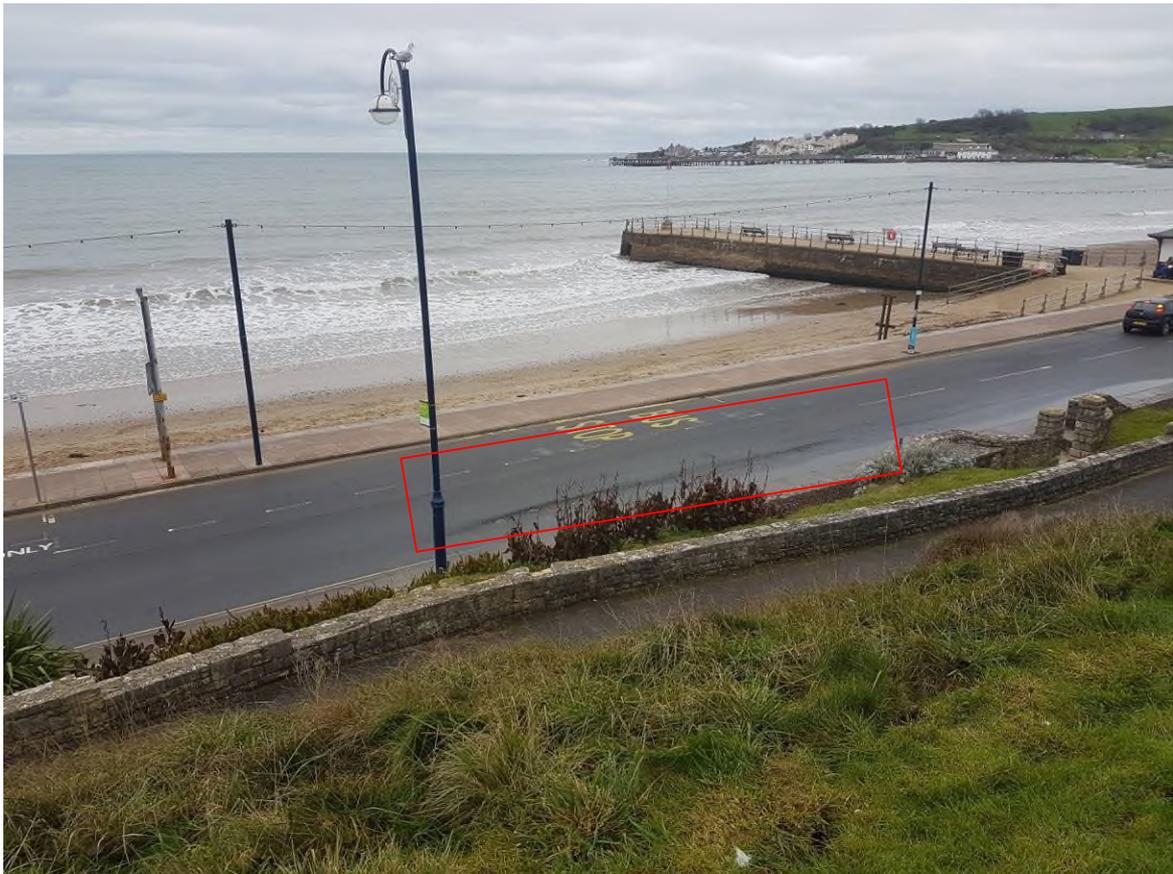
Significant deformation was noted on Shore Road, at the southern end of Sandpit Field (Photos 18 and 23). This may be indicative of a collapsed drain.

Photo 23 – Cracks in the road. (Looking east.)
