TECHNICAL NOTE

DATE:	27 June 2023	CONFIDENTIALITY:	Public
SUBJECT:	Site Monitoring Report – Shore Road		
PROJECT:	Swanage Town Council – Shore Road	AUTHOR:	Sam Rhodes
REVIEWER:	Ben Ward	APPROVER:	David Roy

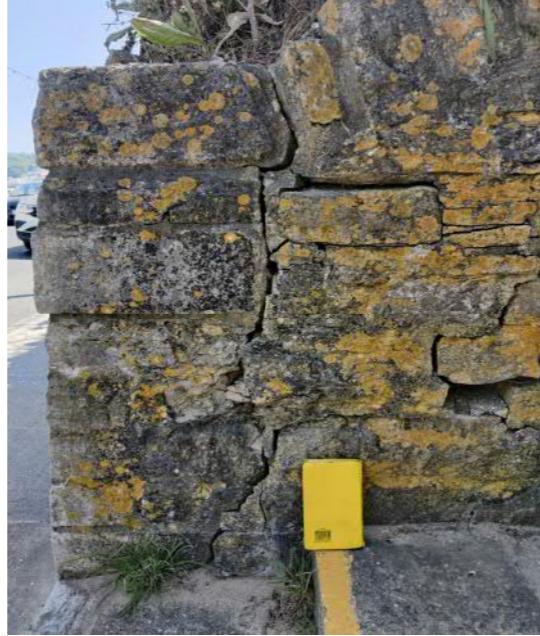
<p>Vertical and horizontal cracking, bulging/horizontal sliding of failing wall section.</p> <p>Crack width 10 - 20mm.</p> <p>Bowing of wall face, up to 40mm.</p> <p>Loose blockwork, missing masonry, loss of mortar between blockwork.</p> <p>Crack length 1.2m</p> <p>wall height 1.2m</p> <p>Retained height 3.0m+.</p>	2	Unlikely	3	High	6	Medium
A2	The Spa	403068	79423	A2

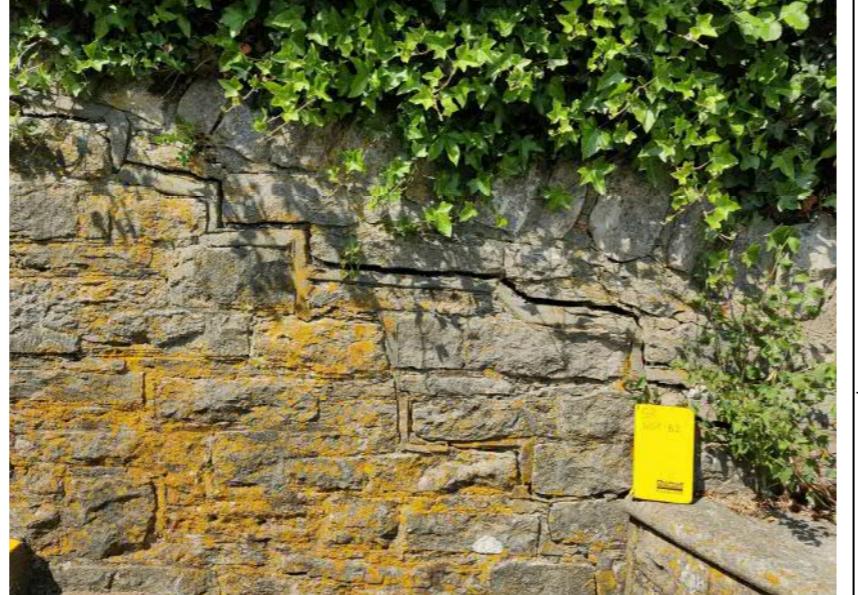
<p>Retaining wall height: 1.3m</p> <p>Retained height: 1.3m</p> <p>Horizontal cracking, crack width up to 10mm. Cracking along failed mortar joint.</p>	2	Unlikely	1	Very Low	2	Low

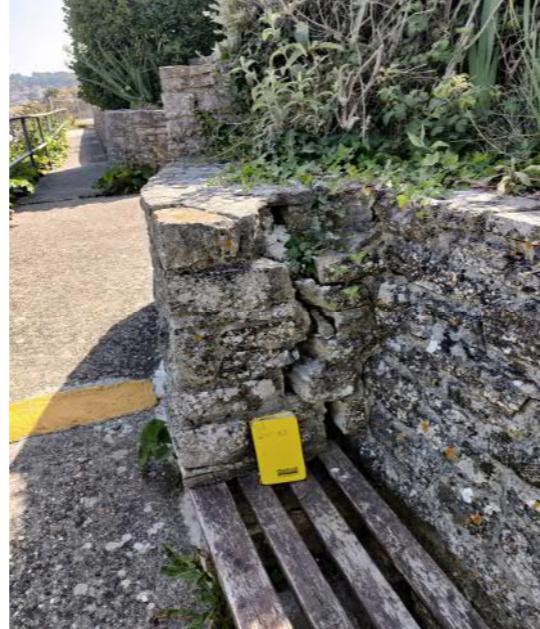
<p>Retaining wall height: 0.8m Retained height: 0.8m</p> <p>Vertical cracking and horizontal displacement of wall. Crack width, 40 - 60mm with loose and missing masonry.</p> <p>Evidence of previous repair attempt with cement mix.</p>	2	Unlikely	1	Very Low	2	Low
A4	The Spa	403060	79395	A4

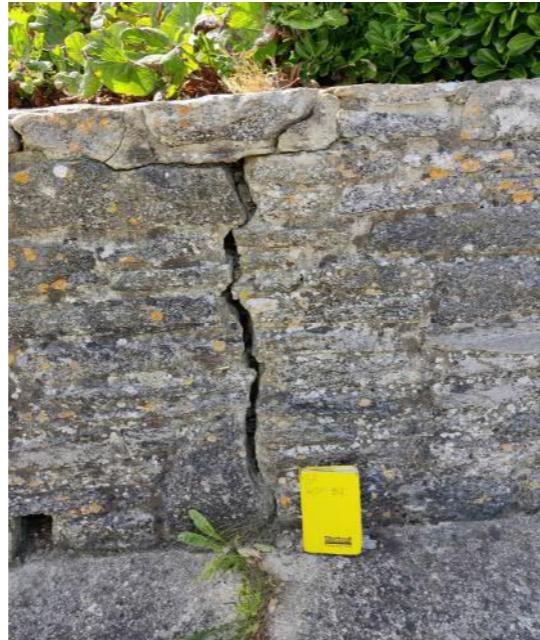
<p>Retaining wall height: 1.0m Retained height: 1.0m</p> <p>Vertical cracking, width up to 30mm. No bowing/bulging of wall face observed.</p> <p>Pavement cracking at base of retaining wall mirroring cracking in retaining wall face.</p>	1	Negligible	1	Very Low	1	Low

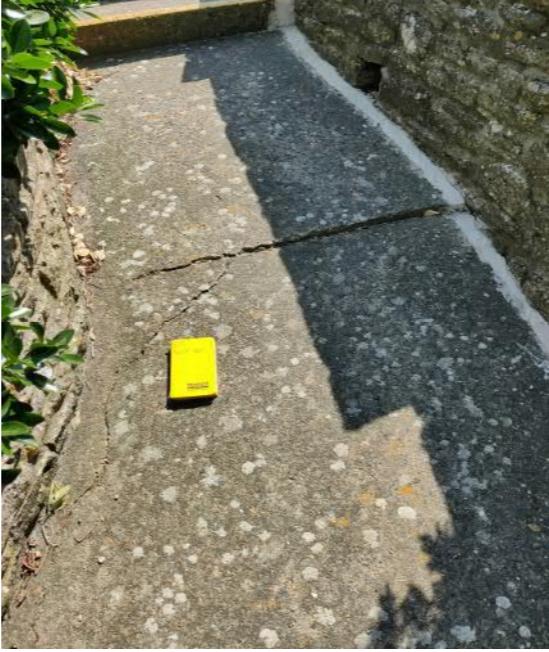
Pavement cracking and uneven ground. Differential settlement/transverse cracking in pavement with height up to 10mm. Longitudinal cracking, with width up to 2mm.	2	Unlikely	1	Very Low	2	Low
A8	The Spa	403052	79390	A8

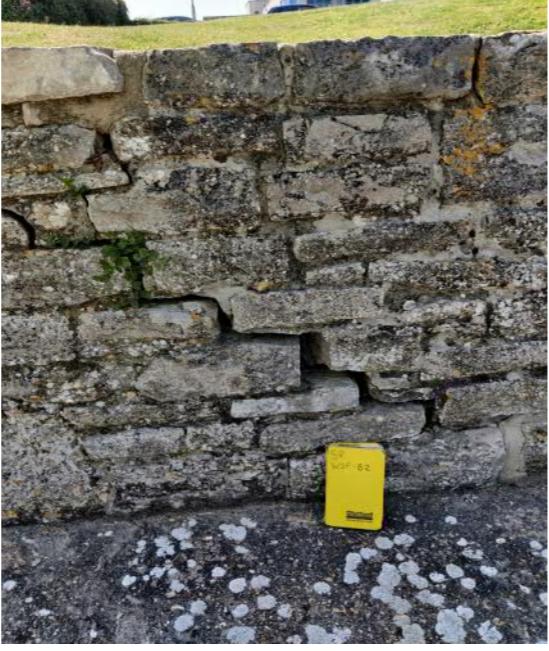
Retaining wall height: 1.0m Retained height: 1.0m Vertical and horizontal cracking, cracking width 30 - 60mm. Length of defect 0.7m. Evidence of minor previous patch repairs with cement mix.	2	Unlikely	1	Very Low	2	Low

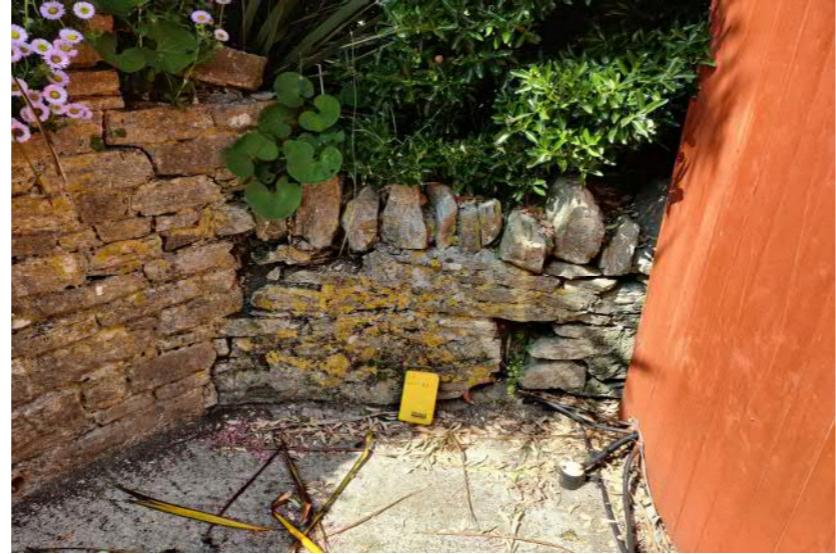
<p>Retaining wall height: 0.9m Retained height: 0.9m</p> <p>Minor vertical cracking, missing masonry blocks and silted up and damaged back of wall drainage.</p> <p>Damage potentially due to running services through wall, post wall construction.</p>	2	Unlikely	1	Very Low	2	Low
A10	Spa Beach Huts	403054	79358	A10

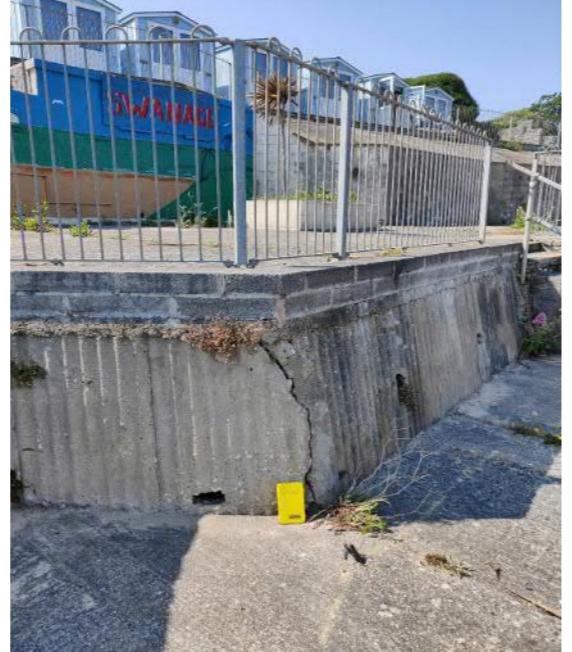
<p>Retaining wall height: 1.25m Retained height: 1.25m</p> <p>Vertical cracking, crack height 0.9m, crack width up to 30mm.</p> <p>Damaged weephole / void at the base of the wall (see left of survey book).</p>	2	Unlikely	2	Low	4	Low

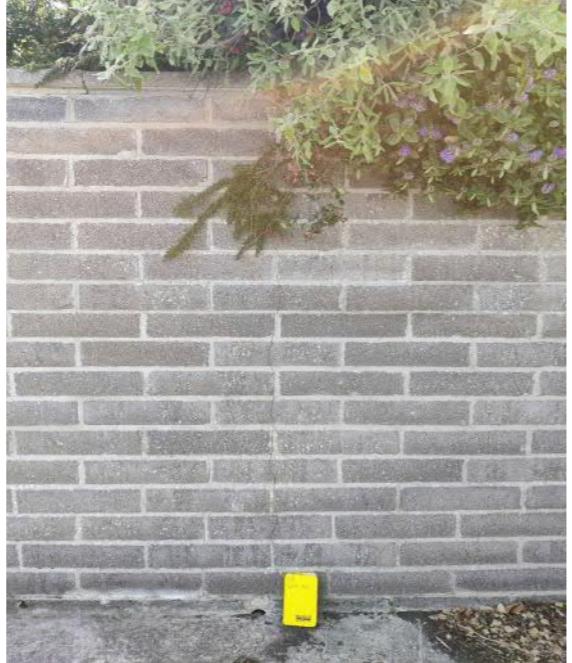
<p>Retaining wall height: 2.15m Retained height 2.15m</p> <p>Hairline vertical cracking full height of the wall, crack width ~1mm.</p> <p>Weephole silted up and 2/3 blocked by additional concrete pours, potentially from previous remedial works.</p>	1	Negligible	3	High	3	Low
A12	Spa Beach Huts	403050	79369	A12

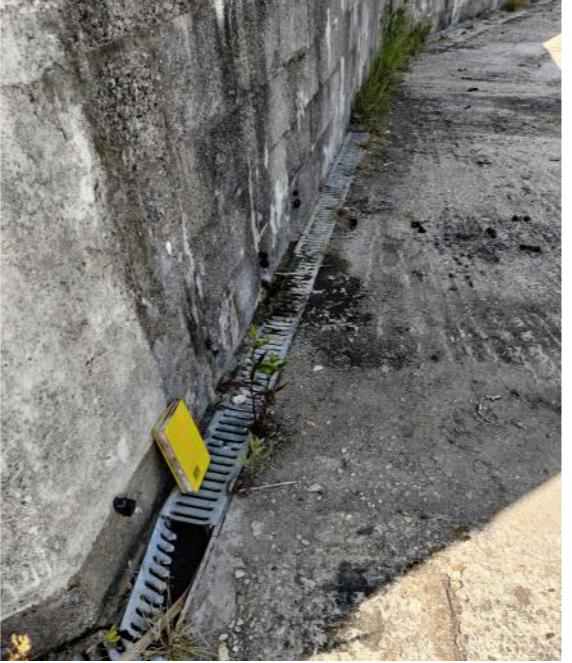
<p>Delapidated aco surface water drainage system.</p> <p>Drainage gratings broken, and invert fully silted up for the full length of the retaining wall.</p>	3	Likely	1	Very Low	3	Low

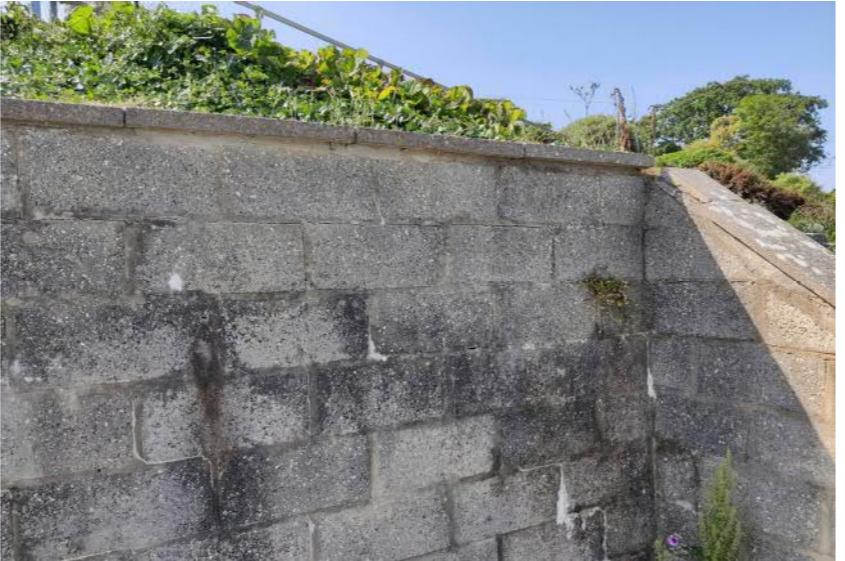
<p>Retaining wall height: 2.15m Retained height: 2.5m</p> <p>Horizontal hairline cracking, crack width 1mm. Cracking located 1.85m from existing ground level.</p> <p>Slight bulging/bowing at the mid span/mid height of retaining wall.</p> <p>Defect length: 8m.</p>	2	Unlikely	1	Very Low	2	Low
A14	Spa Beach Huts	403062	79353	A14

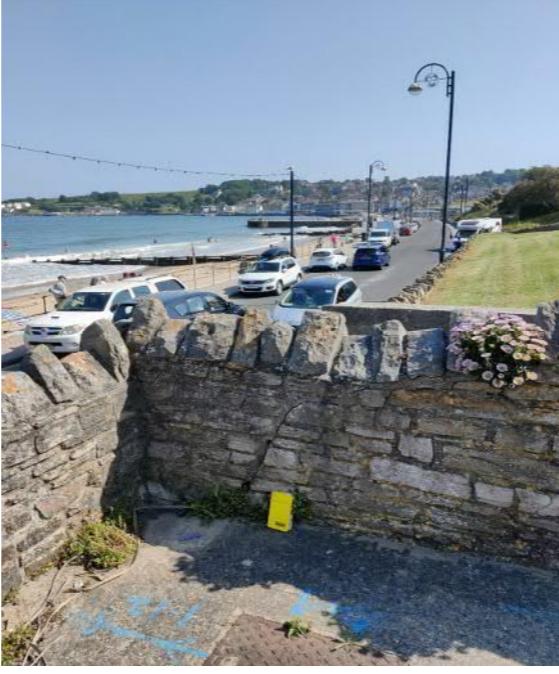
<p>Retaining wall height: 1.2m Retained height: 0m</p> <p>Vertical and horizontal cracking. Crack length 1.1m, crack width up to 3mm.</p> <p>No loose masonry or missing blockwork. No bulging or bowing of the wall structure.</p>	2	Unlikely	1	Very Low	2	Low

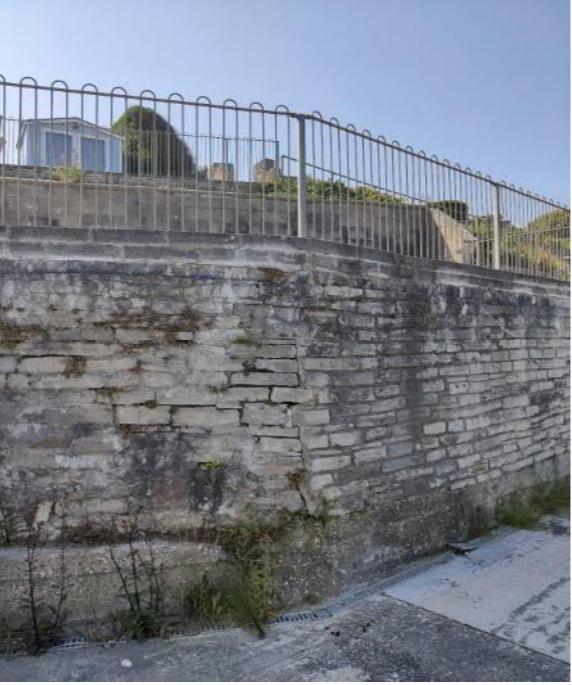
<p>Retaining wall height: 2.55m Retained height: 2.55m</p> <p>Vertical cracking, crack length 1.3m, typical crack width between 3 - 10mm.</p> <p>Bulging/bowing at corner section of masonry wall.</p> <p>Loss of mortar between blockwork.</p>	2	Unlikely	2	Low	4	Low
A16	Spa Beach Huts	403060	79381	A16

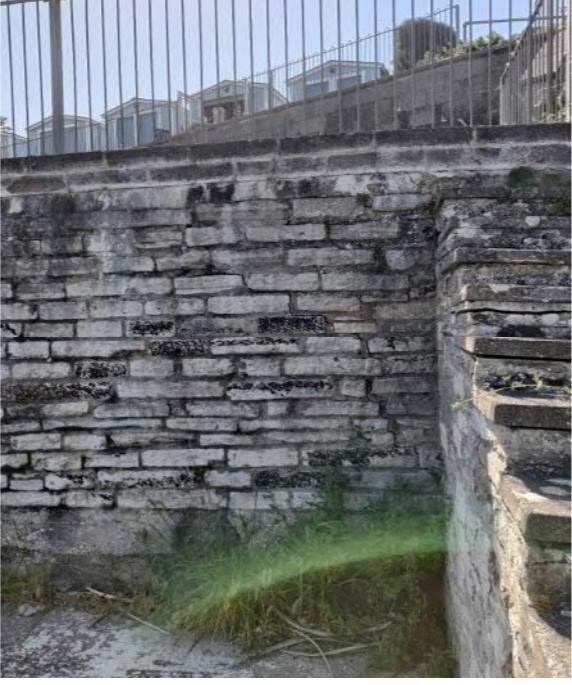
<p>Retaining wall height: 2.55m Retained height: 2.55m</p> <p>Horizontal and vertical cracking. Crack length 1.6m. Typical crack width 3 - 10mm.</p> <p>Bulging/bowing at the mid span of masonry wall.</p>	1	Negligible	2	Low	2	Low

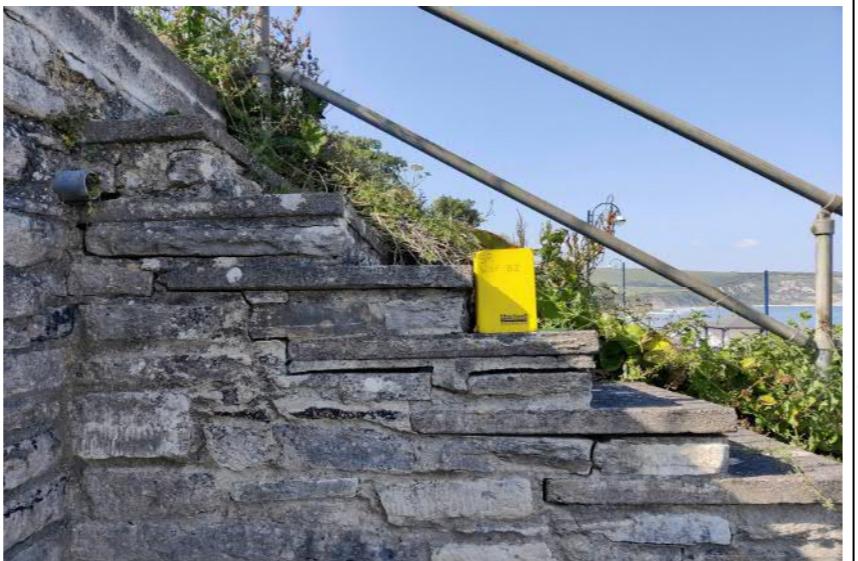
<p>Retaining wall height: up to 2.2m Retained height: up to 2.5m.</p> <p>Horizontal cracking. Crack length 1.8m. Crack width 3 - 12mm.</p> <p>Horizontal movement of return wall causing cracking, potentially due to bulging/bowing from the main span.</p>	1	Negligible	1	Very Low	1	Low
B1	Weather Station Field	403050	79339	B1

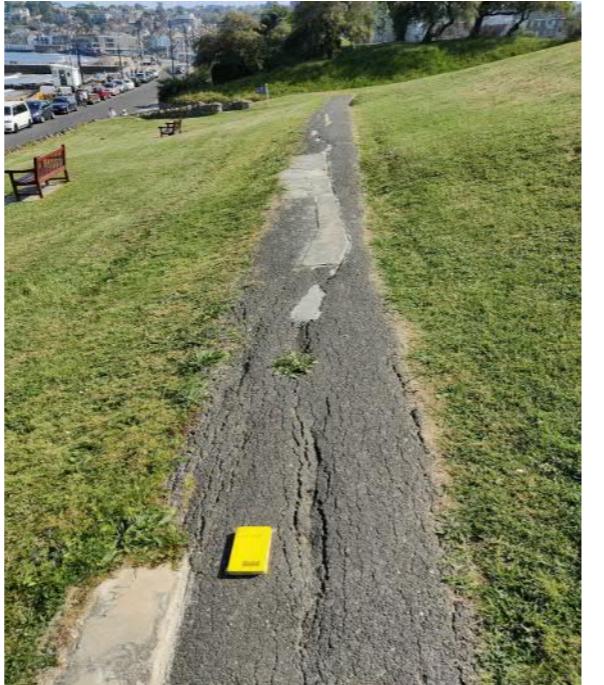
<p>Pavement tension cracking, surface deformation and partial collapse.</p> <p>2no. continuous cracks observed, 3.6m and 11m in length respectively.</p> <p>Multiple patch repairs with asphalt and cement/concrete mix.</p> <p>Ground uneven and with numerous cracks. Crack depths ranging between 5 - 10mm where repairs have not been completed.</p>	3	Likely	2	Low	6	Medium

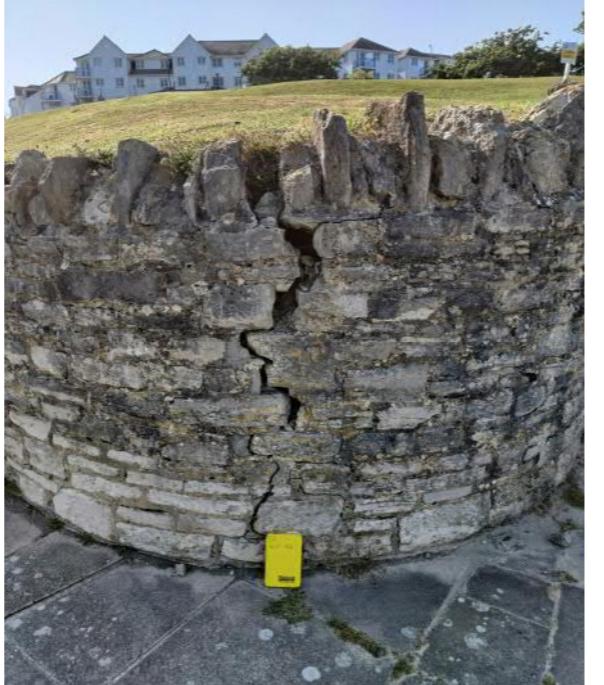
<p>Retaining wall height: 1.8m Retained height: 1.8m</p> <p>Curved wall with 3no. sets of vertical cracking. From south face of retaining wall, cracks are at chainage CH 0, 2.0, and 5.5m. Total length of defect: 5.5m.</p> <p>CH 0m Defect: Vertical cracking, crack width typically 30 - 50mm. Missing blockwork at the head of the wall, with significant voids behind mid span of wall (potentially lost mortar or block work following movement).</p> <p>CH 2.0m Defect: Vertical cracking, max crack width typically 90 - 130mm, increasing with height of wall. Missing blockwork at top of wall.</p> <p>CH 5.5m Defect: Vertical cracking, crack width up to 10mm. Blockwork intact.</p>	3	Likely	3	High	9	High

- Areas identified as having high risk (risk rating equal to or greater than 9), should be visually inspected weekly, or after periods of heavy and prolonged rainfall, to ensure no rapid deterioration in the asset has occurred; and
- The retaining wall at the south east corner of Weather Station field (defect ref. B4), should be fenced off using temporary Heras panels (or similar) to reduce the risk of harm to members of the public, in the event failure of the wall occurs.

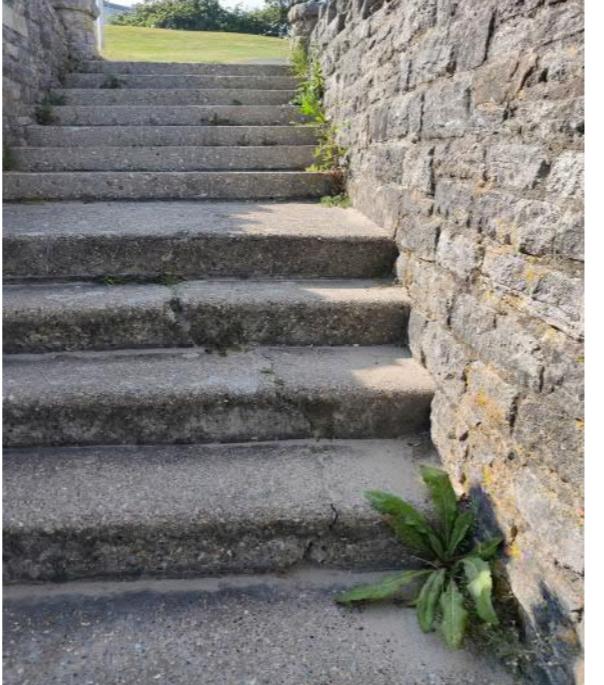
B5	Weather Station Field	403054	79310	B5

<p>Vertical cracking on footpath/stepped access.</p> <p>Crack length 3m, typical crack width 1 - 2mm.</p>	2	Unlikely	1	Very Low	2	Low

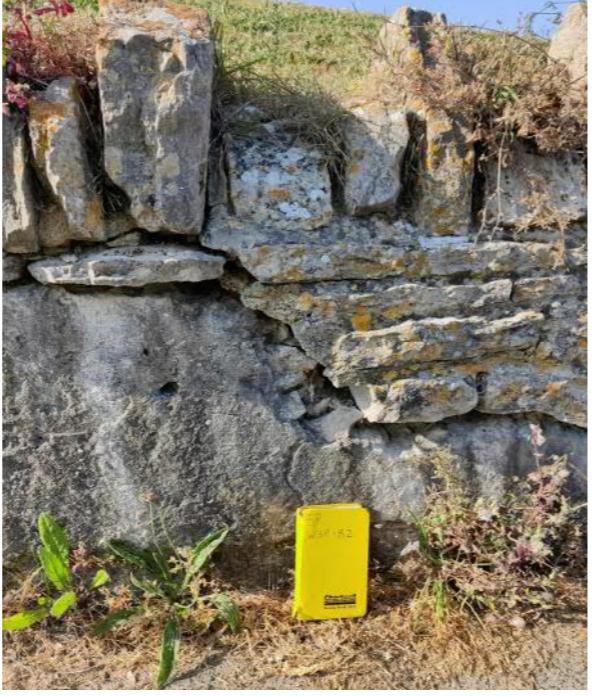
Retaining wall height: 1.0m. Retained height: 1.5m Vertical and horizontal cracking, crack length 0.8m. Typical crack width 40 - 60mm. Minor bowing of the wall at mid height.	1	Negligible	1	Very Low	1	Low
B7	Weather Station Field	403034	79304	B7

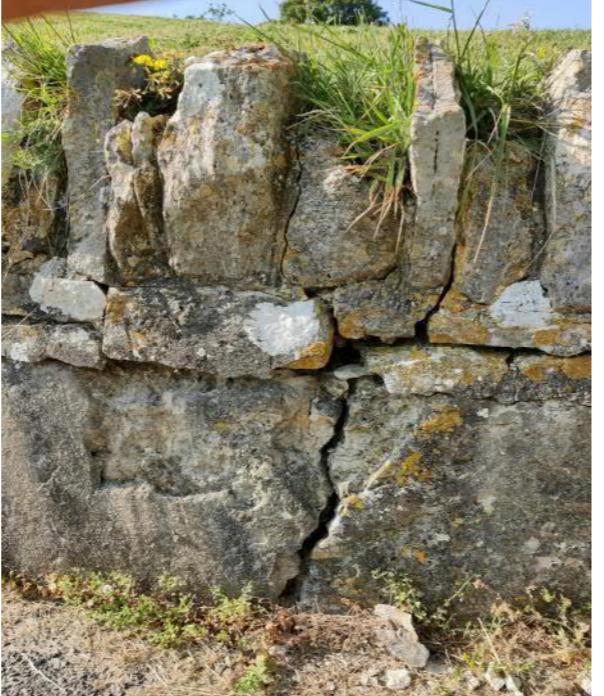
Retaining wall height: 0.9m Retained height: 1.0m. Vertical cracking, from base to top of wall (i.e. 0.9m), crack width between 20 - 40mm.	1	Negligible	1	Very Low	1	Low

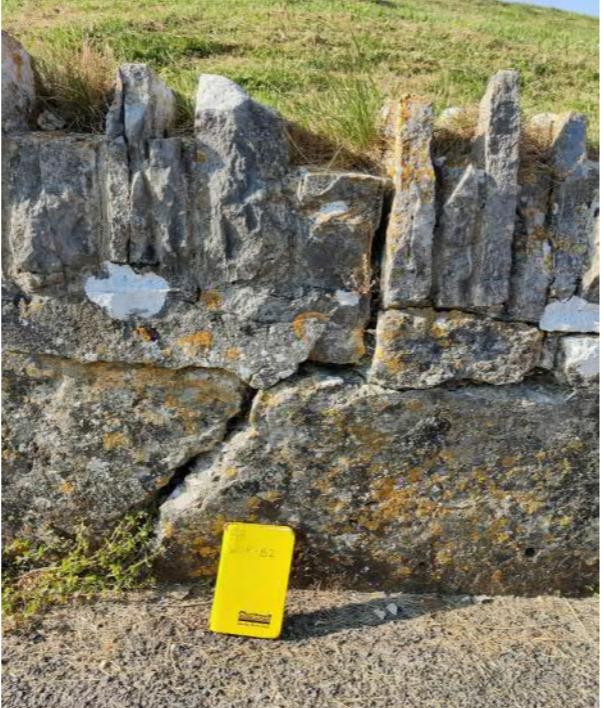
<p>Retaining wall height: 0.85m Retained height: 1m +</p> <p>Vertical and horizontal cracking, the full height of the wall (0.85m), with typical crack width of 20mm.</p> <p>Lower right side (east) of wall translational movement relative to rest of wall.</p>	1	Negligible	1	Very Low	1	Low
B9	Weather Station Field	403017	79304	B9

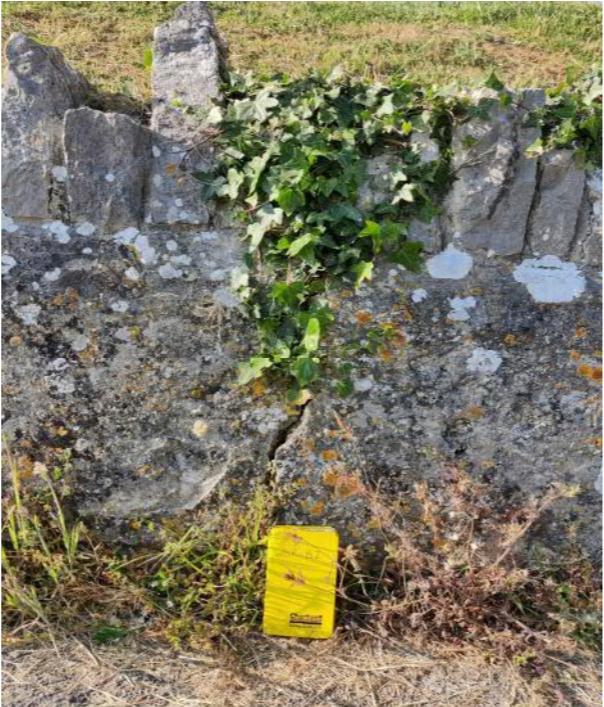
<p>Retaining wall height: 1.0m Retained height: 1.0m</p> <p>Vertical cracking, running full height of the wall. Right of the crack (east side of the wall), 30mm translational movement of the wall relative to the west side.</p> <p>Pavement cracking adjacent to retaining wall observed from base of retaining wall.</p>	1	Negligible	1	Very Low	1	Low

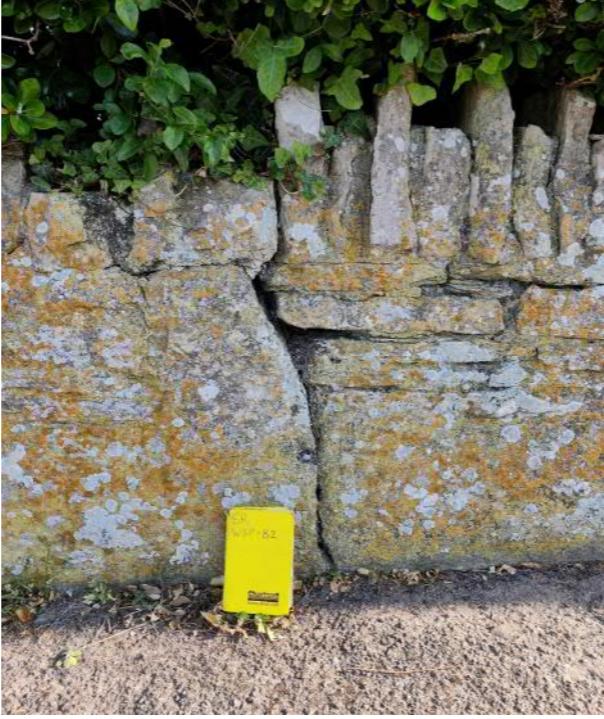
<p>Retaining wall height: 1.0m. Retained height: 1.0m</p> <p>Vertical cracking, full height of wall, typical crack width 5 - 30mm.</p> <p>Large bushes overhanging back of retaining wall, likely the cause of distress observed in the structure.</p>	2	Unlikely	1	Very Low	2	Low
C2	Sandpit Field	403009	79294	C2

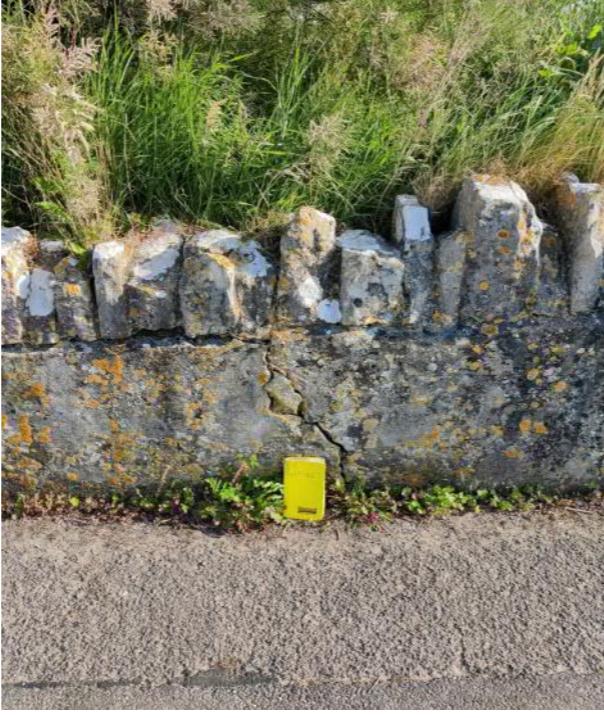
<p>Retaining wall height: 0.8m Retained height: 0.8m</p> <p>Vertical cracking full height of wall, typical crack width 5 - 20mm.</p> <p>Evidence of historic patch repair made previously.</p>	1	Negligible	1	Very Low	1	Low

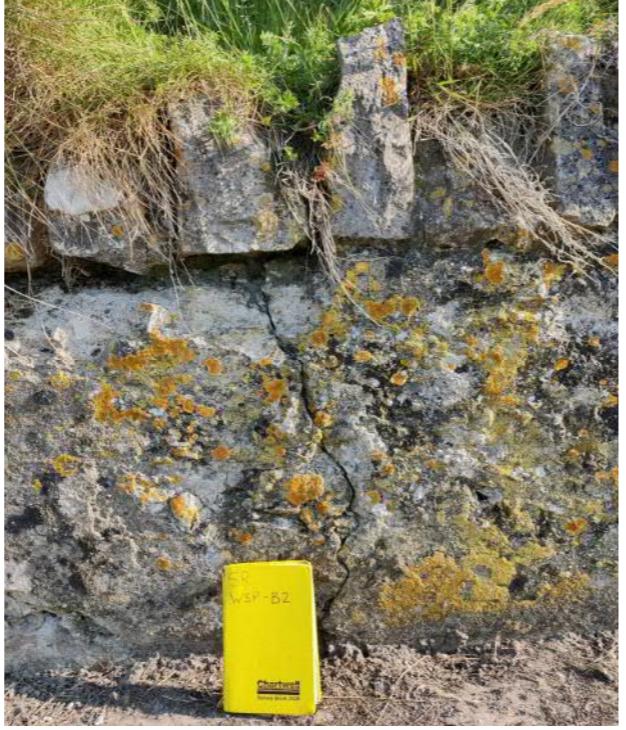
Retaining wall height: 0.95m Retained height 1.0m Vertical cracking, full height of wall, crack width between 1 - 3mm.	1	Negligible	1	Very Low	1	Low
C4	Sandpit Field	403035	79295	C4

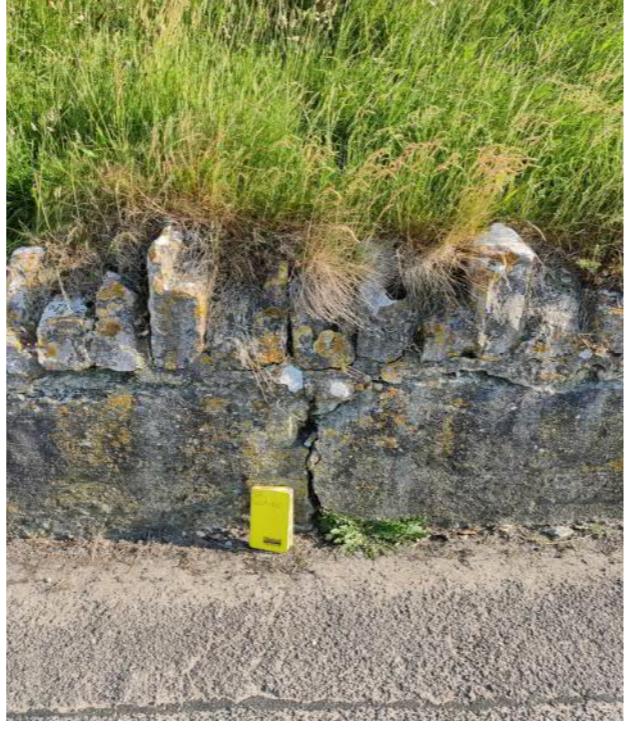
Retaining wall height: 1.0m Retained height: 1.2m Vertical cracking, full height of wall. Crack width 20 - 40mm.	1	Negligible	1	Very Low	1	Low

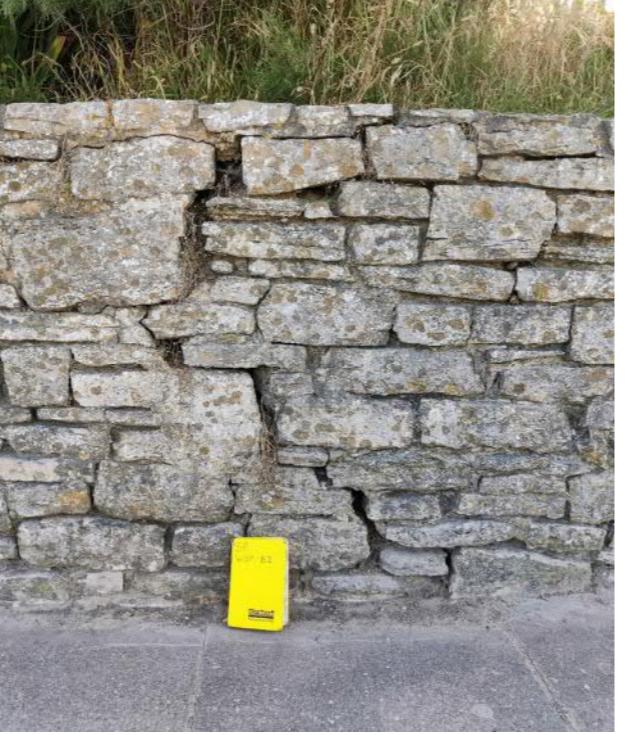
<p>Retaining wall height: 1.25m Retained height 1.25m</p> <p>Vertical and horizontal cracking, typical crack width 20 - 30mm.</p> <p>Transverse movement of the wall, mortar joint failure from masonry blockwork moving apart.</p>	2	Unlikely	2	Low	4	Low
C6	Sandpit Field	403054	79280	C6

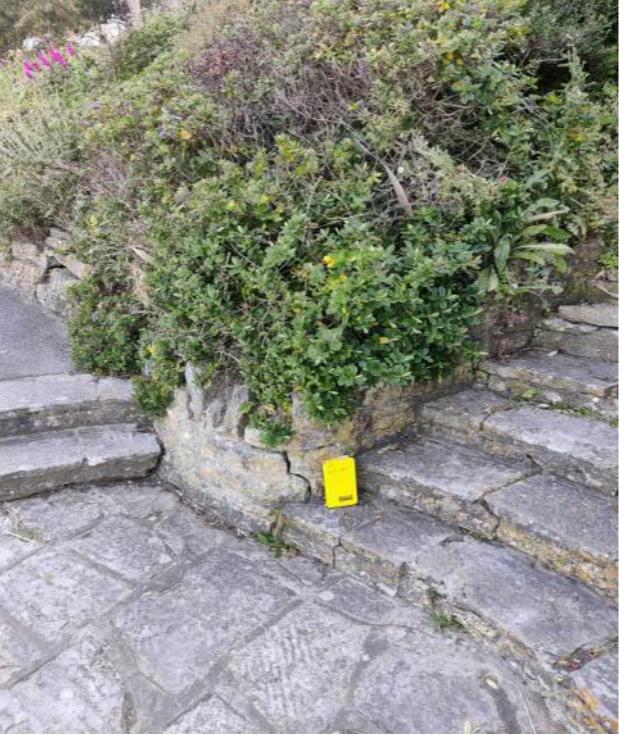
<p>Retaining wall height: 0.6m Retained height: 1.5m+</p> <p>Vertical cracking full height of the wall. Typical crack width between 10 - 15mm. Overgrown bushes and vegetation acting on the back of the wall the likely cause of deterioration of the retaining structure.</p>	2	Unlikely	2	Low	4	Low

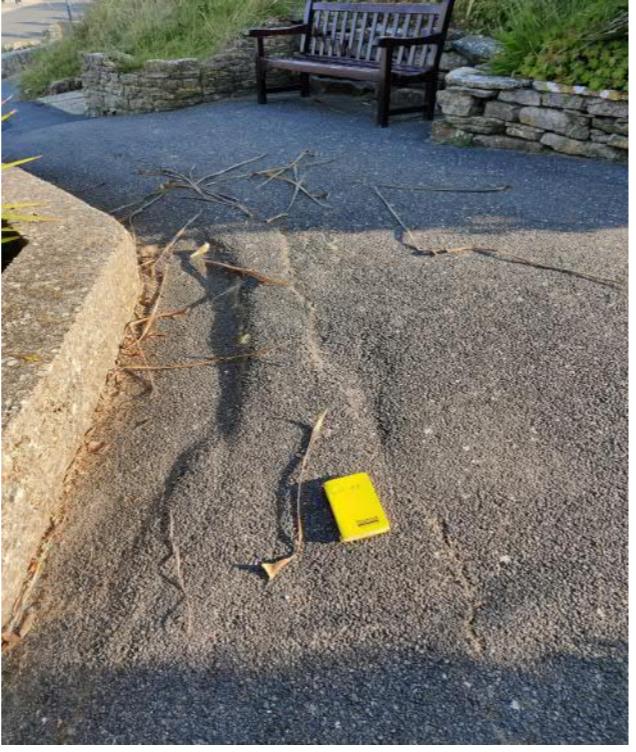
<p>Multiple areas of pavement cracking and surface deformation (one example shown face left).</p> <p>Distress in asphalt behind lower slope retaining walls observed where rotation of lower wall was seen (see defect C13).</p> <p>Additional areas of distress in pavement seen where up slope area is oversteepened and not effectively restrained by retaining structure or otherwise, see defect C12.</p>	3	Likely	2	Low	6	Medium
C8	Sandpit Field	403056	79252	C8

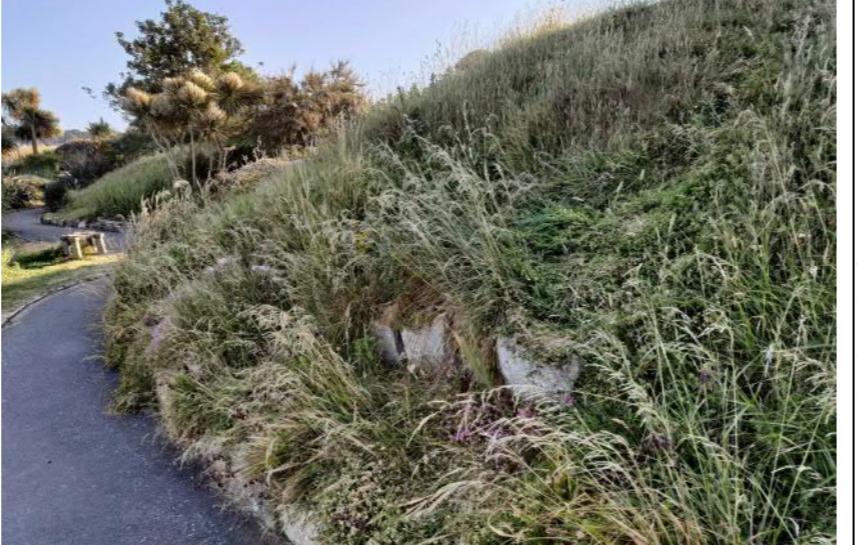
<p>Retaining wall height: 1.3m Retained height 3.0m +</p> <p>6 lm of terraced masonry blocks which were observed to be overturning with over steepened slope behind. Blocks likely installed to prevent shallow slip failure of material above, however global stability of slope borderline.</p>	2	Unlikely	2	Low	4	Low

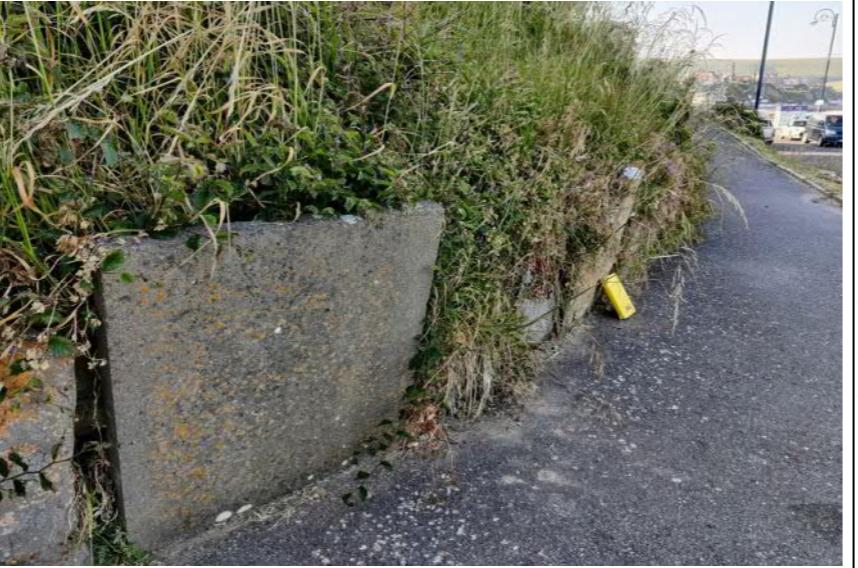
Retaining wall height: 0.6m Retained height: 3m + 7.5 lm of retaining wall blocks partially overturned at toe of retaining wall. Insufficient embedment of blocks at toe, and oversteepened slope behind overloading wall.	2	Unlikely	2	Low	4	Low
C10	Sandpit Field	403052	79239	C10

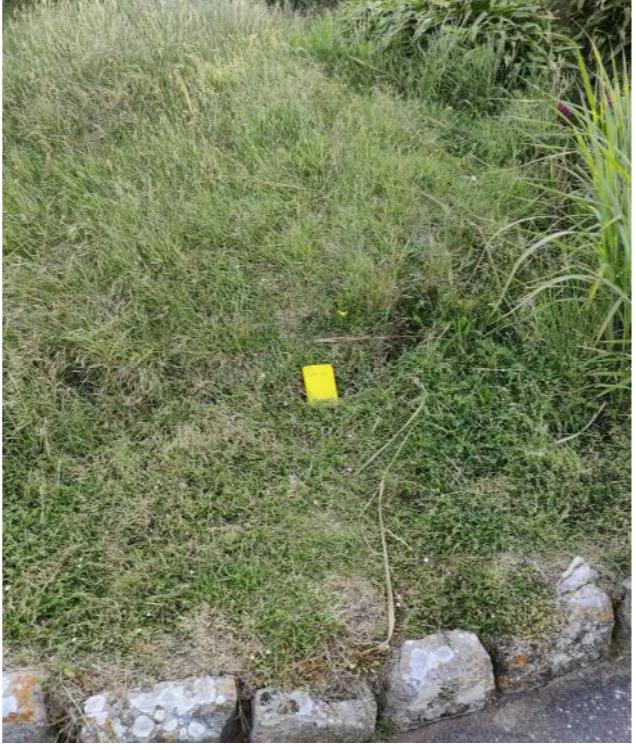
3 lm of tension cracking observed in oversteep section of slope. Width of tension crack approx 200mm, and 250mm depth in areas.	3	Likely	2	Low	6	Medium

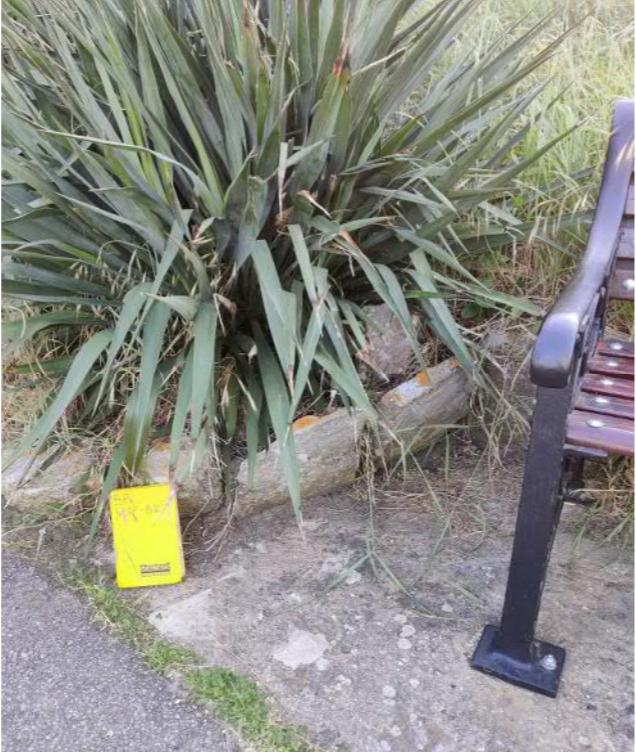
<p>Retaining wall height: 0.3m Retained height: 3m+</p> <p>2 lm section of retaining wall at the rear of benches, has overturned by 30 degrees from vertical.</p> <p>Large overgrown vegetation acting immediately behind the rear of wall, likely cause of issue.</p>	1	Negligible	1	Very Low	1	Low
C12	Sandpit Field	403055	79202	C12

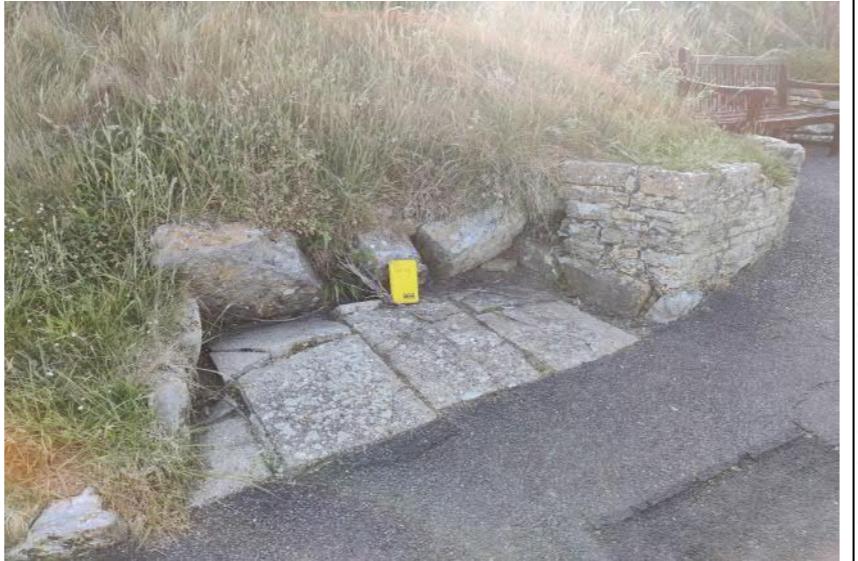
<p>3no. Failed retaining wall which use to house benches.</p> <p>Retaining wall height: 0.6m Retained height 2.5 - 3.5m +</p> <p>Masonry wall fully overturned and collapse of the main wall span. Partial collapse of the return walls either side of each retaining wall.</p> <p>Bulging and hummocking of stone slab at ground level, and signs of distress in adjacent asphalt where retaining walls have failed, indicating greater/deeper global failure occurring.</p>	3	Likely	2	Low	6	Medium

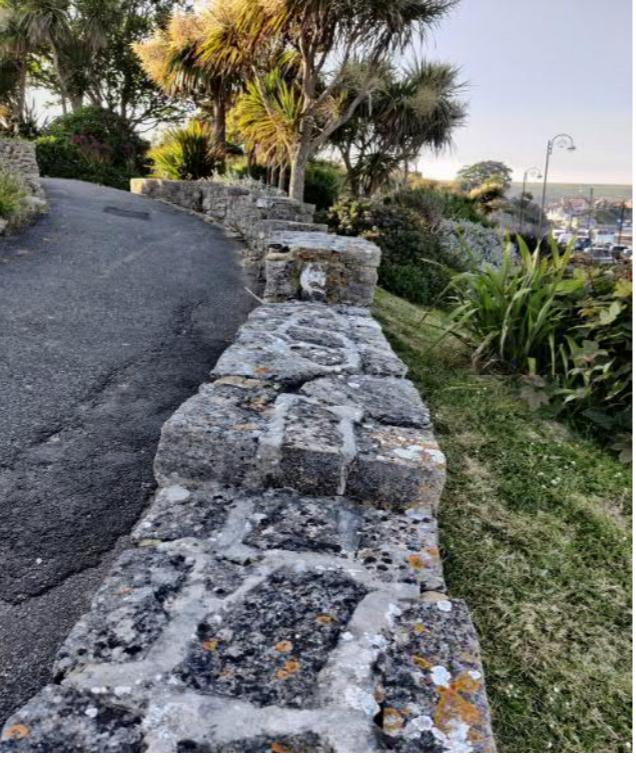
<p>Retaining wall height: 1.0m Retained height: 0.3m</p> <p>Minor tilt/overturning observed in section of masonry wall. Area of overturning matches asphalt repairs and scarring work indicating link between the two.</p> <p>Defect length 22 lm.</p>	2	Unlikely	2	Low	4	Low
C14	Sandpit Field	403039	79146	C14

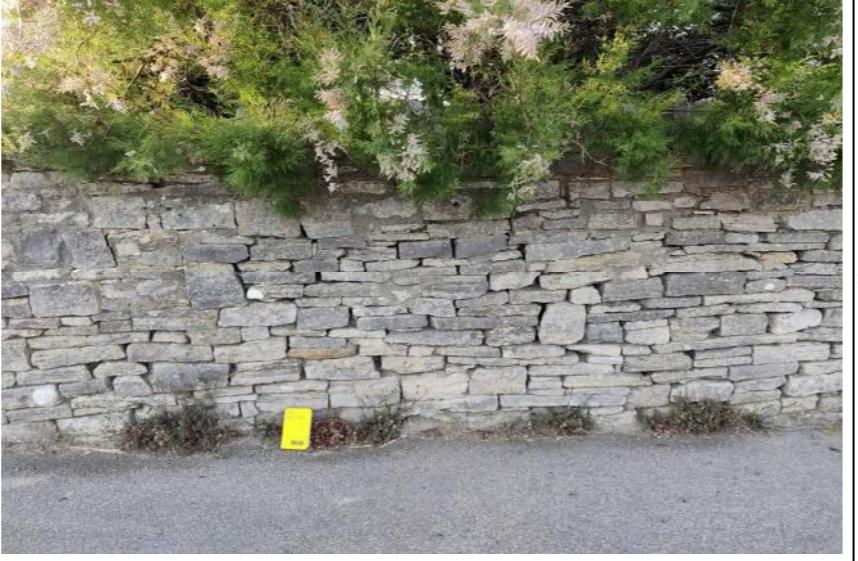
<p>Retaining wall height: 1.25m Retained height: 1.25m</p> <p>Lack of mortar joints connecting this section of wall, therefore potential reconstruction of wall section with dry stone wall technique.</p> <p>Mid height bulging/bowing of the wall likely due to large bushes/trees directly overhanging the back of the wall.</p> <p>Defect length approx 6 lm.</p>	2	Unlikely	2	Low	4	Low

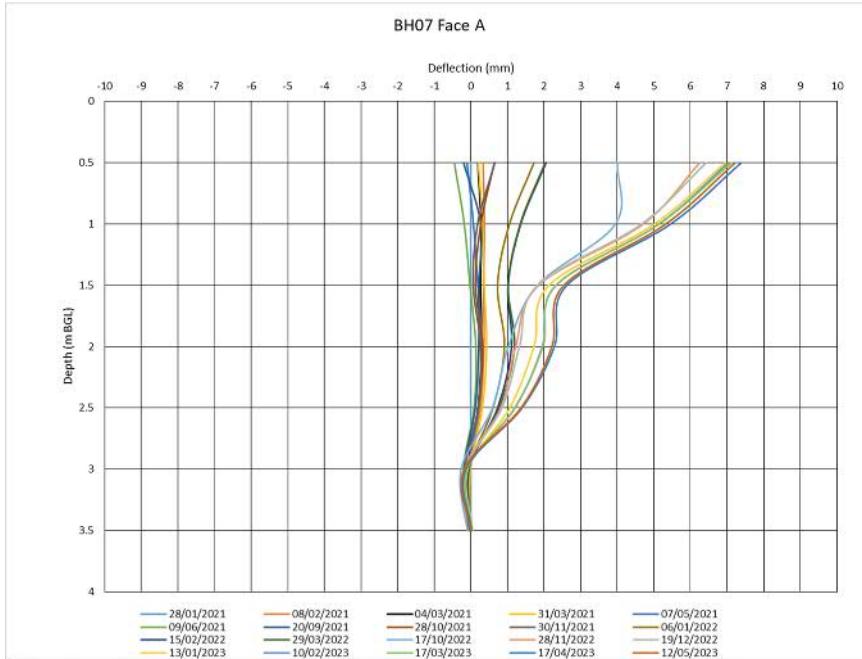
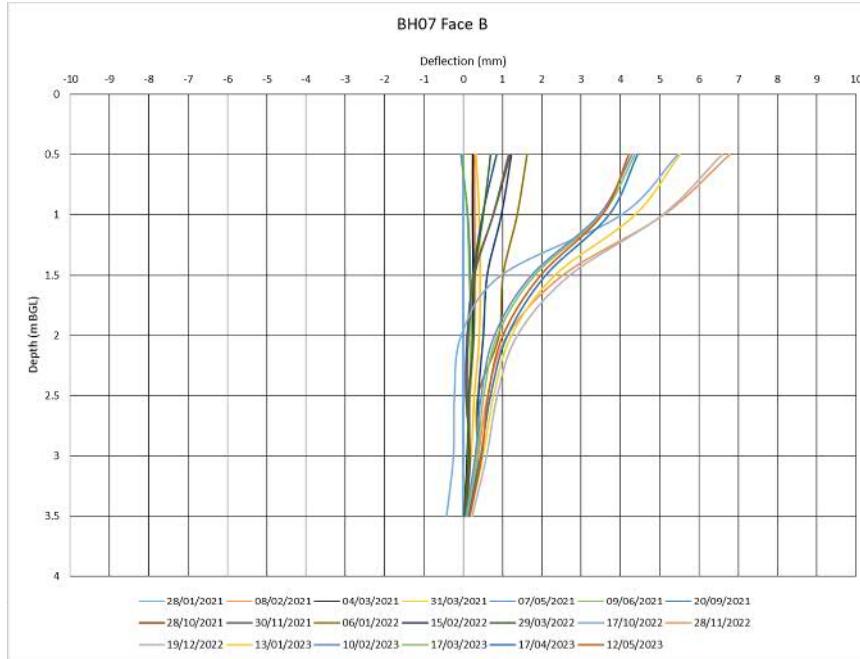
BH07 Inclinometer Results

3.4 Areas where significant wall or slope distress was identified, correlate with inclinometer data, namely BH07 and BH08 in Weather Field Station, and BH10 and BH12 in Sandpit Field. Based on the observations above, further degradation of these assets, are likely only to be observed during periods of wet weather and high GW levels. This shall be confirmed with regular follow up walkovers, to provide an ongoing assessment of active defects.

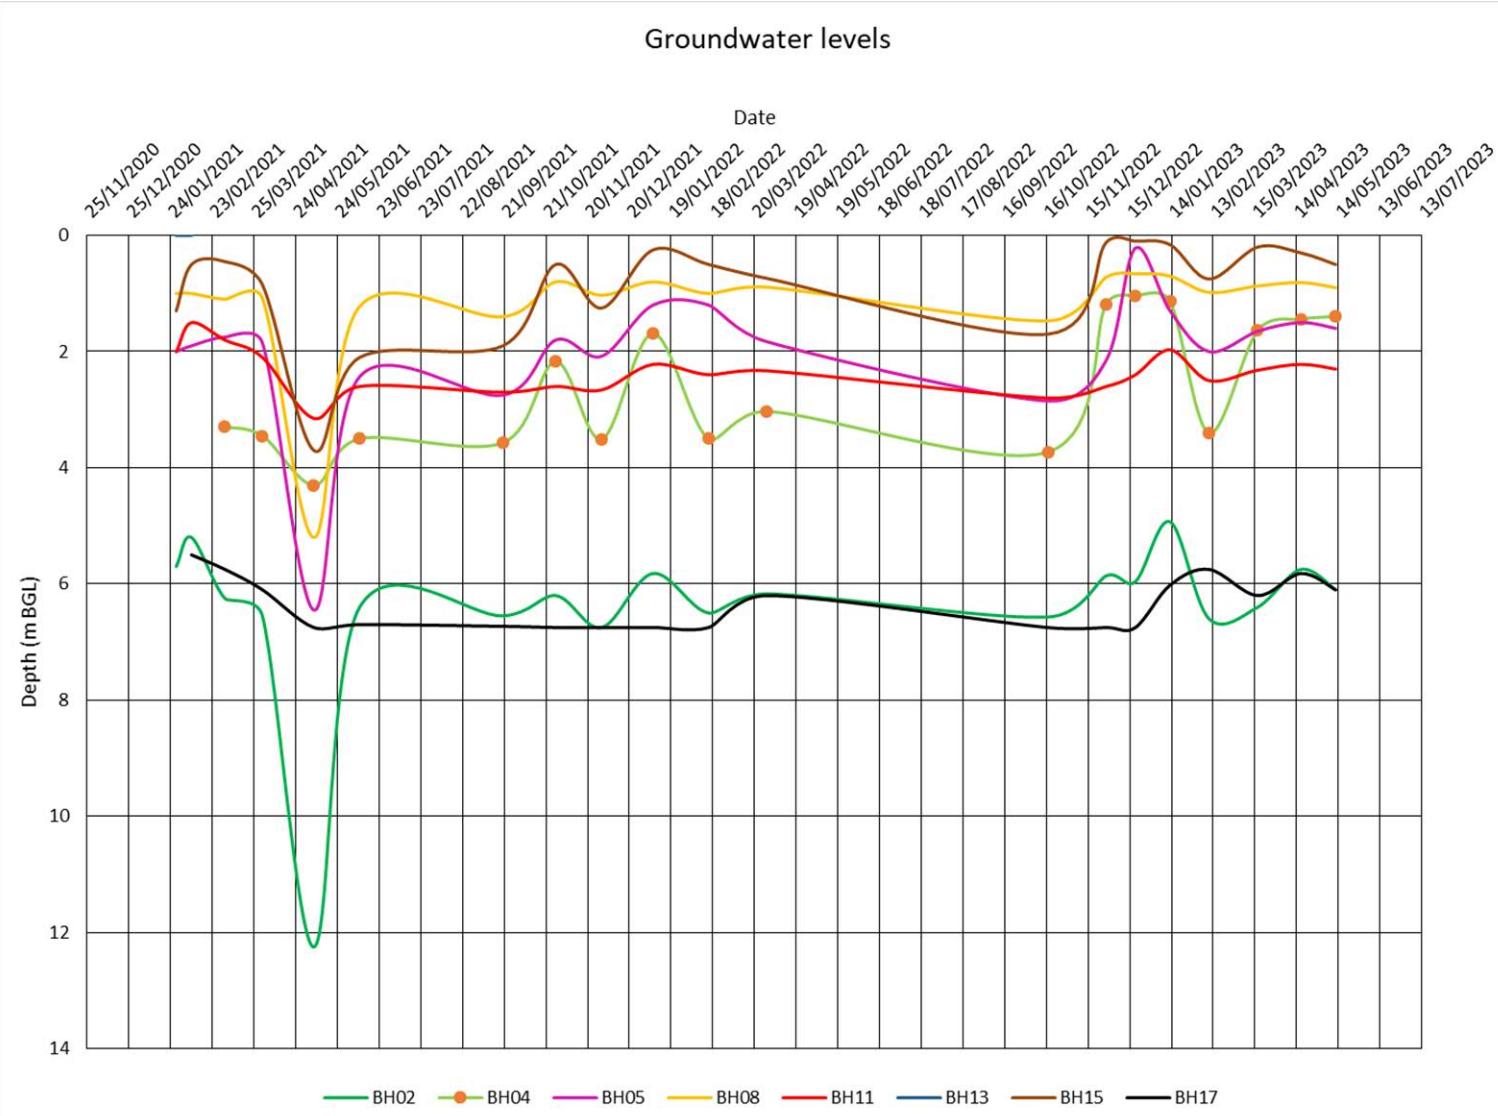
Groundwater Monitoring Results

3.2 Spikes in GW were identified in all boreholes November 2022 and January 2023. This is likely attributed to periods of high rainfall, and recharging of the groundwater table underlying the site. At monitoring locations where significant near surface movement was identified namely BH03, BH07, BH10 and BH12, a jump in inclinometer readings was identified within this period, consistent with the spike in groundwater levels observed across the site.

3.3 Groundwater (GW) monitoring data indicates there has been no significant change in the groundwater regime underlying the site in the from the period of March to May 2023. If ground movements are related to precipitation rates and the groundwater regime at the site, this would be anticipated due to high temperatures and low rainfall recorded in the months prior.
