# TECHNICAL NOTE

| <b>SUBJECT:</b> | Site Monitoring Report – August 2026 | | |
| <b>PROJECT:</b> | Swanage Town Council – Shore Road | <b>AUTHOR:</b> | Sam Horner |

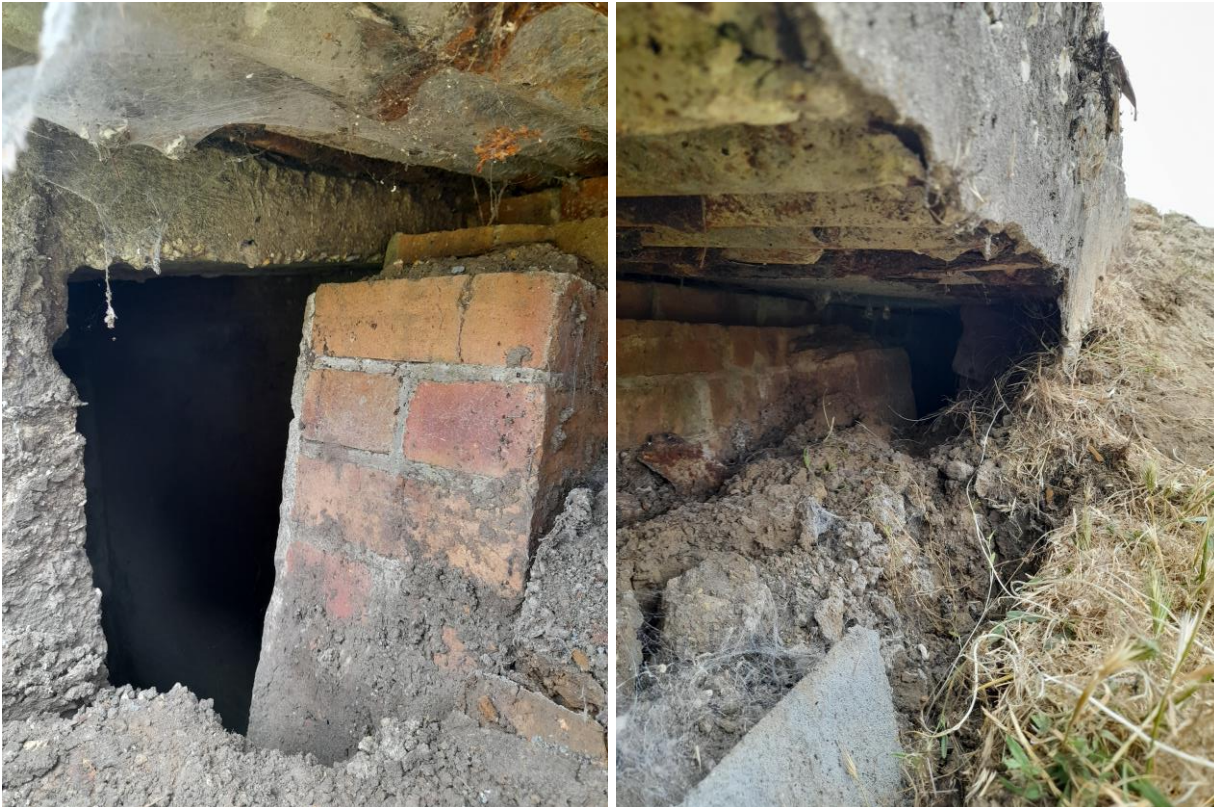
- 2.18 The two tunnel walls were both noted to be leaning, with the northern wall leaning at approximately 12° and resting on the southern wall. The front wall is providing no support to the above slab, and halfway along its length it appears to be leaning in the other direction, with the toe of the wall believed to have kicked out into the centre of the tunnel. See Figure 1.

*Figure 1:a) Voiding created by damaged wall. Looking into front room. b) Displaced northern wall, showing it leaning on the southern wall*

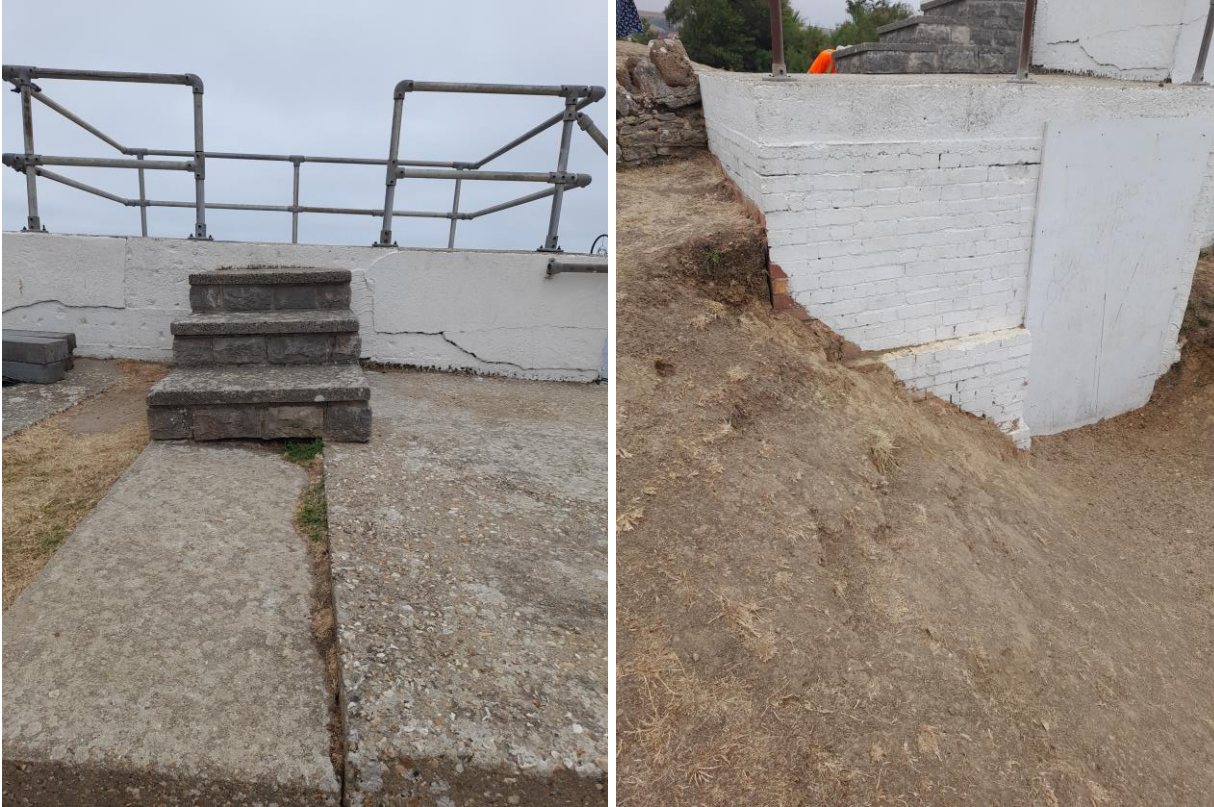
- 2.19 The southern tunnel wall is also leaning into the tunnel, with its outside edge providing a partial support for the roof slab sporadically along its length. The material behind this rear wall was observed to have slightly subsided and the steps for the roof viewpoint access can also be observed to be settling towards the rear of the wall. This is likely a result of the loss of support from the wall. See Figure 2.

Figure 2:a) Subsidence behind the tunnel. b) Staff room showing depth of rooms below ground level.

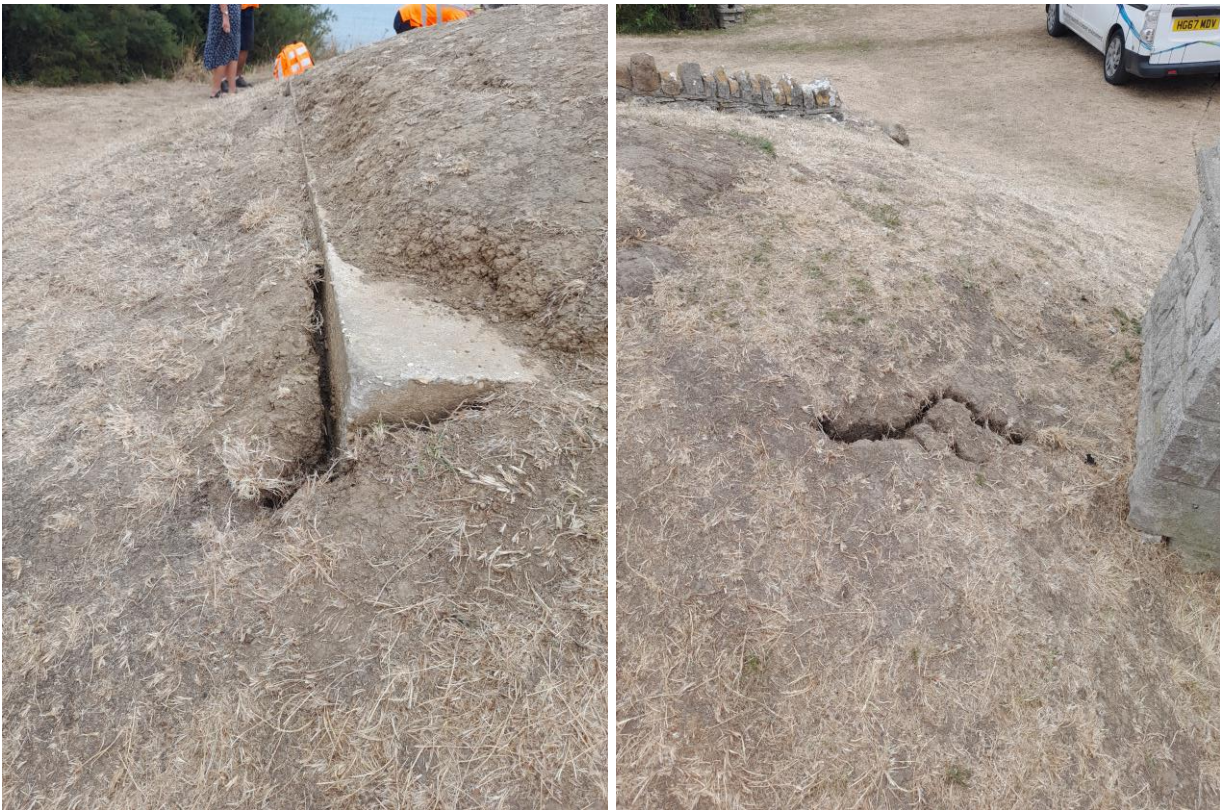
Figure 3: Desiccation and tension cracking in earth placed on top of ammo room

| Defect Ref. | Defect Location | Defect Photo | Recommended Mitigation Measure |
|---|---|---|---|
| C18 | Sandpit Field | | <ul style="list-style-type: none"> <li>Access to roof and area above gun emplacement to be fenced off to members of the public.</li> <li>Continued monitoring to be undertaken to check deterioration of the existing defect area.</li> <li>Ongoing monitoring to assess the areas around the gun emplacement not fenced off to determine any change in their condition.</li> </ul> |

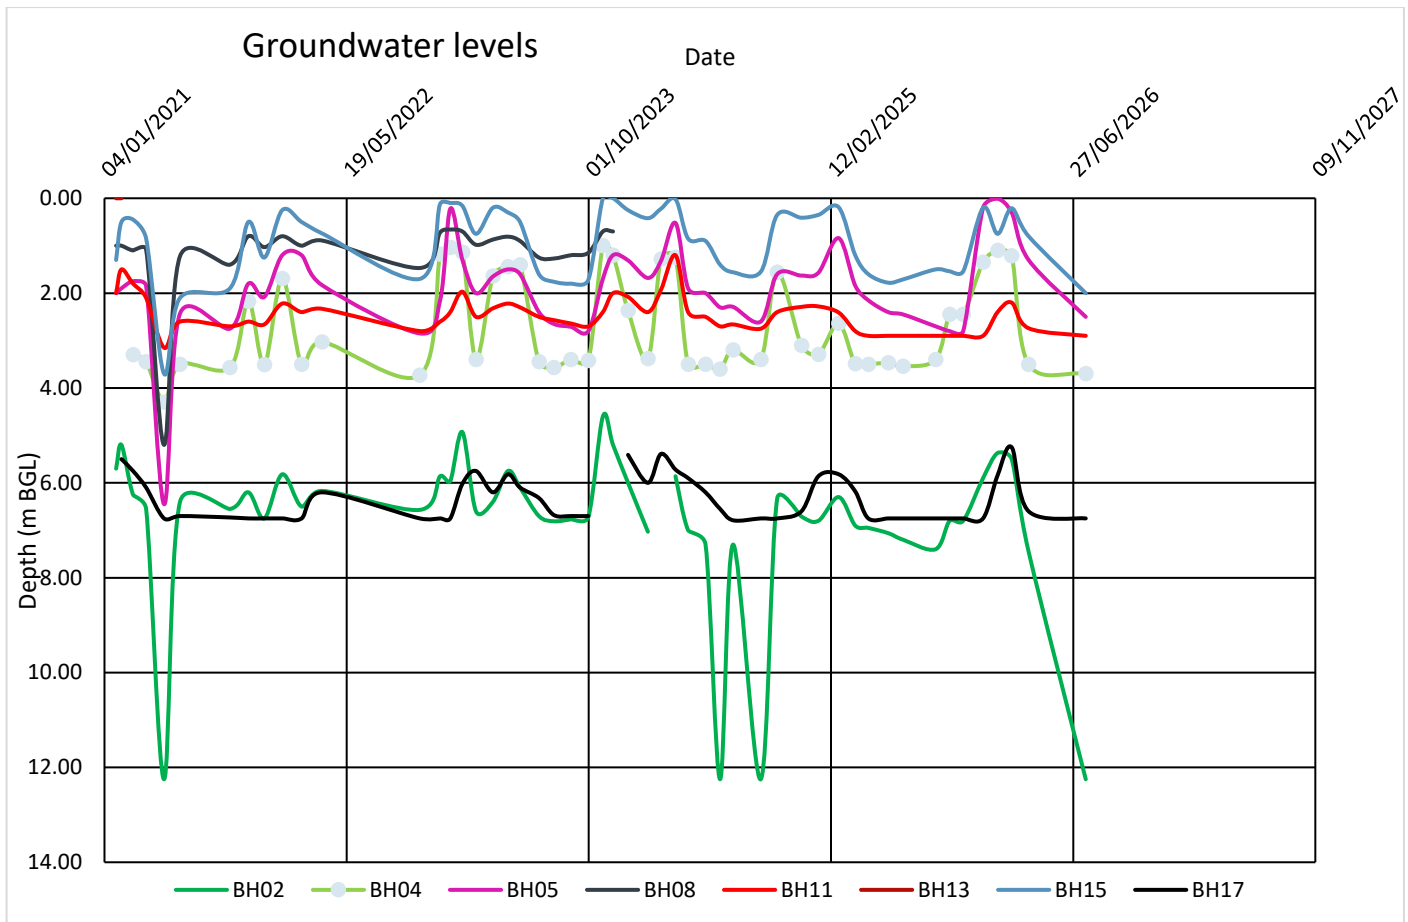
Figure 4: Groundwater monitoring data

- 3.32 During the return visits to monitor the inclinometers the groundwater levels are also recorded where boreholes are installed.
- 3.33 In the period between February 2026 and August 2026 the groundwater monitoring showed lower values than previous period. This likely reflects the dry weather and below average rainfall for the current time of year.

- 3.36 It is recommended that groundwater and inclinometer monitoring is continued alongside periodic site walkovers to ensure that site defects are appropriately risk managed, and areas cordoned off as necessary.

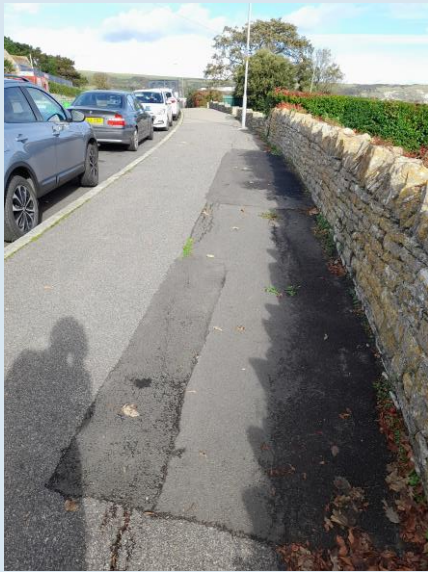
| Swanage Town Council - Shore Road - Asset Defect Schedule (February 2026) | | | | | | | | | | | | | | | | February 2026 Risk Rating | August 2026 Risk Rating | | | | | |
|---|---|---|---|---|---|---|---|---|---|---|---|---|---|---|---|---|---|---|---|---|---|---|
| A18 | Spa Beach Huts | 403026 | 79380 | | N/A | N/A | N/A | N/A | N/A | De Moulham Road Retaining Wall<br><br>Observations:<br>Approx. Defect Length = 18m<br>- Overturning wall<br>- Longitudinal tension cracking in pavement<br>- Multiple tarmac repairs observed in the area.<br>- Settlement of material adjacent to the retained side of the wall (underlying tarmac repair) - approx. 20-30mm.<br>- Settlement consistent with theory of wall overturning, resulting in void developing behind wall for subbase/subgrade material to settle into.<br>- Cracking in masonry wall consistent with location of cracks in the pavement, indicating cause/effect of wall on pavement construction.<br><br>Likely cause of issue:<br>- Poor foundation material, causing differential settlements<br>- Leakage of drainage system in locale causing reduction in strength of the wall formation material. | The pavement has been resurfaced since the last inspection. No cracks present on new surfacing.<br><br>Area below masonry wall fenced off from the public. Wall has minor cracking and vegetation growing in the mortar render between the blocks.<br><br>Desiccation noted in the toe area. | Desiccation not observed at the toe.<br><br>New surfacing is showing minor cracking, and on either end of the repair cracks are extending parallel to the wall.<br><br>Subsidence of the pavement is also present. | Minor leaning of the wall below measured to be 2" - 3".<br>Desiccation not observed at toe, likely due to wet weather.<br><br>New patch repair has been completed since October 2025 visit.<br><br>New surfacing is showing minor cracking, and on either end of the repair cracks are extending parallel to the wall. No significant change since February 2025 survey<br><br>Subsidence of the pavement is also present. | Could not observed wall condition from below due to vegetation cover. Dessication not observed.<br><br>Previous repairs noted.<br><br>New surfacing is showing minor cracking, and on either end of the repair cracks are extending parallel to the wall. No significant change since February 2025 survey<br><br>Subsidence of the pavement is also present. | Medium | 3 | Likely | 2 | Low | 6 | Medium | |

| Defect Ref. | Defect Location | Defect Photo | Recommended Mitigation Measure |
|---|---|---|---|
| A18 | Spa Beach Huts | | <ul style="list-style-type: none"> <li>Continue to monitor after significant rainfall events.</li> <li>Maintain the closure in the grassy area below the wall.</li> <li>If further movement or signs of deterioration continue to develop, consider restricting car parking on the south bound section of road adjacent to the asset.</li> <li>Ongoing patch repairs to help manage risk to public from cracking/ trip hazards, subject to review of any increasing in cracking.</li> </ul> |

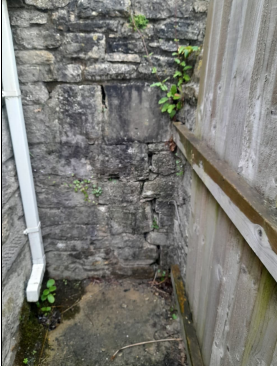
| Swanage Town Council - Shore Road - Asset Defect Schedule (February 2026) | | | | | | | | | | | | | | | | February 2026 Risk Rating | August 2026 Risk Rating | | | | | |
|---|---|---|---|---|---|---|---|---|---|---|---|---|---|---|---|---|---|---|---|---|---|---|
| A19 | Spa Beach Huts | 403063 | 79367 | | N/A | N/A | N/A | N/A | N/A | N/A | N/A | Cracking in wall at base of steps.<br><br>Retaining wall 2.5m in height.<br><br>Crack approx. 1m long and width of up to 30mm. | Minor seepage observed.<br><br>Crack width 30 - 40mm. | Minor seepage observed.<br><br>Crack width 30 - 45mm.<br><br>No significant change to risk profile. | Crack width 30 - 50mm.<br><br>No significant change to risk profile. | Low | 1 | Negligible | 2 | Low | 2 | Low |

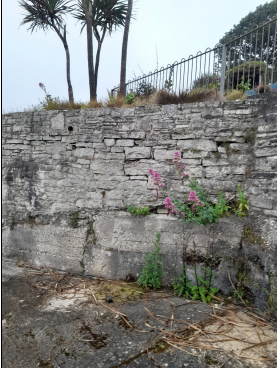
| Swanage Town Council - Shore Road - Asset Defect Schedule (February 2026) | | | | | | | | | | | | | | | | February 2026 Risk Rating | August 2026 Risk Rating | | | | | |
|---|---|---|---|---|---|---|---|---|---|---|---|---|---|---|---|---|---|---|---|---|---|---|
| A20 | Spa Beach Huts | 403059 | 79368 | | N/A | N/A | N/A | N/A | N/A | N/A | N/A | Cracking noted on the south end of the wall with defect A16. Cracking observed within render between blocks.<br><br>Crack length 1m<br><br>Crack width up to 20mm. | No significant change. | No significant change. | No significant change. | Low | 1 | Negligible | 2 | Low | 2 | Low |

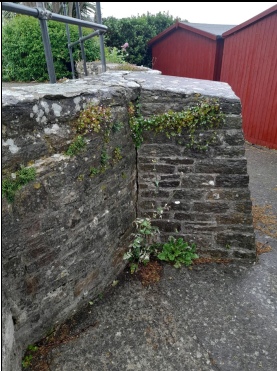
| Swanage Town Council - Shore Road - Asset Defect Schedule (February 2026) | | | | | | | | | | | | | | | | February 2026 Risk Rating | August 2026 Risk Rating | | | | | |
|---|---|---|---|---|---|---|---|---|---|---|---|---|---|---|---|---|---|---|---|---|---|--|
| A21 | Spa Beach Huts | 403027 | 79364 | | | N/A | N/A | N/A | N/A | N/A | Buttresses on retaining wall adjacent to defect A9 are delaminating from retaining wall. Render is cracked between buttress and wall. Crack width of 30mm.<br><br>Retaining wall 1.3m height and 1.0m depth. | No significant change. | Seepage observed on abutment and the wall it is supporting.<br><br>Crack widths measured to be 30 - 40mm. | No significant change<br><br>Seepage not observed | Medium | 2 | Unlikely | 3 | High | 6 | Medium | |

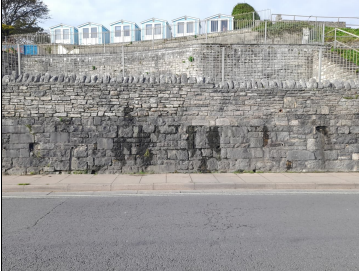
| Swanage Town Council - Shore Road - Asset Defect Schedule (February 2026) | | | | | | | | | | | | | | | | February 2026 Risk Rating | August 2026 Risk Rating | | | | | |
|---|---|---|---|---|---|---|---|---|---|---|---|---|---|---|---|---|---|---|---|---|---|--|
| A22 | Spa Beach Huts | 403064 | 79377 | | | N/A | N/A | N/A | N/A | N/A | N/A | Seepage observed in lower wall below beach huts. Several areas were noted on a dry day. | Seepage observed in lower wall below beach huts. Inspection after a period of wet weather, significant signs of water egress noted all over. | Seepage not observed. | Low | 2 | Unlikely | 2 | Low | 4 | Low | |

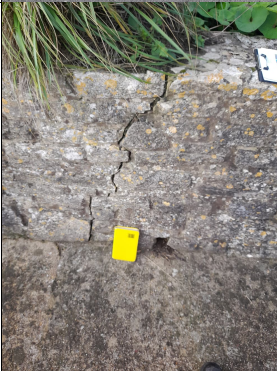
| Swanage Town Council - Shore Road - Asset Defect Schedule (February 2026) | | | | | | | | | | | | | | | | February 2026 Risk Rating | August 2026 Risk Rating | | | | | |
|---|---|---|---|---|---|---|---|---|---|---|---|---|---|---|---|---|---|---|---|---|---|--|
| A23 | Spa Beach Huts | 403058 | 79387 | | | N/A | N/A | N/A | N/A | N/A | N/A | Vertical cracking observed in wall. Widths <10mm. Cracking in place of mortar between blocks.<br><br>Retaining wall height = 0.9m.<br>Retaining wall depth = 0.4m. | No significant change.<br><br>Cracking measured to be <10mm.<br><br>A small pavement crack, running across the footpath was observed at the toe.<br><br>Spoil on top of the wall still present, does not appear to have changed in quantity since October 2025. | No significant change.<br><br>Cracking measured to be 10-15mm.<br><br>A small pavement crack, running across the footpath was still noted, it doesn't appear to have changed in condition since last survey.<br><br>Spoil on top of the wall still present, does not appear to have changed in quantity since October 2025. | Low | 2 | Unlikely | 1 | Very Low | 2 | Low | |

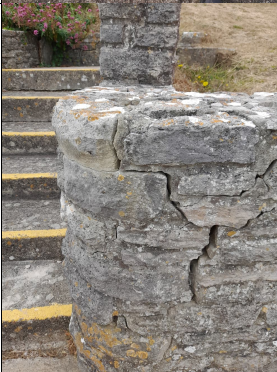
| Swanage Town Council - Shore Road - Asset Defect Schedule (February 2026) | | | | | | | | | | | | | | | | February 2026 Risk Rating | August 2026 Risk Rating | | | | | |
|---|---|---|---|---|---|---|---|---|---|---|---|---|---|---|---|---|---|---|---|---|---|--|
| A24 | Spa Beach Huts | 403051 | 79385 | | | N/A | N/A | N/A | N/A | N/A | N/A | N/A | N/A | Vertical cracking in the wall observed.<br><br>Retained height 1m, width 0.3m.<br><br>Crack length 1m.<br>Crack Width <60mm (largest at the toe)<br><br>Cracking observed on the corner wall adjacent to the steps. Lower blocks have no mortar between them.<br><br>Low height retaining wall which is reflected in the low risk profile. | Low | 1 | Negligible | 2 | Low | 2 | Low | |

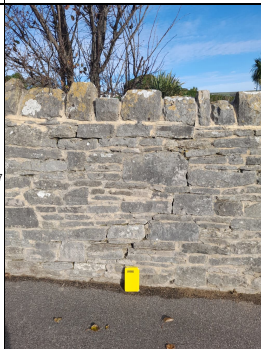
| Swanage Town Council - Shore Road - Asset Defect Schedule (February 2026) | | | | | | | | | | | | | | | | | February 2026 Risk Rating | August 2026 Risk Rating | | | | | |
|---|---|---|---|---|---|---|---|---|---|---|---|---|---|---|---|---|---|---|---|---|---|--|--|
| C20 | Sandpit Field | 403057 | 79147 | | N/A | N/A | N/A | N/A | N/A | N/A | N/A | N/A<br>Vertical cracking observed across full height of retaining wall. Cracking in place between blocks where render is no longer present.<br>Mortar debond. No overhang observed.<br>Wall height = 1.6m.<br>Wall Depth = 0.4m.<br>Crack width <10mm. | Crack width <10mm.<br>No significant change. | Crack width <10mm.<br>No significant change. | Low | 2 | Unlikely | 2 | Low | 4 | Low | | |

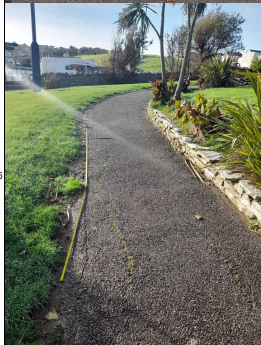
| Swanage Town Council - Shore Road - Asset Defect Schedule (February 2026) | | | | | | | | | | | | | | | | | February 2026 Risk Rating | August 2026 Risk Rating | | | | | |
|---|---|---|---|---|---|---|---|---|---|---|---|---|---|---|---|---|---|---|---|---|---|--|--|
| C21 | Sandpit Field | 403058 | 79166 | | N/A | N/A | N/A | N/A | N/A | N/A | N/A | N/A<br>10m of surface cracking observed in the tarmac pavement within sandpit field. 1 to 2 parallel cracks observed along the whole length. Cracks only in surface of the pavement.<br>Minor subsidence also observed. | No significant change. | No significant change. | Low | 1 | Negligible | 2 | Low | 2 | Low | | |

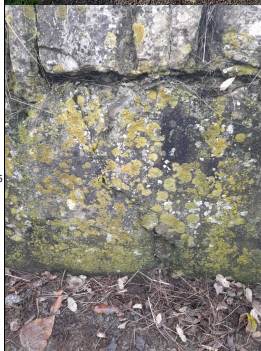
| Swanage Town Council - Shore Road - Asset Defect Schedule (February 2026) | | | | | | | | | | | | | | | | | February 2026 Risk Rating | August 2026 Risk Rating | | | | | |
|---|---|---|---|---|---|---|---|---|---|---|---|---|---|---|---|---|---|---|---|---|---|--|--|
| C22 | Sandpit Field | 403008 | 79295 | | N/A | N/A | N/A | N/A | N/A | N/A | N/A | N/A<br>Vertical cracking observed across full height of retaining wall. Cracking in mortar / render.<br>No overhang observed.<br>Wall height = 0.8m.<br>Wall Depth = 0.4m.<br>Crack width <10mm.<br>Low height wall and low risk profile. | No significant change | No significant change | Low | 2 | Unlikely | 2 | Low | 4 | Low | | |
