TECHNICAL NOTE

DATE:	15 March 2024	CONFIDENTIALITY:	Public
SUBJECT:	Site Monitoring Report – February 2024		
PROJECT:	Swanage Town Council – Shore Road	AUTHOR:	Ben Ward
REVIEWER:	Sam Rhodes	APPROVER:	David Roy

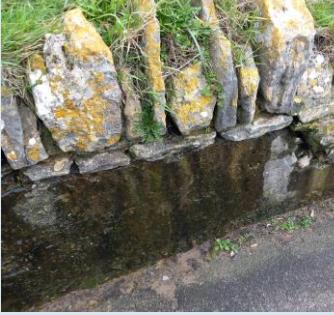
2.11 The following defects were surveyed and observed to have shown more significant degradation in condition compared to the previous survey undertaken in October 2023: B4, B11, C9, C12. Further information on these defects are presented within the defect schedule. The risk level from the previous surveys has been presented within the Defect Schedule to highlight changes in asset condition over time.

Defect Ref.	Defect Location	Defect Photo	Recommended Mitigation Measure
B11	Weather Station Field

<ul style="list-style-type: none"> • 	<ul style="list-style-type: none"> • Continue to monitor regularly. • Further deterioration may require foot path diversion.
C9	Sandpit Field

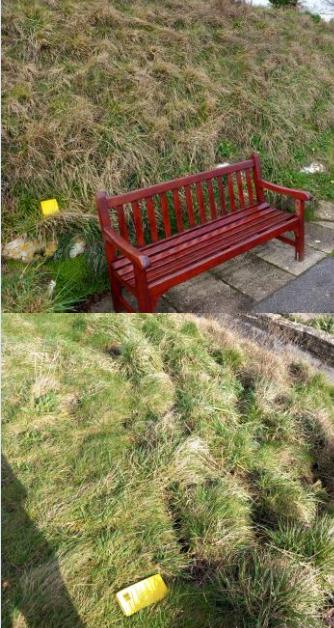
2.12 Tension cracking was noted along the extents of the embankment adjacent to defect C12.

<ul style="list-style-type: none"> • 	<ul style="list-style-type: none"> • Consider removal and light regrade of toe
C12	Sandpit Field

<ul style="list-style-type: none"> • • 	<p>Remove remaining bench and infill.</p> <ul style="list-style-type: none"> • Continue to monitor propagation of tension cracks.

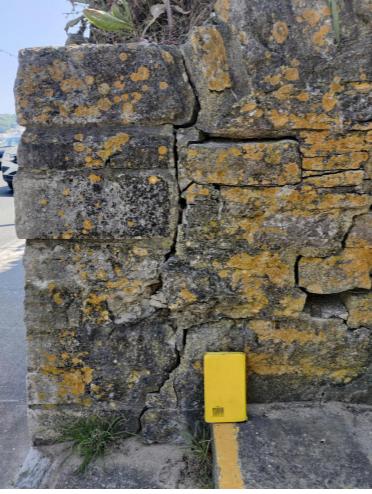
Vertical and horizontal cracking, bulging/horizontal sliding of failing wall section. Crack width 10 - 20mm. Bowing of wall face, up to 40mm. Loose blockwork, missing masonry, loss of mortar between blockwork. Crack length 1.2m wall height 1.2m Retained height 3.0m+.	Crack width increased to 25mm. Bowing of wall face up to 50mm. North facing wall completely sheared from east facing return. Additional bowing/shearing of masonry at bench level adjacent to return wall, with up to 70mm movement. Recommended that area is fenced/closed off. Return wall supports 3.5m of backfill. In the event of total failure, potential to cause significant harm to members of the public.	No significant change Note heras fencing present to separate area from public	High	3	Likely	3	High	9	High

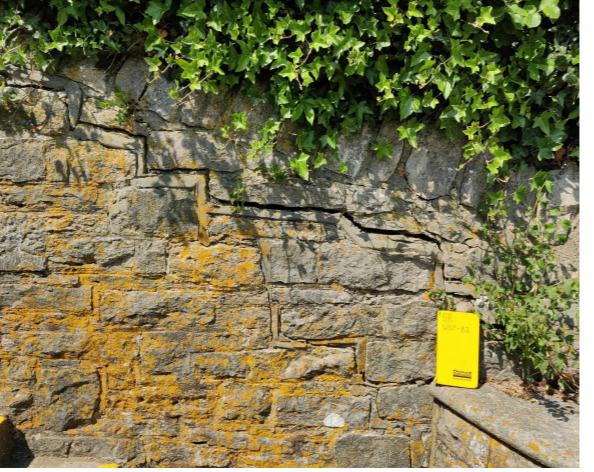
A2	The Spa	403068	79423	A2	A2	A2

Retaining wall height: 1.3m Retained height: 1.3m Horizontal cracking, crack width up to 10mm. Cracking along failed mortar joint.	Max crack width increased 15mm. Otherwise no significant change (NSC) observed.	No significant change	Low	2	Unlikely	1	Very Low	2	Low
A3	The Spa	403061	79407	A3	A3	A3

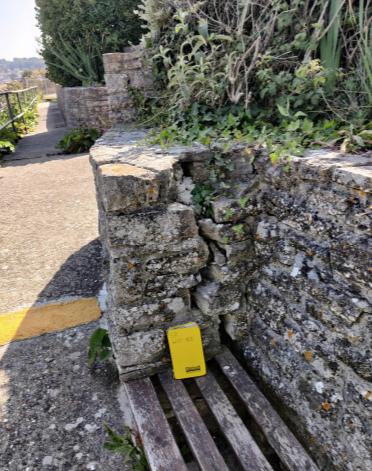
Retaining wall height: 0.8m Retained height: 0.8m Vertical cracking and horizontal displacement of wall. Crack width, 40 - 60mm with loose and missing masonry. Evidence of previous repair attempt with cement mix.	Max crack width 80mm. Max translational movement of masonry (left and right hand side) 50mm. Otherwise no significant change, and low risk.	No significant change	Low	2	Unlikely	1	Very Low	2	Low

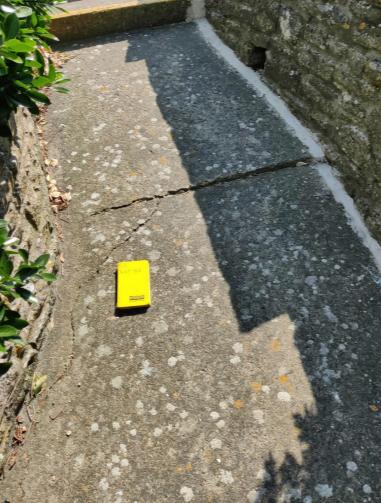
Pavement cracking and uneven ground. Differential settlement/transverse cracking in pavement with height up to 10mm. Longitudinal cracking, with width up to 2mm.	Surveyed - No significant change.	No significant change	Low	2	Unlikely	1	Very Low	2	Low
A8	The Spa	403052	79390	A8	A8	A8

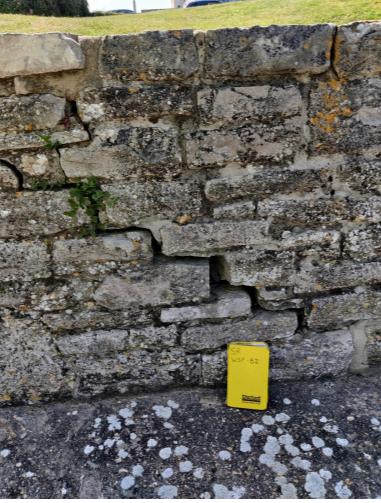
Retaining wall height: 1.0m Retained height: 1.0m Vertical and horizontal cracking, cracking width 30 - 60mm. Length of defect 0.7m. Evidence of minor previous patch repairs with cement mix.	No bowing observed. Surveyed - No significant change.	No significant change At end of wall vertical cracking noted 10-20mm in width	Low	2	Unlikely	1	Very Low	2	Low

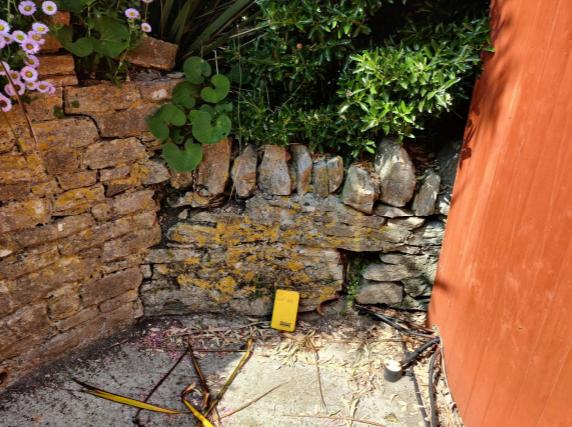
Retaining wall height: 0.9m Retained height: 0.9m Minor vertical cracking, missing masonry blocks and silted up and damaged back of wall drainage. Damage potentially due to running services through wall, post wall construction.	Surveyed - No significant change.	No significant change	Low	2	Unlikely	1	Very Low	2	Low
A10	Spa Beach Huts	403054	79358	A10	A10	A10

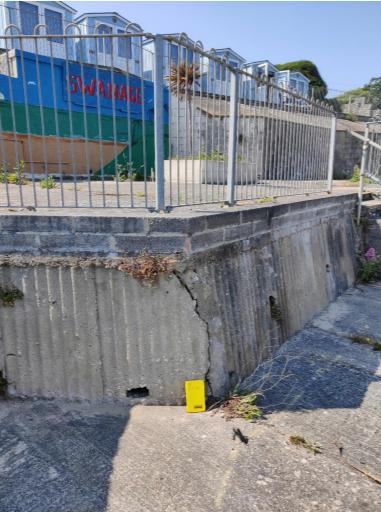
Retaining wall height: 1.25m Retained height: 1.25m Vertical cracking, crack height 0.9m, crack width up to 30mm. Damaged weephole / void at the base of the wall (see left of survey book).	Surveyed - No significant change.	No significant change	Low	2	Unlikely	2	Low	4	Low

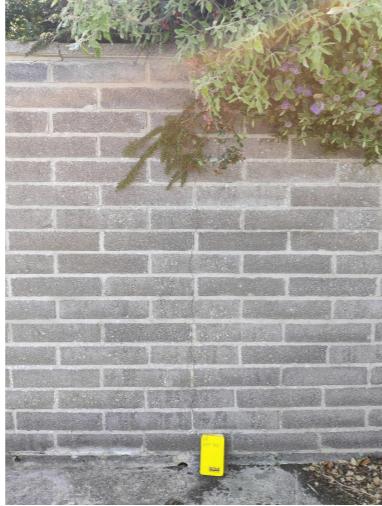
Retaining wall height: 2.15m Retained height 2.15m Hairline vertical cracking full height of the wall, crack width ~1mm. Weephole silted up and 2/3 blocked by additional concrete pours, potentially from previous remedial works.	Could not survey due to lack of access to mid-terrace. From visual inspection in accessible location, no significant change observed.	No significant change	Low	1	Negligible	3	High	3	Low

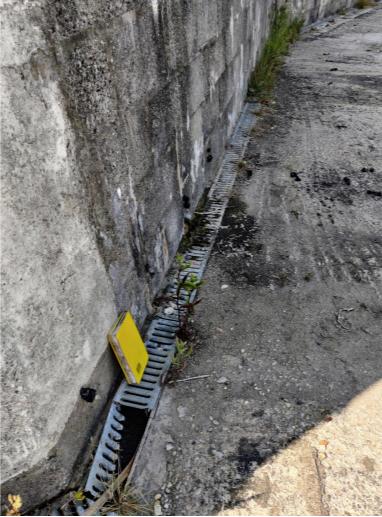
A12	Spa Beach Huts	403050	79369	A12	A12	A12

Delapidated aco surface water drainage system. Drainage gratings broken, and invert fully silted up for the full length of the retaining wall.	Could not survey due to lack of access to mid-terrace. From visual inspection in accessible location, no significant change observed.	No significant change	Low	3	Likely	1	Very Low	3	Low

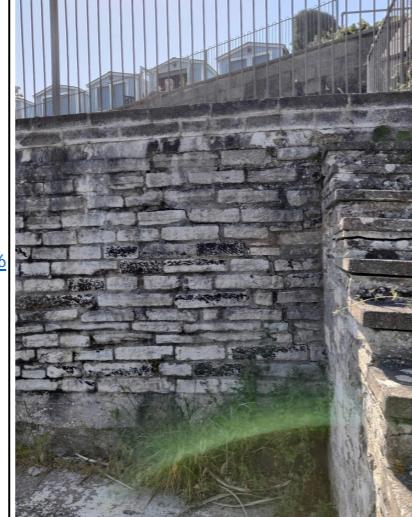
Retaining wall height: 2.55m Retained height: 2.55m Horizontal and vertical cracking. Crack length 1.6m. Typical crack width 3 - 10mm. Bulging/bowing at the mid span of masonry wall.	Surveyed - No significant change.	No significant change	Low	1	Negligible	2	Low	2	Low
A17	Spa Beach Huts	403062	79383	A17	A17	A17

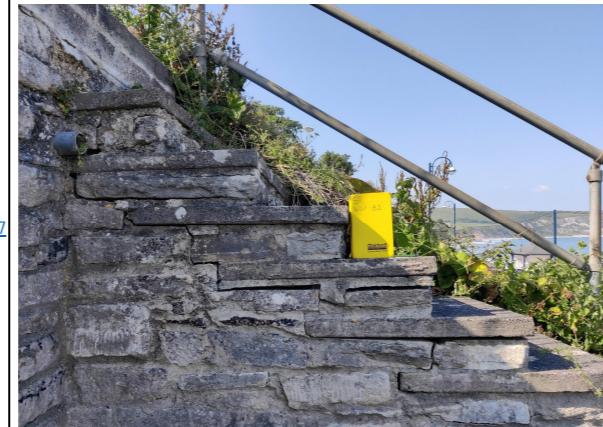
Retaining wall height: up to 2.2m Retained height: up to 2.5m. Horizontal cracking. Crack length 1.8m. Crack width 3 - 12mm. Horizontal movement of return wall causing cracking, potentially due to bulging/bowing from the main span.	Surveyed - No significant change.	No significant change	Low	1	Negligible	1	Very Low	1	Low

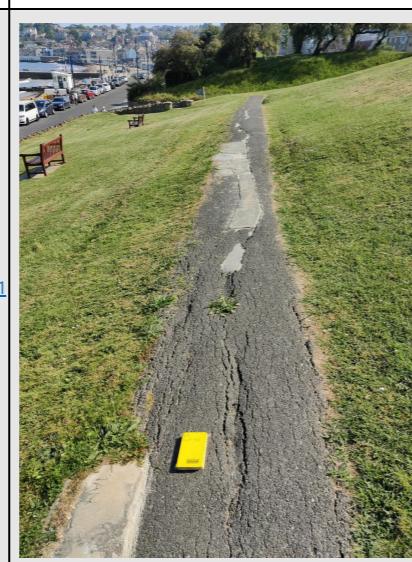
B1	Weather Station Field	403050	79339	B1	B1	B1

Pavement tension cracking, surface deformation and partial collapse. 2no. continuous cracks observed, 3.6m and 11m in length respectively. Multiple patch repairs with asphalt and cement/concrete mix. Ground uneven and with numerous cracks. Crack depths ranging between 5 - 10mm where repairs have not been completed.	Surveyed - No significant change. Slip/trip/fall hazard for members of the public (similar to defect ref. C7). Consider closing off access to footpath, or removing entirely.	Footpath now removed and replaced with grass	Medium	1	Negligible	1	Very Low	1	Low

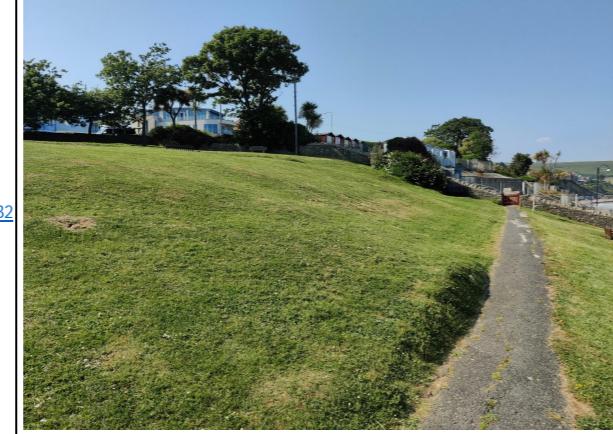
In the field area to the east of weather station, hummocky ground observed, with tension cracking in slope, bulging of surface.	Surveyed - No significant change.	No significant change	Medium	3	Likely	2	Low	6	Medium
B3	Weather Station Field	403059	79309	B3	B3	B3

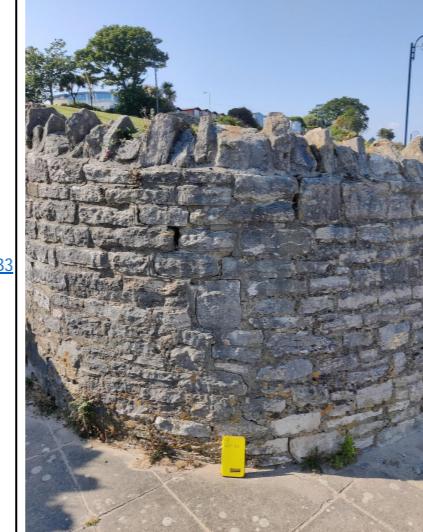
Retaining wall height: 1.8m Retained height: 1.8m Vertical and horizontal cracking, crack width between 2 - 20mm, occurring at apex of wall curvature. No bulging or bowing of the wall observed.	Unable to survey position of maximum crack width due to information signage location. Otherwise no significant change observed.	No significant change	Low	2	Unlikely	2	Low	4	Low

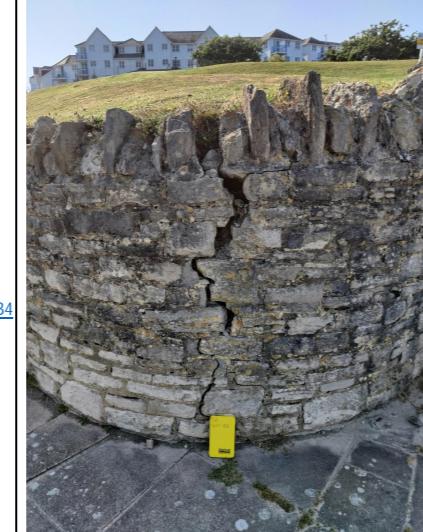
B4	Weather Station Field	403055	79305	B4	B4	B4

Retaining wall height: 1.8m Retained height: 1.8m Curved wall with 3no. sets of vertical cracking. From south face of retaining wall, cracks are at chainage CH 0, 2.0, and 5.5m. Total length of defect: 5.5m. CH 0m Defect: Vertical cracking, crack width typically 30 - 50mm. Missing blockwork at the head of the wall, with significant voids behind mid span of wall (potentially lost mortar or block work following movement). CH 2.0m Defect: Vertical cracking, max crack width typically 90 - 130mm, increasing with height of wall. Missing blockwork at top of wall. CH 5.5m Defect: Vertical cracking, crack width up to 10mm. Blockwork intact.	Survey of crack dimensions hampered by heras fencing panels, which could not be moved. Could not be surveyed accurately. No significant change in structure compared with previous survey.	Maintain heras fencing panel around defect. Continue to monitor regularly.	High	3	Likely	3	High	9	High

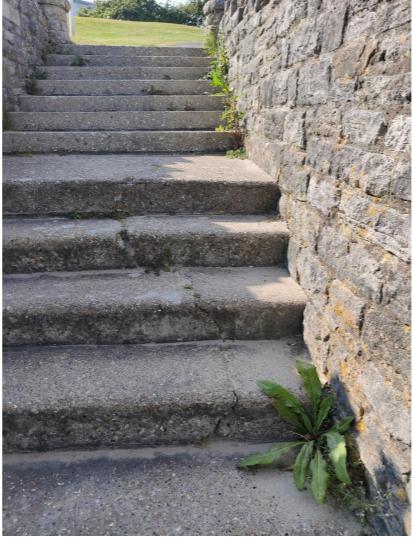
Vertical cracking on footpath/stepped access. Crack length 3m, typical crack width 1 - 2mm.	Additional cracking observed at bottom left stairs area. Crack widths similar to previous survey.	No significant change	Low	2	Unlikely	1	Very Low	2	Low
B6	Weather Station Field	403045	79304	B6	B6	B6

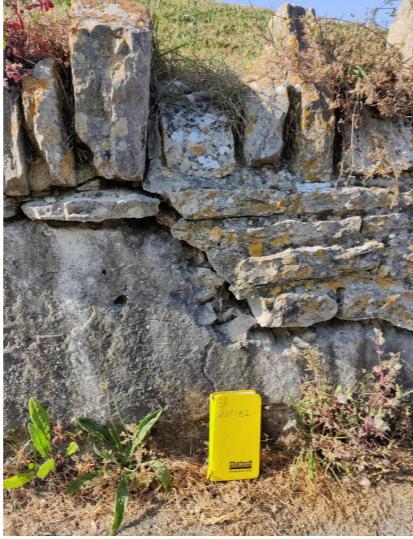
Retaining wall height: 1.0m. Retained height: 1.5m Vertical and horizontal cracking, crack length 0.8m. Typical crack width 40 - 60mm. Minor bowing of the wall at mid height.	Previously identified "minor bowing" appears more akin to shearing of top row of finishing stones of wall span, from the wall below. No significant change in crack widths from previous survey.	No significant change in crack widths Noted to be very wet with water issuing from between cracks	Low	1	Negligible	1	Very Low	1	Low

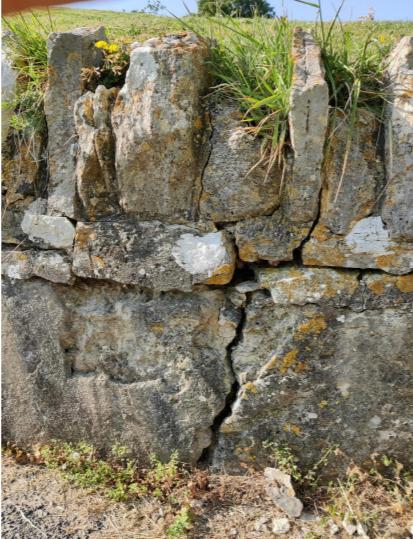
B7	Weather Station Field	403034	79304	B7	B7	B7

Retaining wall height: 0.9m Retained height: 1.0m. Vertical cracking, from base to top of wall (i.e. 0.9m), crack width between 20 - 40mm.	Surveyed - No significant change.	No significant change	Low	1	Negligible	1	Very Low	1	Low

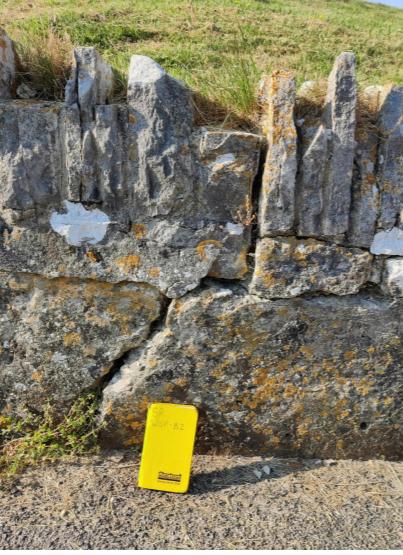
Retaining wall height: 0.85m Retained height: 1m + Vertical and horizontal cracking, the full height of the wall (0.85m), with typical crack width of 20mm. Lower right side (east) of wall translational movement relative to rest of wall.	Max crack width increased to up to 40mm. Otherwise no significant change - low risk.	No significant change	Low	1	Negligible	1	Very Low	1	Low

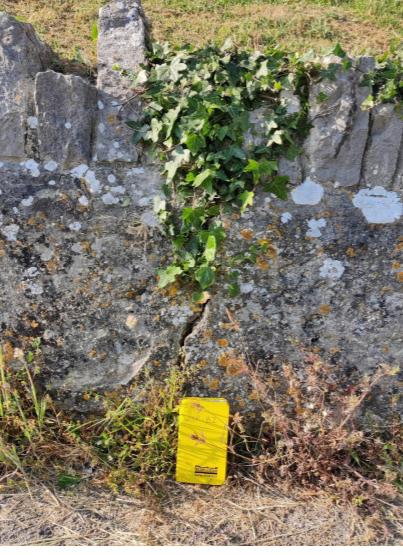
B9	Weather Station Field	403017	79304	B9	B9	B9

Retaining wall height: 1.0m Retained height: 1.0m Vertical cracking, running full height of the wall. Right of the crack (east side of the wall), 30mm translational movement of the wall relative to the west side. Pavement cracking adjacent to retaining wall observed from base of retaining wall.	Surveyed - No significant change.	No significant change	Low	1	Negligible	1	Very Low	1	Low
B10	Weather Station Field	403040	79304	N/A	B10	B10

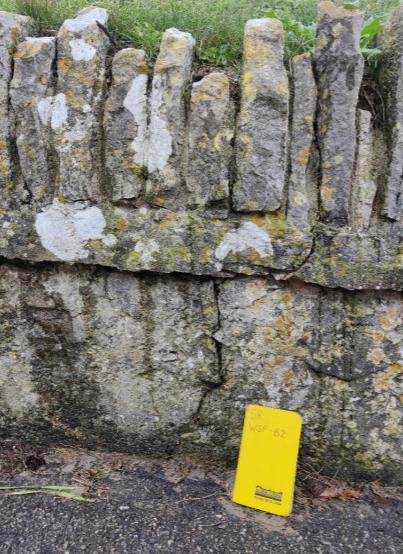
N/A	Retaining wall height: 0.9m Retained height: 1.0m. Vertical cracking, from base to top of wall (i.e. 0.9m), crack width up to 10mm.	No significant change	Low	2	Unlikely	1	Very Low	2	Low

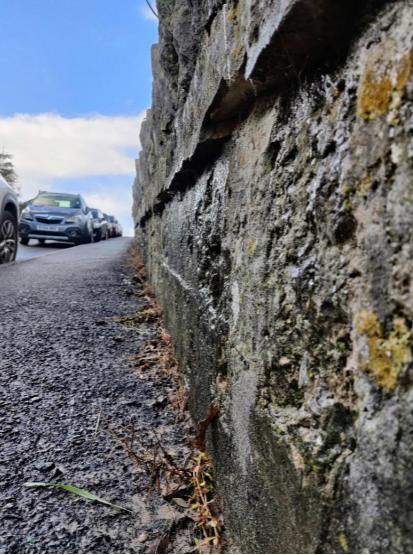
N/A	7.5m length of wall, between defect ref. B6 and B7: Shearing of top span of masonry from base of wall, up to 50mm. Movement in superficial material on retained side of weather station field separating wall at weak/mortar joint location. Risk of collapse over time, and damage to pavement, members of the public, and cars parked on road adjacent to wall. Advise to continue monitoring regularly.	Shearing of top span of masonry from base of wall, increased to 70mm. Evidence of seepage through wall, along extents. Advise to continue monitoring regularly.	Medium	2	Unlikely	3	High	6	Medium

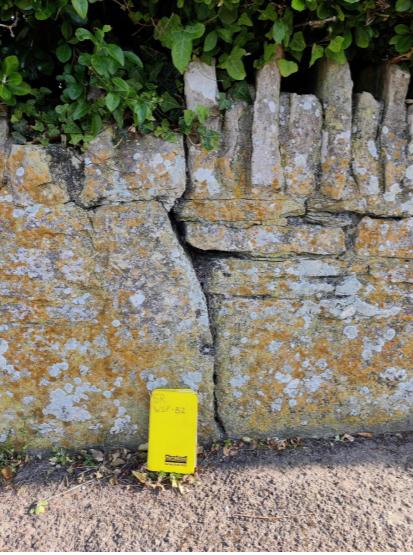
C1	Sandpit Field	403000	79294	C1	C1	C1

Retaining wall height: 1.0m. Retained height: 1.0m Vertical cracking, full height of wall, typical crack width 5 - 30mm. Large bushes overhanging back of retaining wall, likely the cause of distress observed in the structure.	Displacement of east side of wall relative to the west up to 30mm. Otherwise no significant change - low risk.	No significant change	Low	2	Unlikely	1	Very Low	2	Low
C2	Sandpit Field	403009	79294	C2	C2	C2

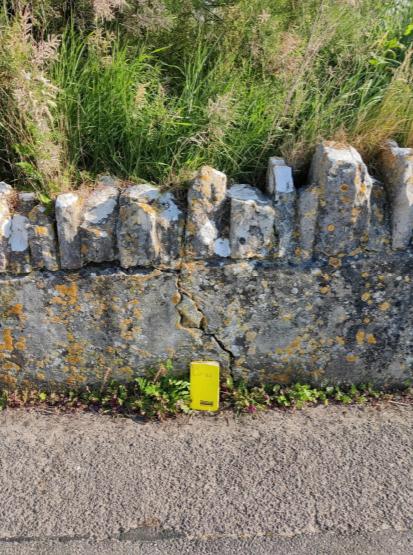
Retaining wall height: 0.8m Retained height: 0.8m Vertical cracking full height of wall, typical crack width 5 - 20mm. Evidence of historic patch repair made previously.	Surveyed - No significant change.	No significant change	Low	1	Negligible	1	Very Low	1	Low

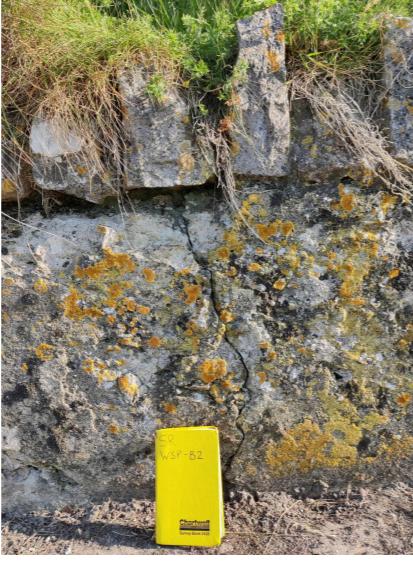
Retaining wall height: 0.95m Retained height 1.0m Vertical cracking, full height of wall, crack width between 1 - 3mm.	Surveyed - No significant change.	No significant change	Low	1	Negligible	1	Very Low	1	Low
C4	Sandpit Field	403035	79295	C4	C4	C4

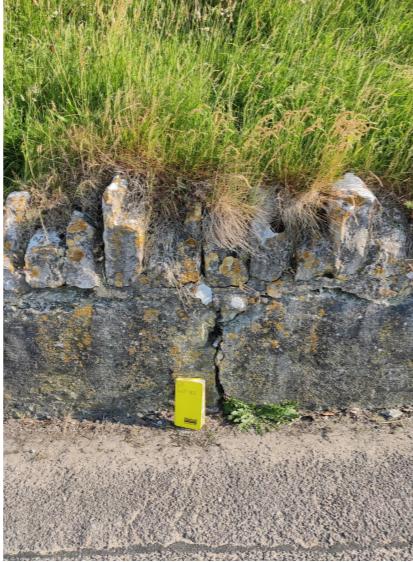
Retaining wall height: 1.0m Retained height: 1.2m Vertical cracking, full height of wall. Crack width 20 - 40mm.	Small void at base of wall due to loss of mortar/masonry. Likely lost from translational movement of the wall. Otherwise no significant change.	No significant change	Low	1	Negligible	1	Very Low	1	Low

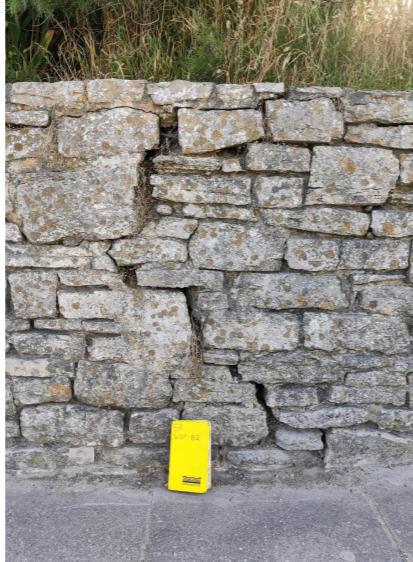
C5	Sandpit Field	403058	79290	C5	C5	C5

Retaining wall height: 1.25m Retained height 1.25m Vertical and horizontal cracking, typical crack width 20 - 30mm. Transverse movement of the wall, mortar joint failure from masonry blockwork moving apart.	Vertical and horizontal cracking increased from 20-30mm to 40-50mm. Otherwise health of asset unchanged. Low risk.	No significant change	Low	2	Unlikely	2	Low	4	Low

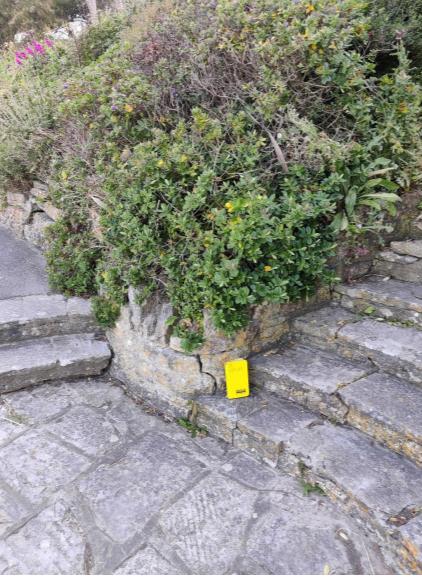
Retaining wall height: 0.6m Retained height: 1.5m+ Vertical cracking full height of the wall. Typical crack width between 10 - 15mm. Overgrown bushes and vegetation acting on the back of the wall the likely cause of deterioration of the retaining structure.	Typical crack width increased to 15-25mm. Otherwise no significant change - low risk.	No significant change	Low	2	Unlikely	2	Low	4	Low

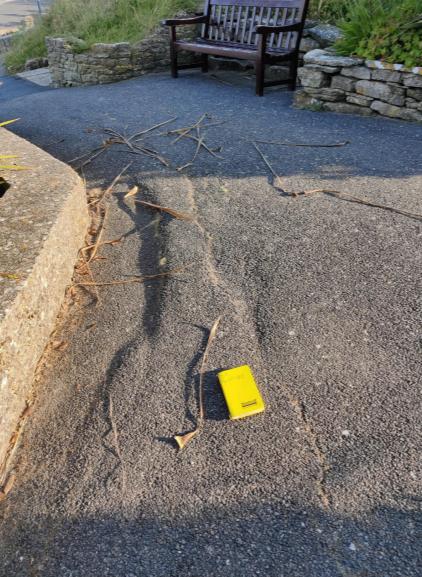
Multiple areas of pavement cracking and surface deformation (one example shown face left). Distress in asphalt behind lower slope retaining walls observed where rotation of lower wall was seen (see defect C13). Additional areas of distress in pavement seen where up slope area is oversteepened and not effectively restrained by retaining structure or otherwise, see defect C12.	Defect has been repaired, asphalt has been re-laid in area following slip/trip/fall incident. Bench removed from area. Area to be checked in follow up surveys to ensure defect does not reoccur.	No significant change	Low	1	Negligible	1	Very Low	1	Low
C8	Sandpit Field	403056	79252	C8	C8	C8

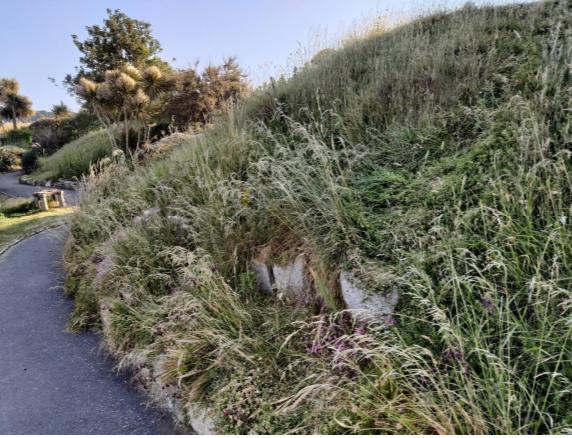
Retaining wall height: 1.3m Retained height 3.0m + 6 l.m of terraced masonry blocks which were observed to be overturning with over steepened slope behind. Blocks likely installed to prevent shallow slip failure of material above, however global stability of slope borderline.	Blocks further overturned. Further ravelling of slope material. A 1 m section of toe has a paving stone/blockwork missing. Unsupported toe area has an increased risk of slip/localised slope failure. Regular inspection of area recommended to inspect condition. Consider replacing stone/blockwork to provide support to the face.	No significant change	Medium	2	Unlikely	3	High	6	Medium

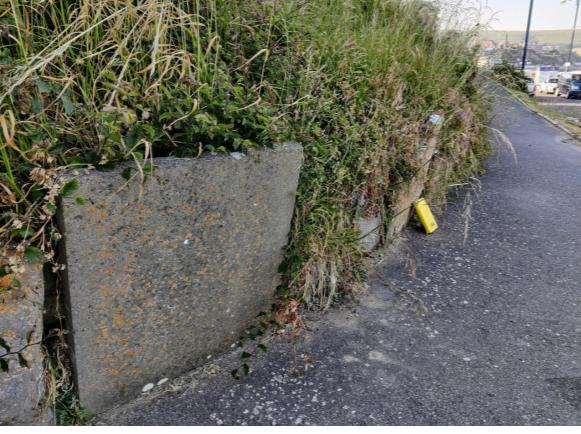
Retaining wall height: 0.6m Retained height: 3m + 7.5 l.m of retaining wall blocks partially overturned at toe of retaining wall. Insufficient embedment of blocks at toe, and oversteepened slope behind overloading wall.	Surveyed - No significant change.	Slabs appear to have rotated further outward, consider removal or replacement	Low	3	Likely	2	Low	6	Medium

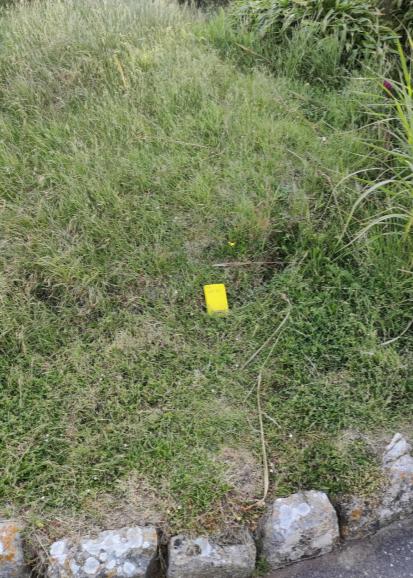
3 l.m of tension cracking observed in oversteep section of slope. Width of tension crack approx 200mm, and 250mm depth in areas.	Tension crack width Otherwise no significant change. Continue to monitor on ongoing basis.	No significant change	Medium	3	Likely	2	Low	6	Medium
C11	Sandpit Field	403055	79235	C11	C11	C11

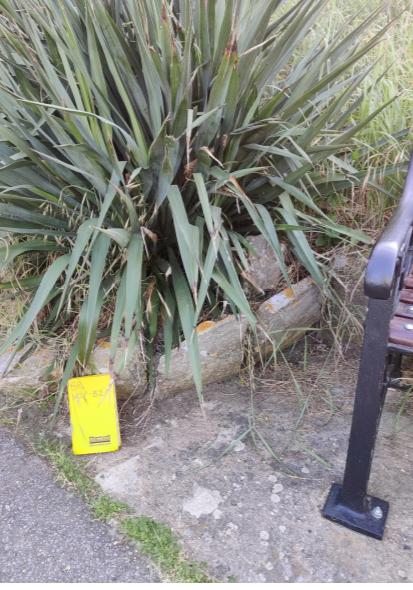
Retaining wall height: 0.3m Retained height: 3m+ 2 lm section of retaining wall at the rear of benches, has overturned by 30 degrees from vertical. Large overgrown vegetation acting immediately behind the rear of wall, likely cause of issue.	Overturning of retaining wall increased to 45 degrees from vertical. Low risk, however continue to monitor. Risk of causing hazards related to slips/trip/falls, particularly adjacent to bench + pedestrian walkway.	Evidence of increased tilt - continue to monitor.	Low	2	Unlikely	1	Very Low	2	Low

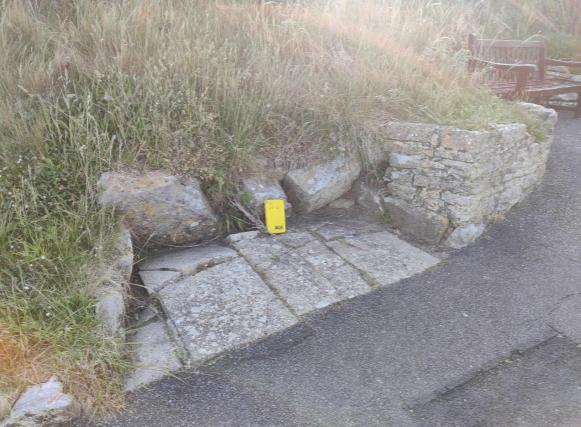
3no. Failed retaining wall which use to house benches. Retaining wall height: 0.6m Retained height 2.5 - 3.5m + Masonry wall fully overturned and collapse of the main wall span. Partial collapse of the return walls either side of each retaining wall. Bulging and hummocking of stone slab at ground level, and signs of distress in adjacent asphalt where retaining walls have failed, indicating greater/deeper global failure occurring.	2nd/Middle retaining wall: - Increased ravelling of shallow material observed. -Shallow slip developing above overturned masonry. Considering heras fencing, cordoning off. Retaining Walls 1 + 3: Surveyed - No significant change observed.	Infilled with sleepers and planting - tension cracking noted above this section and above adjacent retaining walls. Continue to monitor. It is advised that the remaining bench is removed in this section.	Medium	3	Likely	2	Low	6	Medium

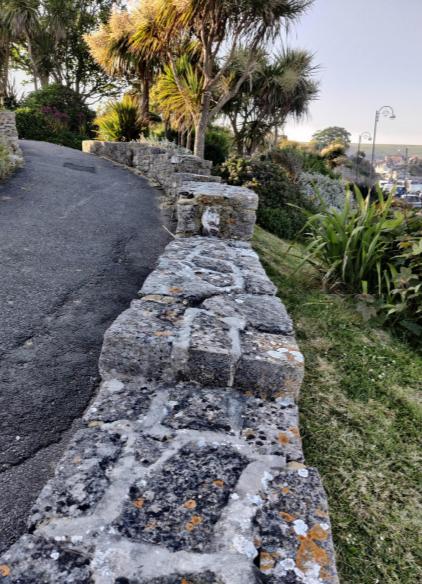
Retaining wall height: 1.0m Retained height: 0.3m Minor tilt/overturning observed in section of masonry wall. Area of overturning matches asphalt repairs and scarring work indicating link between the two. Defect length 22 lm.	Surveyed - No significant change.	No significant change. Footway resurfaced.	Low	2	Unlikely	2	Low	4	Low
C14	Sandpit Field	403039	79146	C14	C14	C14

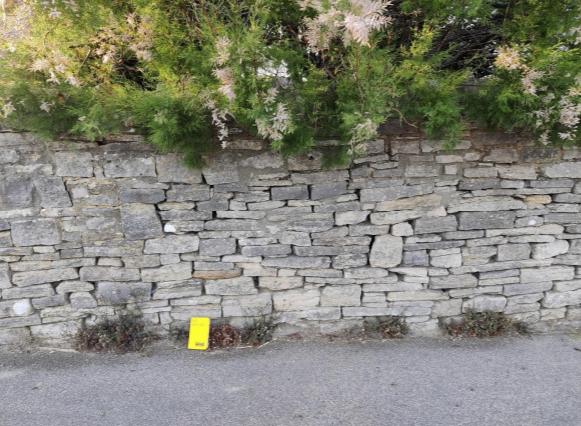
Retaining wall height: 1.25m Retained height: 1.25m Lack of mortar joints connecting this section of wall, therefore potential reconstruction of wall section with dry stone wall technique. Mid height bulging/bowing of the wall likely due to large bushes/trees directly overhanging the back of the wall. Defect length approx 6 lm.	Significant bow in the wall, due to large bushes/trees directly overhanging back of the wall. Bow/overturnd measured as 7 degrees to the vertical. Recommended that trees are coppiced, to remove load from back of the wall, and limit damage to wall without killing tree. Killing or removing the tree would cause the decay/rotting of root system, which is likely providing some integrity to the wall structure.	No significant change.	Medium	3	Likely	2	Low	6	Medium
