TECHNICAL NOTE

DATE:	13 February 2025	CONFIDENTIALITY:	Public
SUBJECT:	Site Monitoring Report – February 2025		
PROJECT:	Swanage Town Council – Shore Road	AUTHOR:	Sam Rhodes
REVIEWER:	Ben Ward	APPROVER:	David Roy

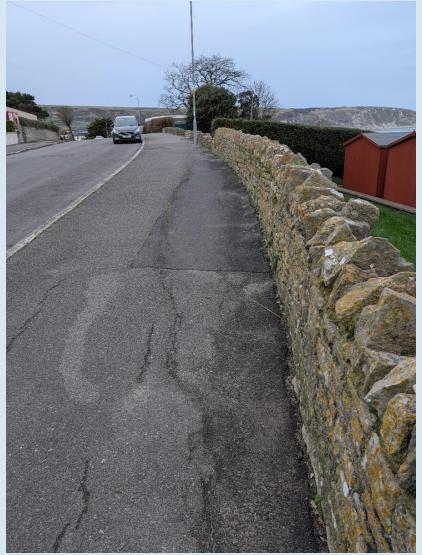
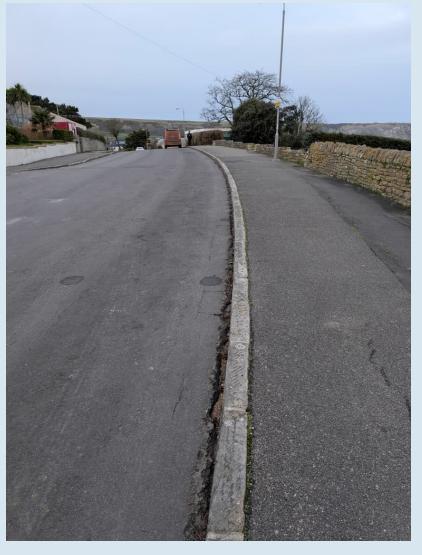
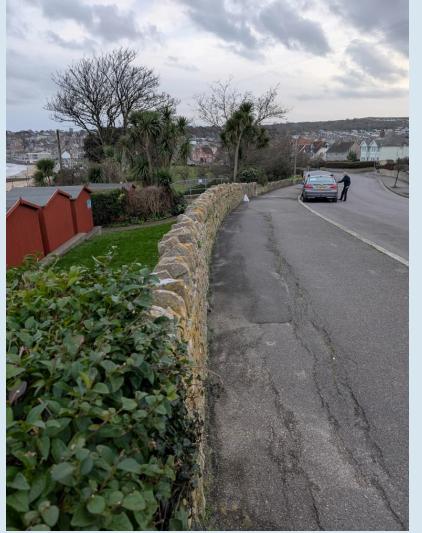
Defect Ref.	Defect Location	Defect Photo	Recommended Mitigation Measure
A18	Spa Beach Huts

- 4.3 At the Client's request, WSP undertook an inspection of wall running north-south at the boundary between De Moulham Road to the west, and the Spa Beach Hut area to the east. Based on the February 2025 walkover survey, the following observations were made:
 - The defect comprised an approximately 18m long section of masonry retaining wall, which was observed to be overturning to the east;

- Longitudinal cracking of the pavement was witnessed, typically running parallel to the wall defect, set back approximately 1m from the wall face. There was evidence of multiple repair attempts to this section of footway, indicating this defect has been present for a prolonged period;

- In addition to the cracking, settlement of the pavement in the order of 20-30mm was observed in the surface material immediately adjacent (i.e. within 1m) from the retained side of the wall. This observation is consistent with the overturning mechanism, as voids behind the wall would develop as the structure rotates away from the footpath alignment; and

- Vertical cracking in the masonry wall were found to occur at the locations where pavement cracking intersected the wall, consistent with the hypothesis that the issues observed are linked.

4.4 From the information available, the likely cause of the defect is one of, or a combination of the following:

- Poor or variable founding stratum/material, resulting in differential settlement of the wall over time;
- Seepage of surface water or leakage from adjacent drainage systems, resulting in strength reduction of foundation soil causing progressive bearing capacity failure of the structure.

4.5 The PAS 128 survey undertaken by Twenty 20 Surveys Ltd in January 2023, identify a combined drainage system running north south through the centreline of De Moulham Road. From the latest walkover survey, surface scarring was observed relating to a chamber on this network, adjacent to the defect. Should defects be present in this stormwater network affecting its performance or watertightness, this may be impacting the groundwater regime in the surrounding locale, impacting the stability of the retaining wall.

4.6 In addition to the above, significant cracking was observed between the edge of the carriageway surfacing and the southbound kerb line, particularly in the area adjacent to the retaining wall defect. The carriageway drainage system appears to camber to the west, therefore stormwater should not be directed into this void. If sufficient water has is being channelled into this void, due to direct rainfall, or adverse cambering of the road, this could significantly weaken the subgrade material underlying the road, pavement and retaining wall. This would cause defects to present in a similar manner to those observed during the site walkover.

<ul style="list-style-type: none"> • Continue to monitor regularly (weekly), or after significant rainfall events. • Consider closing off green area on the east face of the wall, to prevent access to the at risk area, in the event of wall collapse. • Repair carriageway longitudinal surface cracking adjacent to kerbing, to reduce ingress of surface water into underlying formation material. • If further movement or signs of deterioration present moving following repair works, the following measures should be considered: <ul style="list-style-type: none"> - Consider isolating/closing the affected width of footpath, to mitigate risk of persons in the vicinity of potential wall collapse. The sections of uneven footway also present a trip hazard to pedestrians. - If further movement or signs of deterioration present moving following repair works, consider restricting car parking on the south bound section of road, adjacent to the asset.

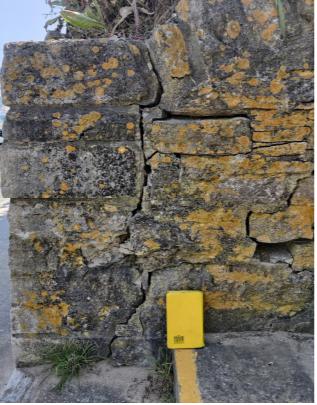
Vertical and horizontal cracking, bulging/horizontal sliding of failing wall section. Crack width 10 - 20mm. Bowing of wall face, up to 40mm. Loose blockwork, missing masonry, loss of mortar between blockwork. Crack length 1.2m wall height 1.2m Retained height 3.0m+.	Crack width increased to 25mm. Bowing of wall face up to 50mm. North facing wall completely sheared from east facing return. Additional bowing/shearing of masonry at bench level adjacent to return wall, with up to 70mm movement. Recommended that area is fenced/closed off. Return wall supports 3.5m of backfill. In the event of total failure, potential to cause significant harm to members of the public.	No significant change Note heras fencing present to separate area from public	No significant change	No significant change	No significant change	High	3	Likely	3	High	9	High

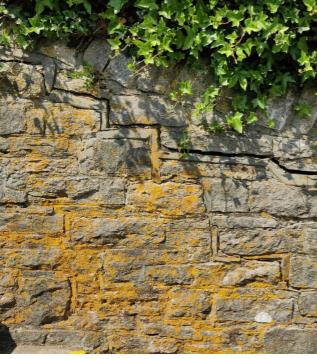
A2	The Spa	403068	79423

Retaining wall height: 1.3m Retained height: 1.3m Horizontal cracking, crack width up to 10mm. Cracking along failed mortar joint.	Max crack width increased 15mm. Otherwise no significant change (NSC) observed.	No significant change	Slight increase increase in crack width observed. Otherwise, no significant change.	Max crack width increased from 15mm to approx. 17mm. Otherwise no significant change.	No significant change	Low	2	Unlikely	1	Very Low	2	Low
A3	The Spa	403061	79407

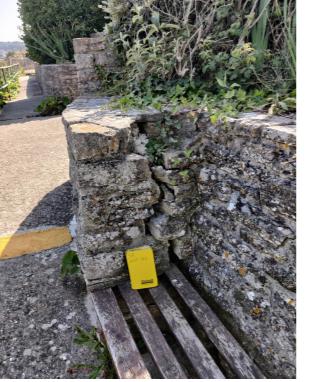
Retaining wall height: 0.8m Retained height: 0.8m Vertical cracking and horizontal displacement of wall. Crack width: 40 - 60mm with loose and missing masonry. Evidence of previous repair attempt with cement mix.	Max crack width 80mm. Max translational movement of masonry (left and right hand side) 50mm. Otherwise no significant change, and low risk.	No significant change	No significant change	Loose masonry to the touch observed. No significant change.	No significant change	Low	2	Unlikely	1	Very Low	2	Low

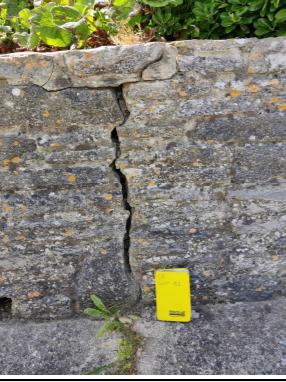
Retaining wall height: 1.0m Retained height: 1.0m Vertical cracking, width up to 30mm. No bowing/bulging of wall face observed. Pavement cracking at base of retaining wall mirroring cracking in retaining wall face.	Surveyed - No significant change.	Vertical cracking, width 40mm	No significant change	No significant change	No significant change	Low	1	Negligible	1	Very Low	1	Low

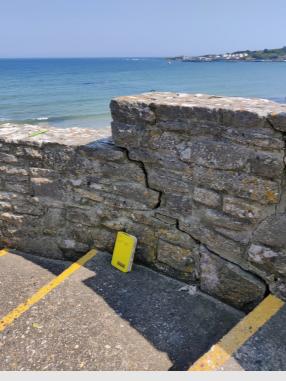
A5	The Spa	403051	79400

Retaining wall height: 0.9m Retained height: 0.2m Vertical and horizontal cracking, crack width up to 30mm. Appears lower section of wall has settled/rotated away from top section, causing failure of mortar joint and cracking in wall.	Surveyed - No significant change.	No significant change	No significant change	Repair to the mortar joints has been made since the last inspection. Risk of failure significantly reduced, however recommended to monitor asset condition in future surveys to ensure repair remains serviceable.	No significant change. Repair has held.	Low	1	Negligible	1	Very Low	1	Low
A6	The Spa	403060	79402

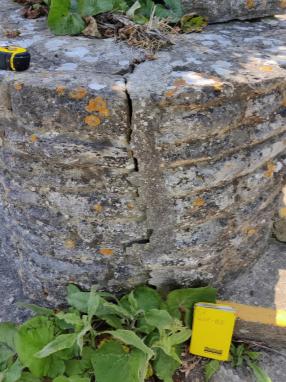
Retaining wall height: 0.9m Retained height: 0.9m Vertical cracking, crack width up to 20mm. Horizontal displacement of right side of wall 10mm from left side. Evidence of previous mortar joint repair, which has since re-failed.	Horizontal displacement of right side of wall increased to 15mm. Otherwise, no significant change, and low risk.	No significant change	No significant change	Horizontal displacement has increased in areas to a max. of 60mm. No significant change in risk profile for asset.	No significant change	Low	2	Unlikely	1	Very Low	2	Low

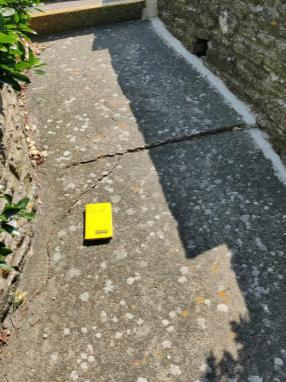
A7	The Spa	403058	79400

Pavement cracking and uneven ground. Differential settlement/transverse cracking in pavement with height up to 10mm. Longitudinal cracking, with width up to 2mm.	Surveyed - No significant change.	No significant change	Differential settlement/transverse cracking in pavement increased from 10mm to 30mm. No significant change to risk rating.	Differential settlement in pavement at maximum, increased from 30mm to 35mm. No significant change in asset risk. Note: Extreme south sloping of pavement in this area, consider risk to pedestrians if this becomes more pronounced.	No significant change	Low	2	Unlikely	1	Very Low	2	Low

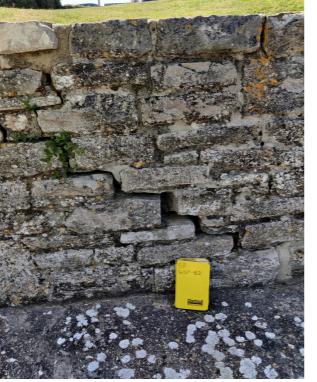
Retaining wall height: 1.0m Retained height: 1.0m Vertical and horizontal cracking, cracking width 30 - 60mm. Length of defect 0.7m. Evidence of minor previous patch repairs with cement mix.	No bowing observed. Surveyed - No significant change.	No significant change At end of wall vertical cracking noted 10-20mm in width	No significant change	Length of defect increased from 0.7m to 0.95m. No significant change in asset condition or risk rating.	No significant change	Low	2	Unlikely	1	Very Low	2	Low

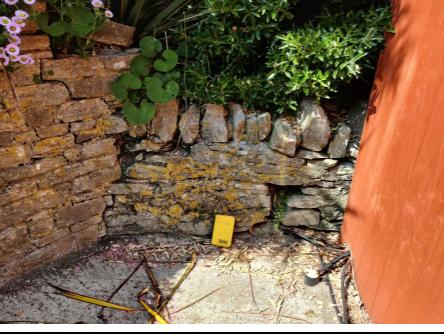
A9	Spa Beach Huts	403028	79367

Retaining wall height: 0.9m Retained height: 0.9m Minor vertical cracking, missing masonry blocks and silted up and damaged back of wall drainage. Damage potentially due to running services through wall, post wall construction.	Surveyed - No significant change.	No significant change	No significant change	No significant change	No significant change	Low	2	Unlikely	1	Very Low	2	Low
A10	Spa Beach Huts	403054	79358

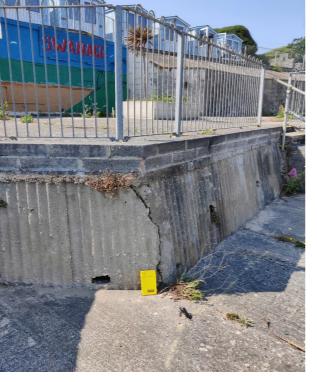
Retaining wall height: 1.25m Retained height: 1.25m Vertical cracking, crack height 0.9m, crack width up to 30mm. Damaged weephole / void at the base of the wall (see left of survey book).	Surveyed - No significant change.	No significant change	No significant change	No significant change	No significant change	Low	2	Unlikely	2	Low	4	Low
A11	Spa Beach Huts	403042	79361

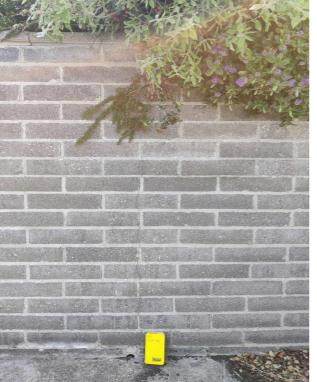
Retaining wall height: 2.15m Retained height 2.15m Hairline vertical cracking full height of the wall, crack width ~1mm. Weephole silted up and 2/3 blocked by additional concrete pours, potential from previous remedial works.	Could not survey due to lack of access to mid-terrace. From visual inspection in accessible location, no significant change observed.	No significant change	No significant change From visual inspection in accessible location, no significant change observed.	Could not survey due to lack of access to mid-terrace. From visual inspection in accessible location, no significant change observed.	Could not survey due to lack of access to mid-terrace. From visual inspection in accessible location, no significant change observed.	Low	1	Negligible	3	High	3	Low

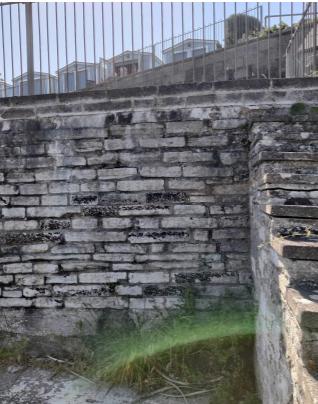
Retaining wall height: 2.55m Retained height: 2.55m Horizontal and vertical cracking. Crack length 1.6m. Typical crack width 3-10mm. Bulging/bowing at the mid span of masonry wall.	Surveyed - No significant change.	No significant change	No significant change	No significant change	No significant change	Low	1	Negligible	2	Low	2	Low
A17	Spa Beach Huts	403062	79383

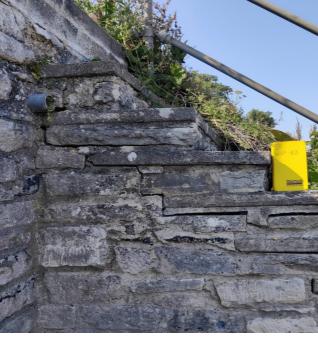
Retaining wall height: up to 2.2m Retained height: up to 2.5m. Horizontal cracking. Crack length 1.8m. Crack width 3 - 12mm. Horizontal movement of return wall causing cracking, potentially due to bulging/bowing from the main span.	Surveyed - No significant change.	No significant change	No significant change	No significant change	No significant change	Low	1	Negligible	1	Very Low	1	Low

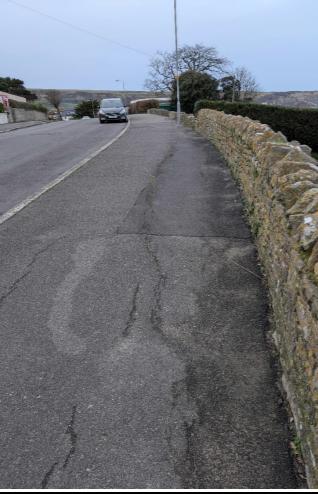
A18	Spa Beach Huts	403026	79380

N/A	N/A	N/A	N/A	N/A	De Moulham Road Retaining Wall Observations: - Approx. Defect Length = 18m - Overturning wall - Longitudinal tension cracking in pavement - Multiple tarmac repairs observed in the area. - Settlement of material adjacent to the retained side of the wall (underlying tarmac repair) - approx. 20-30mm. - Settlement consistent with theory of wall overturning, resulting in void developing behind wall, for subbase/subgrade material to settle into. - Cracking in masonry wall consistent with location of cracks in the pavement, indicating cause/effect of wall on pavement construction. Likely cause of issue: - Poor foundation material, causing differential settlements - Leakage of drainage system in locale causing reduction in strength of the wall formation material.	N/A	3	Likely	2	Low	6	Medium
B1	Weather Station Field	403050	79339

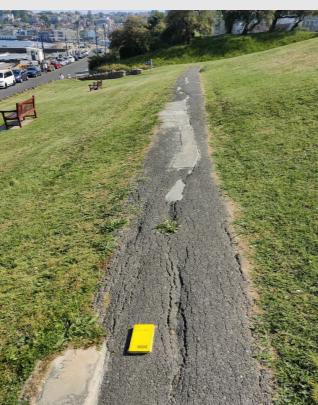
Pavement tension cracking, surface deformation and partial collapse. 2no. continuous cracks observed, 3.6m and 11m in length respectively. Multiple patch repairs with asphalt and cement/concrete mix. Ground uneven and with numerous cracks. Crack depths ranging between 5 - 10mm where repairs have not been completed.	Surveyed - No significant change. Slip/trip/hazard for members of the public (similar to defect ref. C7). Consider closing off access to footpath, or removing entirely.	Footpath now removed and replaced with grass	No significant change.	No significant change.	No significant change Repair still intact.	Low	1	Negligible	1	Very Low	1	Low

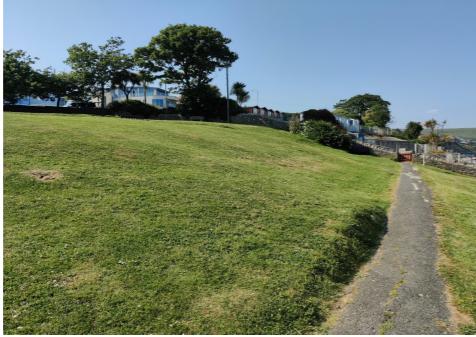
In the field area to the east of weather station, hummocky ground observed, with tension cracking in slope, bulging of surface.	Surveyed - No significant change.	No significant change	No significant change	At south east corner of field, a BH / inclinometer cap missing, with open pipework exposed. This is likely to cause erroneous recordings with regards to groundwater measurements. Review of data to be undertaken.	BH cap at south east corner has been replaced since last inspection. Rectified. Bulging slope surface shows no significant change. However, still presents a remedial risk. Regular topographical survey works would be required to assess minor slope movements.	Medium	3	Likely	2	Low	6	Medium

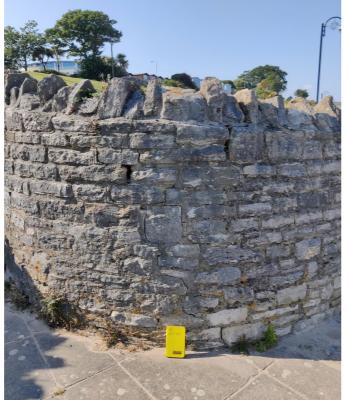
B3	Weather Station Field	403059	79309

Retaining wall height: 1.8m Retained height: 1.8m Vertical and horizontal cracking, crack width between 2 - 20mm, occurring at apex of wall curvature. No bulging or bowing of the wall observed.	Unable to survey position of maximum crack width due to information signage location. Otherwise no significant change observed.	No significant change	No significant change	No significant change	No significant change	Low	2	Unlikely	2	Low	4	Low
B4	Weather Station Field	403055	79305

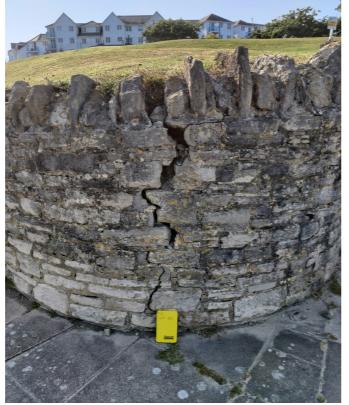
Retaining wall height: 1.8m Retained height: 1.8m Curved wall with 3no. sets of vertical cracking. From south face of retaining wall, cracks are at chainage CH 0, 2.0, and 5.5m. Total length of defect: 5.5m. CH 0m Defect: Vertical cracking, crack width typically 30 - 50mm. Missing blockwork at the head of the wall, with significant voids behind mid span of wall (potentially lost mortar or block work following movement). CH 2.0m Defect: Vertical cracking, max crack width typically 90 - 130mm, increasing with height of wall. Missing blockwork at top of wall. CH 5.5m Defect: Vertical cracking, crack width up to 10mm. Blockwork intact.	Survey of crack dimensions hampered by heras fencing panels, which could not be moved. Could not be surveyed accurately. No significant change in structure compared with previous survey.	Heras fencing forming exclusion zone. No direct measurements made, however general observations indicate further movement. Continue to monitor and maintain exclusion.	Heras fencing forming exclusion zone. No direct measurements made, due to presence of fencing panels. Continue to monitor and maintain exclusion.	No significant change. Continue to monitor and maintain exclusion zone.	No significant change. Continue to monitor and maintain exclusion zone.	High	3	Likely	3	High	9	High

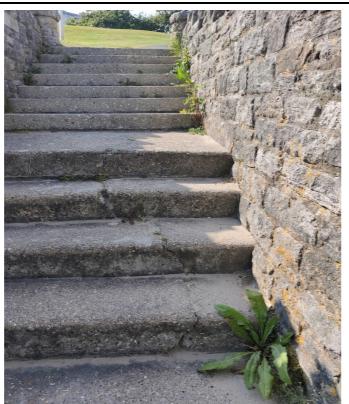
B5	Weather Station Field	403054	79310

Vertical cracking on footpath/stepped access. Crack length 3m, typical crack width 1 - 2mm.	Additional cracking observed at bottom left stairs area. Crack widths similar to previous survey.	No significant change	Additional loss of material/concrete from steps, with voids/cracking up to 40-50mm observed. No significant change to risk level currently.	Additional cracking of pavement slabs observed. No significant change to risk profile.	Significant cracking of pavement slabs. Concrete pavers still stable (i.e. no rocking), however continued deterioration of the asset may give cause to a trip hazard. Recommend to continue monitoring. No significant change in geotechnical risk profile.	Low	2	Unlikely	1	Very Low	2	Low

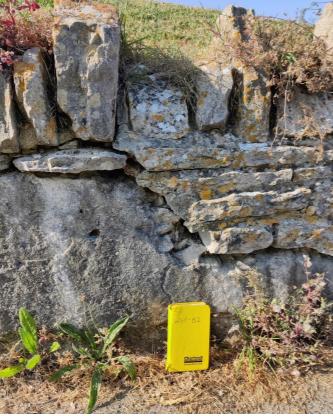
Retaining wall height: 1.0m. Retained height: 1.5m Vertical and horizontal cracking, crack length 0.8m. Typical crack width 40 - 60mm. Minor bowing of the wall at mid height.	Previously identified "minor bowing" appears more akin to shearing of top row of finishing stones of wall span, from the wall below. No significant change in crack widths from previous survey.	No significant change in crack widths	No significant change.	Max crack width increased from 60mm to 90mm. Top of wall has sheared further outwards from lower wall.	Max crack width 90mm - maintained. Top of wall has sheared further outwards from lower wall. Significant water egress from wall face at joint with flag stones. Increased geotechnical risk, however risk profile has been kept same, due to limited exposure risk following installation of exclusion zone at Walrond Road north.	Low	2	Unlikely	1	Very Low	2	Low

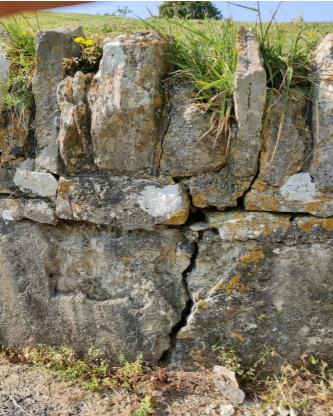
B7	Weather Station Field	403034	79304

Retaining wall height: 0.9m Retained height: 1.0m. Vertical cracking, from base to top of wall (i.e. 0.9m), crack width between 20 - 40mm.	Surveyed - No significant change.	No significant change	No significant change	No significant change	Significant water egress from wall face at joint with flag stones. Increased geotechnical risk, however risk profile has been kept same, due to limited exposure risk following installation of exclusion zone at Walrond Road north.	Low	1	Negligible	1	Very Low	1	Low
B8	Weather Station Field	403026	79304

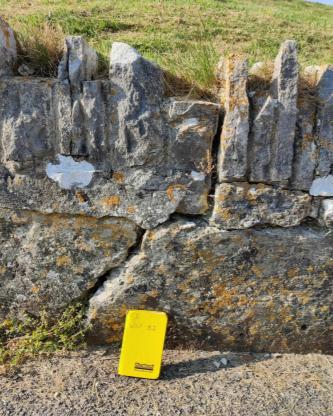
Retaining wall height: 0.85m Retained height: 1m + Vertical and horizontal cracking, the full height of the wall (0.85m), with typical crack width of 20mm. Lower right side (east) of wall translational movement relative to rest of wall (<30mm).	Max crack width increased to up to 40mm. Otherwise no significant change - low risk.	No significant change	No significant change	No significant change	No significant change	Low	1	Negligible	1	Very Low	1	Low

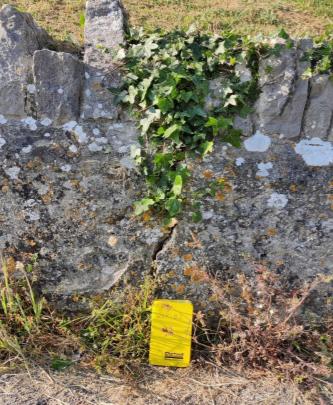
B9	Weather Station Field	403017	79304

Retaining wall height: 1.0m Retained height: 1.0m Vertical cracking, running full height of the wall. Right of the crack (east side of the wall), 30mm translational movement of the wall relative to the west side. Pavement cracking adjacent to retaining wall observed from base of retaining wall.	Surveyed - No significant change.	No significant change	Crack width observed up to 20mm. No significant change to translation movement or pavement cracking adjacent to the wall.	No significant change	No significant change	Low	1	Negligible	1	Very Low	1	Low

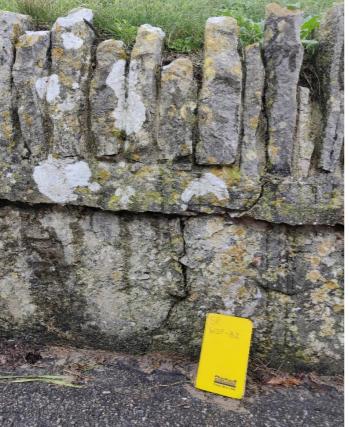
N/A Retaining wall height: 0.9m Retained height: 1.0m. Vertical cracking, from base to top of wall (i.e. 0.9m), crack width up to 10mm.	No significant change	No significant change	No significant change	No significant change	No significant change Significant overhang of upper flag stone sections to lower wall. Risk covered under defect Ref. B11.	Low	2	Unlikely	1	Very Low	2	Low

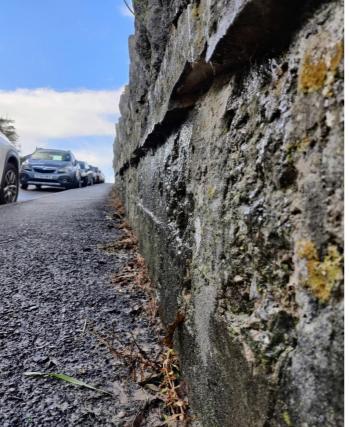
B11	Weather Station Field	403040	79304

N/A 7.5m length of wall, between defect ref. B6 and B7: Shearing of top span of masonry from base of wall, up to 50mm. Movement in superficial material on retained side of weather station field separating wall at weak/mortar joint location. Risk of collapse over time, and damage to pavement, members of the public, and cars parked on road adjacent to wall. Advise to continue monitoring regularly.	Shearing of top span of masonry from base of wall, increased to 70mm. Evidence of seepage through wall, along extents. Advise to continue monitoring regularly. Further deterioration may require foot path diversion.	Condition of asset as per February 2024 inspection. Lateral extents of the defect has increased from 7.5m to 9m. Advise to continue monitoring regularly. Continue to monitor, if further degradation occurs, or additional spalling of wall material, consider exclusion zone around affected section and footpath diversion.	Length of defect observed increased from 7.5m to 10m. Significant evidence of seepage egressing from behind the wall, between the upper and lower wall sections. Evidence of spalling of facing material in multiple locations. Recommend to maintain exclusion zone and regularly monitoring in accordance with main report recommendations.	Exclusion zone has been erected since previous site walkover over (October 2024), in accordance with report recommendations. Longitudinal cracking + footpath bulge/heaving at locations of worst affected area + max slumping of material above wall.	High	3	Likely	3	High	9	High

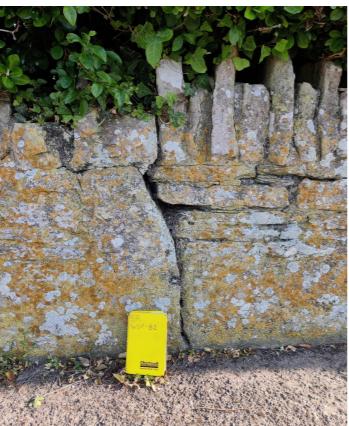
C1	Sandpit Field	403000	79294

Retaining wall height: 1.0m. Retained height: 1.0m. Vertical cracking, full height of wall, typical crack width 5 - 30mm. Large bushes overhanging back of retaining wall, likely the cause of distress observed in the structure.	Displacement of east side of wall relative to the west up to 30mm. Otherwise no significant change - low risk.	No significant change	No significant change	Typical crack width increased from 30mm to 40mm. No significant change in asset risk.	No significant change	Low	2	Unlikely	1	Very Low	2	Low
C2	Sandpit Field	403009	79294

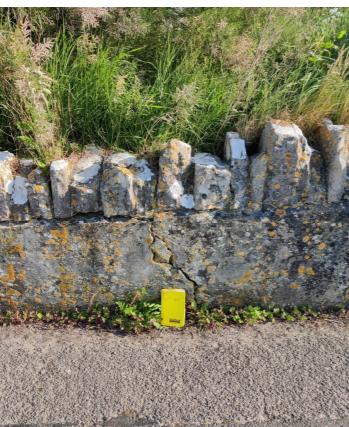
Retaining wall height: 0.8m Retained height: 0.8m Vertical cracking full height of wall, typical crack width 5 - 20mm. Evidence of historic patch repair made previously.	Surveyed - No significant change.	No significant change	No significant change	No significant change	No significant change	Low	1	Negligible	1	Very Low	1	Low

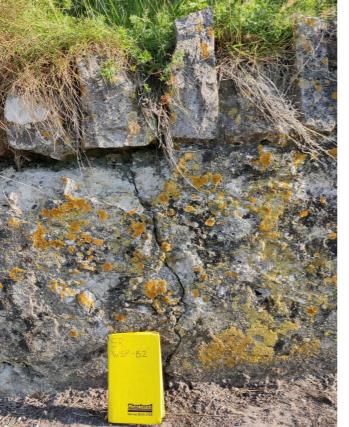
Retaining wall height: 0.95m Retained height 1.0m Vertical cracking, full height of wall, crack width between 1 - 3mm.	Surveyed - No significant change.	No significant change	No significant change	No significant change	No significant change	Low	1	Negligible	1	Very Low	1	Low
C4	Sandpit Field	403035	79295

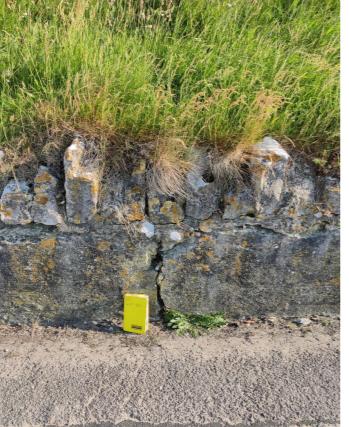
Retaining wall height: 1.0m Retained height: 1.2m Vertical cracking, full height of wall. Crack width 20 - 40mm.	Small void at base of wall due to loss of mortar/masonry. Likely lost from translational movement of the wall. Otherwise no significant change.	No significant change	No significant change	Masonry appears to have been lost / fallen off of wall face in section surrounding the crack (See latest images for comparison). Slight increase in asset risk, however still low due to general condition and retained height.	No significant change	Low	2	Unlikely	2	Low	4	Low

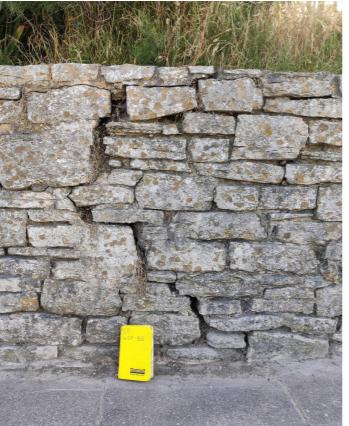
C5	Sandpit Field	403058	79290

Retaining wall height: 1.25m Retained height 1.25m Vertical and horizontal cracking increased from 20-30mm to 40-50mm. Transverse movement of the wall, mortar joint failure from masonry blockwork moving apart.	Vertical and horizontal cracking increased from 20-30mm to 40-50mm. Otherwise health of asset unchanged. Low risk.	No significant change	No significant change	No significant change	No significant change	Low	2	Unlikely	2	Low	4	Low
C6	Sandpit Field	403054	79280

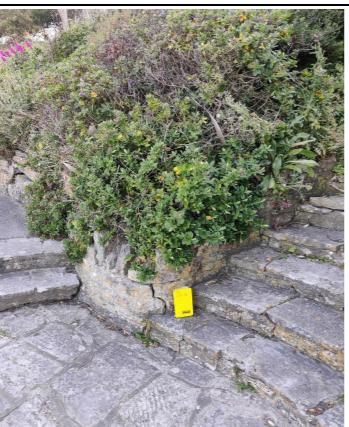
Retaining wall height: 0.6m Retained height: 1.5m+ Vertical cracking full height of the wall. Typical crack width between 10 - 15mm. Overgrown bushes and vegetation acting on the back of the wall the likely cause of deterioration of the retaining structure.	Typical crack width increased to 15-25mm. Otherwise no significant change - low risk.	No significant change	No significant change	No significant change. Asset partially obscured by vegetation.	No significant change. Asset partially obscured by vegetation.	Low	2	Unlikely	2	Low	4	Low

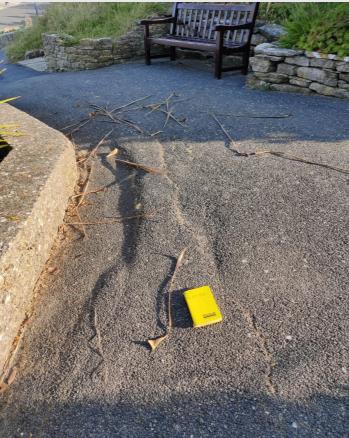
Multiple areas of pavement cracking and surface deformation (one example shown face left). Distress in asphalt behind lower slope retaining walls observed where rotation of lower wall was seen (see defect C13). Additional areas of distress in pavement seen where up slope area is oversteepened and not effectively restrained by retaining structure or otherwise, see defect C12.	Defect has been repaired, asphalt has been re-laid in area following slip/trip/fall incident. Bench removed from area. Area to be checked in follow up surveys to ensure defect does not reoccur.	No significant change	No significant change	No significant change Current pavement repair has held.	No significant change. Pavement repair in good condition.	Low	1	Negligible	1	Very Low	1	Low

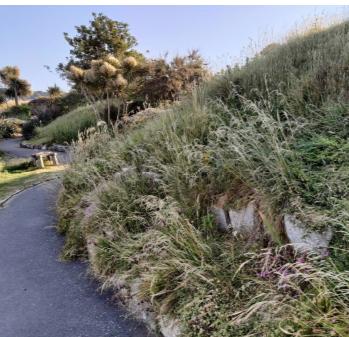
C8	Sandpit Field	403056	79252

Retaining wall height: 1.3m Retained height 3.0m + 6 l.m of terraced masonry blocks which were observed to be overturning with over steepened slope behind. Blocks likely installed to prevent shallow slip failure of material above, however global stability of slope borderline.	Blocks further overturned. Further ravelling of slope material. A 1 m section of toe has a paving stone/blockwork missing. Unsupported toe area has an increased risk of slip/localised slope failure. Regular inspection of area recommended to inspect condition. Consider replacing stone/blockwork to provide support to the face.	No significant change	2no. Replacement blockwork paving slabs installed on the base row. Southern one has already overturned with voiding behind the rear face of panel observed.	Southern paving slab referred to within May 2024 defect schedule has been repaired/reinstated. Continue to monitor, however risk profile remains same from May 2024 inspection.	No significant change. Asset partially obscured by vegetation.	Medium	2	Unlikely	3	High	6	Medium

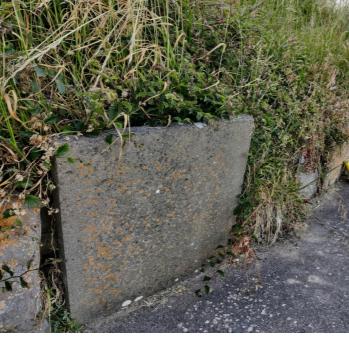
C9	Sandpit Field	403056	79246

Retaining wall height: 0.6m Retained height: 3m + 7.5 l.m of retaining wall blocks partially overturned at toe of retaining wall. Insufficient embedment of blocks at toe, and oversteepened slope behind overloading wall.	Surveyed - No significant change.	Slabs appear to have rotated further outward, consider removal or replacement	Further overturning of southern most slab and newly replaced slab observed. Consider removal and reinstatement with greater toe embedment.	Southern most slab has been repaired/replaced and levelled. Continue to monitor. No significant change in risk profile.	No significant change. Continue to monitor pavers for movement/displacement.	Medium	2	Unlikely	2	Low	4	Low
C10	Sandpit Field	403052	79239

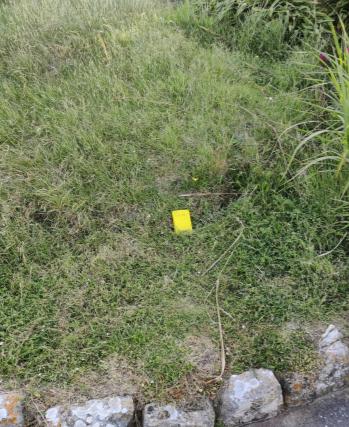
3 l.m of tension cracking observed in oversteep section of slope. Width of tension crack approx 200mm, and 250mm depth in areas.	Tension crack width Otherwise no significant change. Continue to monitor on ongoing basis.	No significant change	No significant change.	No significant change. Due to heavy vegetation, quantifying the crack width of asset difficult. From general visual inspection, asset condition has not changed since previous inspection.	Area de-vegetated following previous inspection circa October 2024. Hummocky ground and tension crack on embankment toe observed, resulting in 200-300mm vertical face of material. Recommend to continue monitoring for further degradation.	Medium	3	Likely	2	Low	6	Medium
