# TECHNICAL NOTE

<b>DATE:</b>	02 April 2026	<b>CONFIDENTIALITY:</b>	Public
<b>SUBJECT:</b>	Site Monitoring Report – February 2026		
<b>PROJECT:</b>	Swanage Town Council – Shore Road	<b>AUTHOR:</b>	Sam Horner
<b>REVIEWER:</b>	Ben Ward	<b>APPROVER:</b>	David Roy

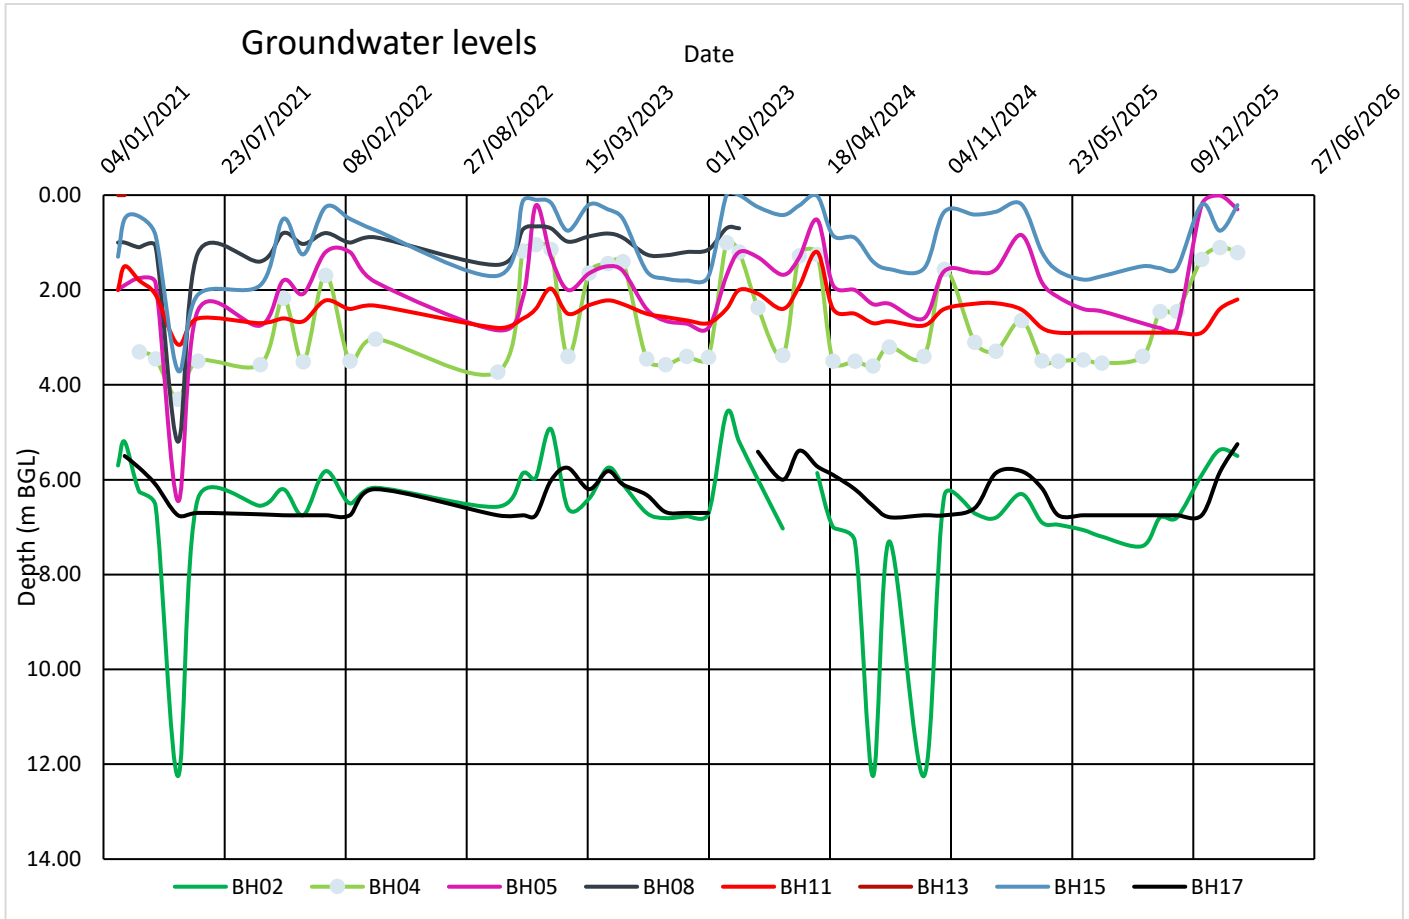
Figure 1: Groundwater monitoring data

3.33 As shown in the figure below these groundwater readings peaked and the latest readings in February 2026 showed values to be returning back to their typical level. The levels observed in these boreholes are not greater than the previous recorded peaks.

3.34 It was noted during the site walkover that the ground was heavily saturated and soft underfoot, this is supported by the high groundwater readings as measured. This data should be reviewed in conjunction with the next site walkover to determine whether the monitored groundwater levels are representative of site conditions.

3.35 It is recommended that groundwater and inclinometer monitoring is continued alongside periodic site walkovers to ensure that site defects are appropriately risk managed, and areas cordoned off as necessary.

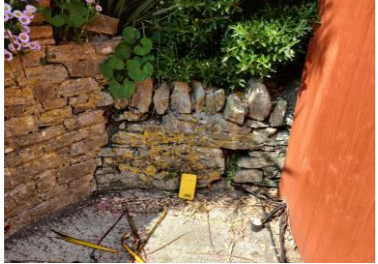
Retaining wall height: 0.9m Retained height: 0.9m Minor vertical cracking, missing masonry blocks and silted up and damaged back of wall drainage. Damage potentially due to running services through wall, post wall construction.	Surveyed - No significant change.	No significant change	No significant change	No significant change	No significant change	No significant change.	No significant change.	No significant change.	Low	2	Unlikely	1	Very Low	2	Low

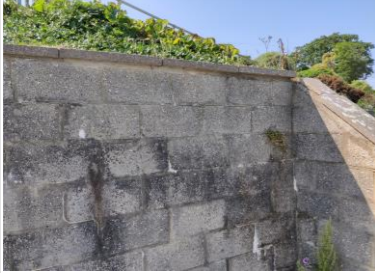
A13	Spa Beach Huts	403055	79380

Retaining wall height: 2.15m Retained height: 2.5m Horizontal hairline cracking, crack width 1mm. Cracking located 1.85m from existing ground level. Slight bulging/bowing at the mid span/mid height of retaining wall. Defect length: 8m.	Could not survey due to lack of access to mid-terrace. From visual inspection in accessible location, no significant change observed.	No significant change	No significant change. Could not survey due to lack of access to mid-terrace. From visual inspection in accessible location, no significant change observed.	Evidence of water ingress through the mortar joints, indicating perch groundwater behind wall could be present. No significant change in risk rating.	No significant change	Could not survey due to lack of access to mid-terrace. From visual inspection in accessible location, no significant change observed.	Could not survey due to no access to mid-terrace. From visual inspection in accessible location, no significant change observed.	Could not survey due to no access to mid-terrace. From visual inspection it appeared a small amount of water egress was occurring. Wall appeared wet in places. No significant change to risk profile.	Low	2	Unlikely	1	Very Low	2	Low

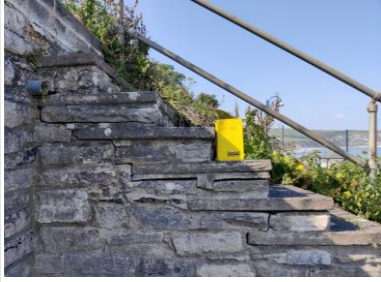
A17	Spa Beach Huts	403062	79383

Retaining wall height: up to 2.2m Retained height: up to 2.5m. Horizontal cracking. Crack length 1.8m. Crack width 3 - 12mm. Horizontal movement of return wall causing cracking, potentially due to bulging/bowing from the main span.	Surveyed - No significant change.	No significant change	No significant change	No significant change	No significant change	maximum vertical crack width recorded to be 10mm. Horizontal crack width up to 5mm.	Vertical crack width 10 - 15mm. No significant change	Vertical crack width measured, still 10 - 15mm. No significant change	Low	1	Negligible	1	Very Low	1	Low	Low	
A18	Spa Beach Huts	403026	79380

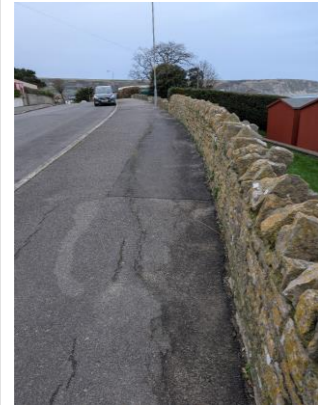
N/A	N/A	N/A	N/A	N/A	N/A	De Moulham Road Retaining Wall Observations: Approx. Defect Length = 18m - Overturning wall - Longitudinal tension cracking in pavement - Multiple tarmac repairs observed in the area. - Settlement of material adjacent to the retained side of the wall (underlying tarmac repair) - approx. 20-30mm. - Settlement consistent with theory of wall overturning, resulting in void developing behind wall, for subbase/subgrade material to settle into. - Cracking in masonry wall consistent with location of cracks in the pavement, indicating cause/effect of wall on pavement construction.  Likely cause of issue: - Poor foundation material, causing differential settlements - Leakage of drainage system in locale causing reduction in strength of the wall formation material.	The pavement has been resurfaced since the last inspection. No cracks present on new surfacing. Area below masonry wall fenced off from the public. Wall has minor cracking and vegetation growing in the mortar render between the blocks. Desiccation noted in the toe area.	Desiccation not observed at the toe. New surfacing is showing minor cracking, and on either end of the repair cracks are extending parallel to the wall. Subsidence of the pavement is also present.	Minor leaning of the wall below measured to be 2" - 3". Desiccation not observed at toe, likely due to wet weather. New patch repair has been completed since October 2025 visit. New surfacing is showing minor cracking, and on either end of the repair cracks are extending parallel to the wall. Subsidence of the pavement is also present.	Medium	3	Likely	2	Low	6	Medium	Medium

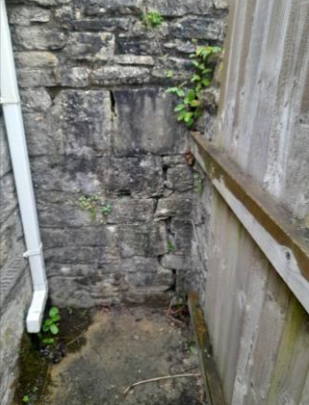
A19	Spa Beach Huts	403063	79367

N/A	N/A	N/A	N/A	N/A	N/A	Cracking in wall at base of steps. Retaining wall 2.5m in height. Crack approx. 1m long and width of up to 30mm.	Minor seepage observed. Crack width 30 - 40mm.	Minor seepage observed. Crack width 30 - 45mm. No significant change to risk profile.	Low	1	Negligible	2	Low	2	Low	Low

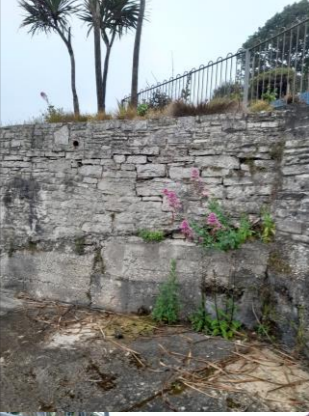
N/A	N/A	N/A	N/A	N/A	N/A	Cracking noted on the south end of the wall with defect A16. Cracking observed within render between blocks. Crack length 1m Crack width up to 20mm.	No significant change.	No significant change.	Low	1	Negligible	2	Low	2	Low	Low

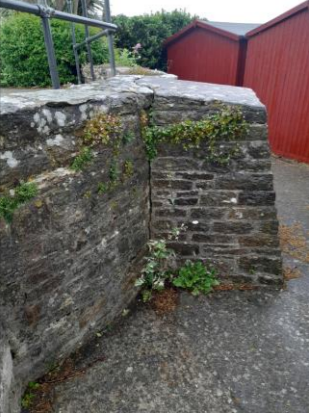
A21	Spa Beach Huts	403027	79364

N/A	N/A	N/A	N/A	N/A	N/A	Buttresses on retaining wall adjacent to defect A9 are delaminating from retaining wall. Render is cracked between buttress and wall. Crack width of 30mm. Retaining wall 1.3m height and 1.0m depth.	No significant change.	Seepage observed on abutment and the wall it is supporting. Crack widths measured to be 30 - 40mm.	Medium	2	Unlikely	3	High	6	Medium	Medium
A22	Spa Beach Huts	403064	79377	 	N/A	N/A	N/A	N/A	N/A	N/A	N/A	N/A	Seepage observed in lower wall below beach huts. Several areas were noted on a dry day.	Low	2	Unlikely	2	Low	4	Low	Low
A23	Spa Beach Huts	403058	79387

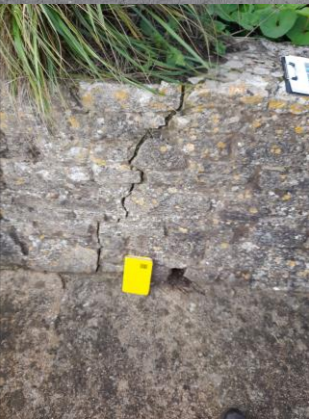
N/A	N/A	N/A	N/A	N/A	N/A	N/A	N/A	Vertical cracking observed in wall. Widths <10mm. Cracking in place of mortar between blocks. Retaining wall height = 0.9m. Retaining wall depth = 0.4m.	Low	2	Unlikely	1	Very Low	2	Low	Low

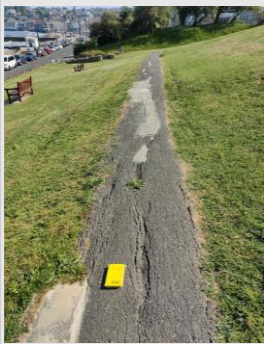
Pavement tension cracking, surface deformation and partial collapse. 2no. continuous cracks observed, 3.6m and 11m in length respectively. Multiple patch repairs with asphalt and cement/concrete mix. Ground uneven and with numerous cracks. Crack depths ranging between 5 - 10mm where repairs have not been completed.	Surveyed - No significant change. Slip/trip/fall hazard for members of the public (similar to defect ref. C7). Consider closing off access to footpath, or removing entirely.	Footpath now removed and replaced with grass	No significant change.	No significant change.	No significant change Repair still intact.	No significant change. Bare earth noted on old path location, grass growing in patches.	No significant change. More grass cover over bare earth. Occasional bare earth.	No significant change. More grass cover over bare earth. Occasional bare earth.	Low	1	Negligible	1	Very Low	1	Low

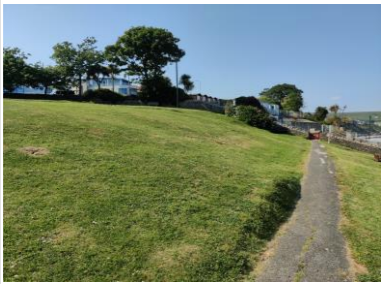
B2	Weather Station Field	403042	79330

In the field area to the east of weather station, hummocky ground observed, with tension cracking in slope, bulging of surface.	Surveyed - No significant change.	No significant change	No significant change	At south east corner of field, a BH / inclinometer cap missing, with open pipework exposed. This is likely to cause erroneous recordings with regards to groundwater measurements. Review of data to be undertaken. Bulging of surface slope material remains, and hummocky ground building up behind wall running to the south.	BH cap at south east corner has been replaced since last inspection. Rectified. Bulging slope surface shows no significant change. However, still presents a remedial risk. Regular topographical survey works would be required to assess minor slope movements. Risk of failure to the south reduced with the erection of an exclusion zone around southern wall section.	Hummocky ground with desiccated ground in areas. Bulging slope surface shows no significant change. However, still presents a remedial risk. Regular topographical survey works would be required to assess minor slope movements.	No significant change Regular topographical survey works would be required to assess minor slope movements.	No significant change Area was significantly wet under foot. Soft ground around the weather station and above in line with saturation. Regular topographical survey works would be required to assess minor slope movements.	Medium	3	Likely	2	Low	6	Medium

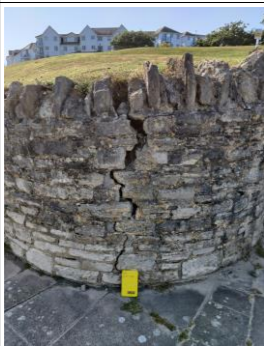
Retaining wall height: 1.8m Retained height: 1.8m Curved wall with 3no. sets of vertical cracking. From south face of retaining wall, cracks are at chainage CH 0, 2.0, and 5.5m. Total length of defect: 5.5m. CH 0m Defect: Vertical cracking, crack width typically 30 - 50mm. Missing blockwork at the head of the wall, with significant voids behind mid span of wall (potentially lost mortar or block work following movement). CH 2.0m Defect: Vertical cracking, max crack width typically 90 - 130mm, increasing with height of wall. Missing blockwork at top of wall. CH 5.5m Defect: Vertical cracking, crack width up to 10mm. Blockwork intact.	Survey of crack dimensions hampered by heras fencing panels, which could not be moved. Could not be surveyed accurately. No significant change in structure compared with previous survey. Maintain heras fencing panel around defect. Continue to monitor regularly.	Heras fencing forming exclusion zone. No direct measurements made, however general observations indicate further movement. Continue to monitor and maintain exclusion.	Heras fencing forming exclusion zone. No direct measurements made, due to presence of fencing panels. Continue to monitor and maintain exclusion.	No significant change. Continue to monitor and maintain exclusion zone.	No significant change. Continue to monitor and maintain exclusion zone.	No significant change. Continue to monitor and maintain exclusion zone.	No significant change. Continue to monitor and maintain exclusion zone.	No significant change. Continue to monitor and maintain exclusion zone.	No significant change. Continue to monitor and maintain exclusion zone.	No significant change. Continue to monitor and maintain exclusion zone.	No significant change. Cacking measured <70mm Continue to monitor and maintain exclusion zone.	High	3	Likely	3	High	9	High

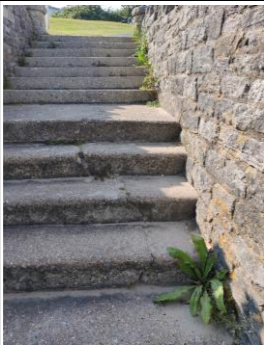
B5	Weather Station Field	403054	79310

Vertical cracking on footpath/stepped access. Crack length 3m, typical crack width 1 - 2mm.	Additional cracking observed at bottom left stairs area. Crack widths similar to previous survey.	No significant change	Additional loss of material/concrete from steps, with voids/cracking up to 40-50mm observed. No significant change to risk level currently.	Additional cracking of pavement slabs observed. No significant change to risk profile.	Concrete pavers still stable (i.e. no rocking), however continued deterioration of the asset may give cause to a trip hazard. Recommend to continue monitoring. No significant change in geotechnical risk profile.	Concrete pavement slabs still stable (i.e. no rocking), however continued deterioration of the asset may give cause to a trip hazard. Recommend to continue monitoring. No significant change in geotechnical risk profile.	Concrete pavement slabs still stable (i.e. no rocking), however continued deterioration of the asset may give cause to a trip hazard. Recommend to continue monitoring. No significant change in geotechnical risk profile.	Concrete pavement slabs still stable (i.e. no rocking), however continued deterioration of the asset may give cause to a trip hazard. Recommend to continue monitoring. No significant change in geotechnical risk profile.	Low	2	Unlikely	1	Very Low	2	Low

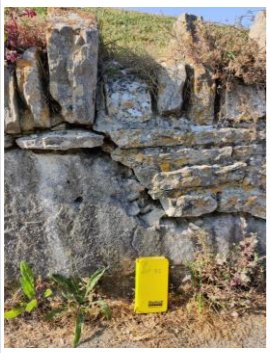
Retaining wall height: 1.0m. Retained height: 1.5m Vertical and horizontal cracking, crack length 0.8m. Typical crack width 40 - 60mm. Minor bowing of the wall at mid height.	Previously identified "minor bowing" appears more akin to shearing of top row of finishing stones of wall span, from the wall below. No significant change in crack widths from previous survey.	No significant change in crack widths Noted to be very wet with water issuing from between cracks	No significant change. No water observed expelling from the wall face, however weather conditions were dry on date of inspection.	Max crack width increased from 60mm to 90mm. Top of wall has sheared further outwards from lower wall. No significant change in risk profile.	Max crack width 90mm - maintained. Top of wall has sheared further outwards from lower wall. Significant water egress from wall face at joint with flag stones. Increased geotechnical risk, however risk profile has been kept same, due to limited exposure risk following installation of exclusion zone at Walrond Road north.	Max crack width 90mm. Overhang from top section (shear failure) up to 45mm. No significant change.	No significant change. Crack widths and overhang not increased.	No significant change. Crack widths and overhang not increased. Seepage was observed through the cracks.	Low	2	Unlikely	1	Very Low	2	Low

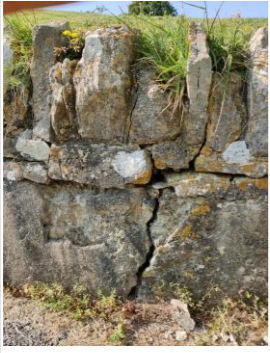
B7	Weather Station Field	403034	79304

Retaining wall height: 0.9m Retained height: 1.0m. Vertical cracking, from base to top of wall (i.e. 0.9m), crack width between 20 - 40mm.	Surveyed - No significant change.	No significant change	No significant change	No significant change	Significant water egress from wall face at joint with flag stones. Increased geotechnical risk, however risk profile has been kept same, due to limited exposure risk following installation of exclusion zone at Walrond Road north.	Vertical crack width measured to be between 20 - 50mm. No water egress noted however this may have been masked by the heavy rainfall present during the monitoring visit.	No significant change. Crack widths still similar. Water egress noted in February 2025 not observed on dry day either.	No significant change. Vertical crack width measured to be between 20 - 50mm. Seepage observed from cracks.	Low	1	Negligible	1	Very Low	1	Low

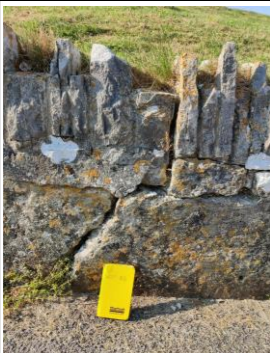
B8	Weather Station Field	403026	79304

Retaining wall height: 0.85m Retained height: 1m + Vertical and horizontal cracking, the full height of the wall (0.85m), with typical crack width of 20mm. Lower right side (east) of wall translational movement relative to rest of wall (<30mm).	Max crack width increased to up to 40mm. Otherwise no significant change - low risk.	No significant change	No significant change	No significant change	No significant change	Crack widths measured between 20 - 30mm. No significant change.	No significant change. No increase in crack width measured.	No significant change. Crack widths measured between 20 - 30mm. Overhang / translational movement up to 30mm.	Low	1	Negligible	1	Very Low	1	Low
B9	Weather Station Field	403017	79304

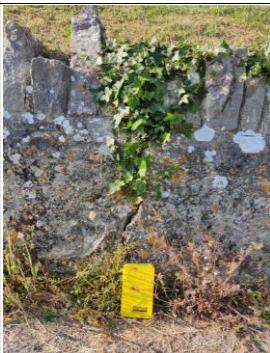
Retaining wall height: 1.0m Retained height: 1.0m Vertical cracking, running full height of the wall. Right of the crack (east side of the wall), 30mm translational movement of the wall relative to the west side. Pavement cracking adjacent to retaining wall observed from base of retaining wall.	Surveyed - No significant change.	No significant change	Crack width observed up to 20mm. No significant change to translation movement or pavement cracking adjacent to the wall.	No significant change	No significant change	Crack width measured up to 20mm. No significant change.	No significant change. No increase in crack width measured.	No significant change. Vertical crack widths 10 - 20mm. Translational movement <30mm.	Low	1	Negligible	1	Very Low	1	Low

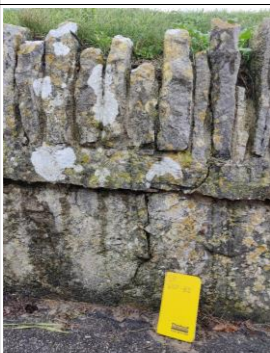
B10	Weather Station Field	403040	79304

N/A Vertical cracking, from base to top of wall (i.e. 0.9m), crack width up to 10mm.	No significant change	No significant change	No significant change	No significant change	No significant change Significant overhang of upper flag stone sections to lower wall. Risk covered under defect Ref. B11.	Pavement rutting noted at toe of wall. No significant change in the condition of the wall.	No significant change.	No significant change. Crack widths <10mm.	Low	2	Unlikely	1	Very Low	2	Low

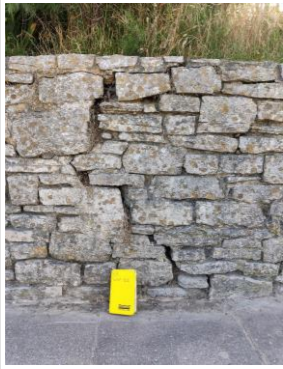
Retaining wall height: 1.25m Retained height 1.25m Vertical and horizontal cracking, typical crack width 20 - 30mm. Transverse movement of the wall, mortar joint failure from masonry blockwork moving apart.	Vertical and horizontal cracking increased from 20-30mm to 40-50mm. Otherwise health of asset unchanged. Low risk.	No significant change	No significant change	No significant change	No significant change	No significant change	Increase in crack widths measured, latest measurements between 40 - 60mm. Wall appears in good condition despite crack increase.	Crack widths measured to be 40 - 60mm. No significant change in wall condition or risk profile.	Low	2	Unlikely	2	Low	4	Low

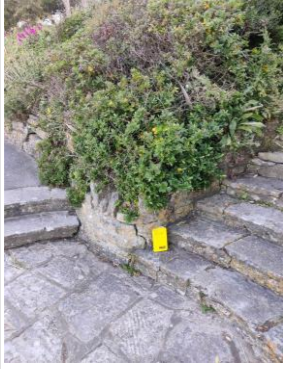
C6	Sandpit Field	403054	79280

Retaining wall height: 0.6m Retained height: 1.5m+ Vertical cracking full height of the wall. Typical crack width between 10 - 15mm. Overgrown bushes and vegetation acting on the back of the wall the likely cause of deterioration of the retaining structure.	Typical crack width increased to 15-25mm. Otherwise no significant change - low risk.	No significant change	No significant change	No significant change. Asset partially obscured by vegetation.	No significant change. Asset partially obscured by vegetation.	Vegetation cover obscuring asset. Flagstone from wall noted to have fallen onto step above defect. See report for photos. Block approximately 0.4 x 0.4 x 0.1m in size. No significant change to crack.	Vegetation cover obscuring asset. No significant change to crack. Block noted in the June 2025 inspections has been moved up the steps.	Vegetation cover obscuring asset. No significant change to crack, measured to be 15 - 25mm. Ponding was observed at the toe of the wall, the wall itself was wet indicating water egress. Block noted in the June 2025 inspections has been moved.	Low	2	Unlikely	2	Low	4	Low

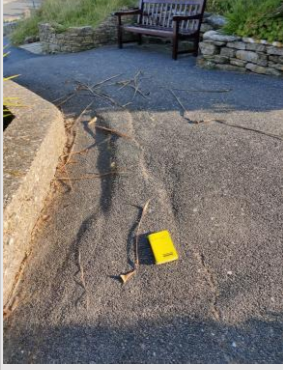
C7	Sandpit Field	403057	79248

Multiple areas of pavement cracking and surface deformation (one example shown face left). Distress in asphalt behind lower slope retaining walls observed where rotation of lower wall was seen (see defect C13). Additional areas of distress in pavement seen where up slope area is over steepened and not effectively restrained by retaining structure or otherwise, see defect C12.	Defect has been repaired, asphalt has been re-laid in area following slip/trip/fall incident. Bench removed from area. Area to be checked in follow up surveys to ensure defect does not reoccur.	No significant change	No significant change	No significant change Current pavement repair has held.	No significant change. Pavement repair in good condition.	Pavement repair in good condition. Minor cracking in the surface of the unrepaired section of pavement. Cracks approximately 5mm. Debond noted between pavement repair and unrepaired section.	No significant change - June 2025 observations all still apply.	No significant change - June 2025 observations all still apply.	Low	1	Negligible	1	Very Low	1	Low

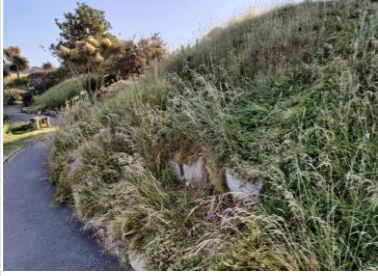
C8	Sandpit Field	403056	79252

Retaining wall height: 1.3m Retained height 3.0m + 6.1m of terraced masonry blocks which were observed to be overturning with over steepened slope behind. Blocks likely installed to prevent shallow slip failure of material above, however global stability of slope borderline.	Blocks further overturned. Further ravelling of slope material. A 1 m section of toe has a paving stone/blockwork missing. Unsupported toe area has an increased risk of slip/localised slope failure. Regular inspection of area recommended to inspect condition. Consider replacing stone/blockwork to provide support to the face.	No significant change	2no. Replacement blockwork paving slabs installed on the base row. Southern one has already overturned with voiding behind the rear face of panel observed. Advise to continue monitoring these slabs. If these significantly overturn or come loose they could present a trip hazard to pedestrians.	Southern paving slab referred to within May 2024 defect schedule has been repaired/reinstated. Continue to monitor, however risk profile remains same from May 2024 inspection.	No significant change. Asset partially obscured by vegetation.	Vegetation cover obscuring asset. No significant change.	Vegetation cover obscuring asset. No significant change.	Vegetation cover obscuring asset. No significant change.	Medium	2	Unlikely	3	High	6	Medium

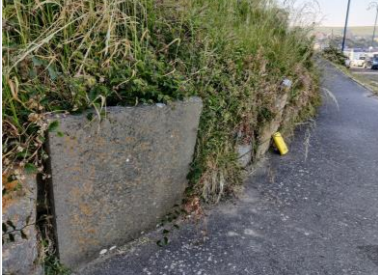
C9	Sandpit Field	403056	79246

Retaining wall height: 0.6m Retained height: 3m + 7.5.1m of retaining wall blocks partially overturned at toe of retaining wall. Insufficient embedment of blocks at toe, and over steepened slope behind overloading wall.	Surveyed - No significant change.	Slabs appear to have rotated further outward, consider removal or replacement	Further overturning of southern most slab and newly replaced slab observed. Consider removal and reinstatement with greater toe embedment.	Southern most slab has been repaired/replaced and levelled. Continue to monitor. No significant change in risk profile.	No significant change. Continue to monitor pavers for movement/displacement.	No significant change. Continue to monitor pavers for movement/displacement.	No significant change. Distortion measured to be up to 11"	No significant change. Distortion measured to be up to 12"	Low	2	Unlikely	2	Low	4	Low

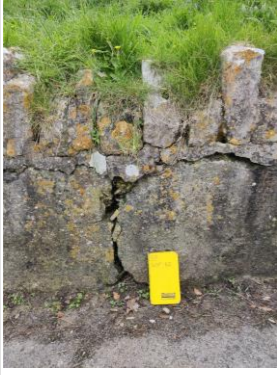
N/A	N/A	N/A	Retaining wall height: 0.9m Retained height 0.9m Vertical cracking, full height of wall, hairline cracking of width up to 2mm.	No significant change	No significant change	No significant change	Vertical crack width measured up to 70mm. No significant change in risk profile.	Vertical crack width measured up to 70mm. Seepage observed in the crack and from the render below the flagstones. No significant change in risk profile.	Low	1	Negligible	1	Very Low	1	Low

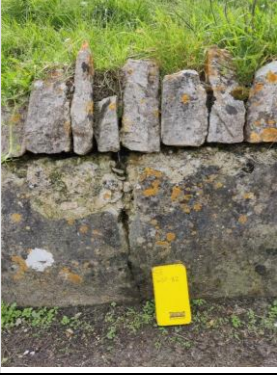
C16	Sandpit Field	403053	79295

N/A	N/A	N/A	Retaining wall height: 1.0m Retained height 1.0m Vertical cracking, full height of wall, cracking up to 50mm.	No significant change	No significant change	No significant change	No significant change	No significant change Crack widths <50mm. Seepage observed from the crack.	Low	1	Negligible	1	Very Low	1	Low	
C17	Sandpit Field	403503	9208

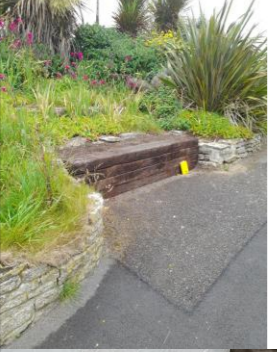
N/A	N/A	N/A	N/A	N/A	N/A	2 new retaining walls installed on the footpath further north of C12.  Sleeper retaining wall 1 (Furthest north) Height 0.5m, depth 0.25m, length 2.35m. 4 wooden railway sleepers bolted to the floor and each other in front of stone retaining wall which the client reported as having slipped. Backfilled with soil behind wooden wall.  Sleeper retaining wall 2 (Second wall from north) Height 0.4m, depth 0.23m, length 1.84m. 4 wooden railway sleepers bolted to the floor and each other in front of stone retaining wall which the client reported as having slipped. Backfilled with soil behind wooden wall. Wall placed on slabs in the SW corner.  A 10mm crack is forming between the wood on the masonry wall.	No significant change in new retaining walls.	No significant change in new retaining walls.	Medium	3	Likely	2	Low	6	Medium

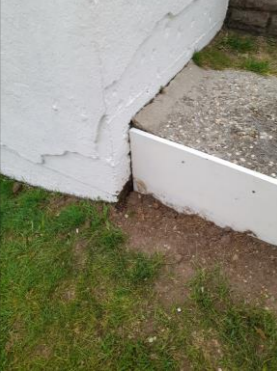
C18	Sandpit Field - Gun turret	403046	79255

N/A	N/A	N/A	N/A	N/A	N/A	N/A	New defect reported by the client on gun turret in sandpit field.  Reported as follows - Collapse of buried wall (believed to be supporting tunnel) underground causing a hole to open up and minor subsidence.  The hole has been boarded up and the contractor is to return to site and pack stone under the corner of the slab that is now unsupported due to collapsed wall.  Desiccation noted on the earth mound above the tunnels.	No significant change. Desiccation previously observed is forming small tension cracks in the bank.  Tension cracking observed between fill and structure, minimal risk to public safety due to low height earthwork.	No significant change in structure condition / boarding.  Tension cracking and minor desiccation still observed however due to wet weather and saturation of the material these appear to be smaller. The field around the gun turret is heavily saturated underfoot.	Medium	3	Likely	2	Low	6	Medium

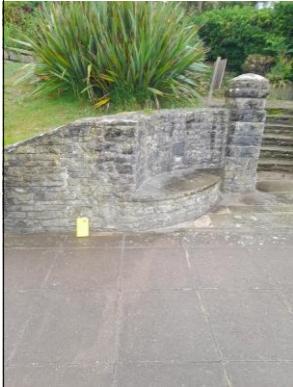
N/A	N/A	N/A	N/A	N/A	N/A	Crack on the road face of the retaining wall around the steps. Crack on the corner of the south wall. Retaining wall dimensions - Height 1.16m, Depth 0.5m Small vertical crack noted on wall face between 2 - 5mm width. Crack on top of wall 10 - 30mm width.	No significant change.	No significant change.	Low	2	Unlikely	2	Low	4	Low

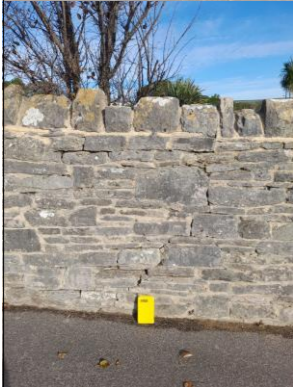
C20	Sandpit Field	403057	79147

N/A	N/A	N/A	N/A	N/A	N/A	N/A	Vertical cracking observed across full height of retaining wall. Cracking in place between blocks where render is no longer present. Mortar debond. No overhang observed. Wall height = 1.6m. Wall Depth = 0.4m. Crack width <10mm.	Crack width <10mm. No significant change.	Low	2	Unlikely	2	Low	4	Low
C21	Sandpit Field	403058	79166

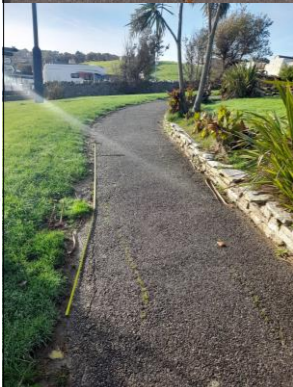
N/A	N/A	N/A	N/A	N/A	N/A	N/A	10m of surface cracking observed in the tarmac pavement within sandpit field. 1 to 2 parallel cracks observed along the whole length. Cracks only in surface of the pavement. Minor subsidence also observed.	No significant change.	Low	1	Negligible	2	Low	2	Low
C22	Sandpit Field	403008	79295

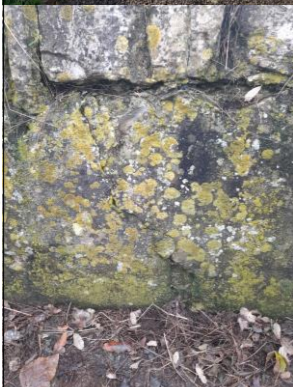
N/A	N/A	N/A	N/A	N/A	N/A	N/A	Vertical cracking observed across full height of retaining wall. Cracking in mortar / render. No overhang observed. Wall height = 0.8m. Wall Depth = 0.4m. Crack width <10mm. Low height wall and low risk profile.	N/A	Low	2	Unlikely	2	Low	4	Low
