TECHNICAL NOTE

DATE:	01 August 2025	CONFIDENTIALITY:	Public
SUBJECT:	Site Monitoring Report – June 2025		
PROJECT:	Swanage Town Council – Shore Road	AUTHOR:	Sam Horner
REVIEWER:	Ben Ward	APPROVER:	David Roy

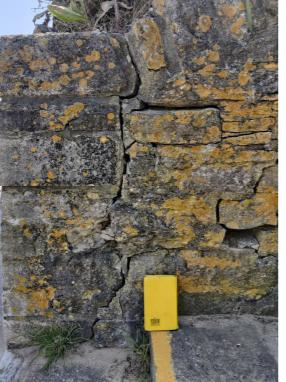
Vertical and horizontal cracking, bulging/horizontal sliding of failing wall section. Crack width 10 - 20mm. Bowing of wall face, up to 40mm. Loose blockwork, missing masonry, loss of mortar between blockwork. Crack length 1.2m wall height 1.2m Retained height 3.0m+.	Crack width increased to 25mm. Bowing of wall face up to 50mm. North facing wall completely sheared from east facing return.	No significant change Note heras fencing present to separate area from public	No significant change	No significant change	No significant change	No significant change. As noted in 2024, Heras fencing prevents measurement of the cracks.	High	3	Likely	3	High	9	High

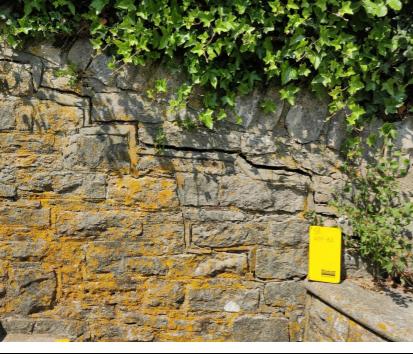
A2	The Spa	403068	79423

Retaining wall height: 1.3m Retained height: 1.3m Horizontal cracking, crack width up to 10mm. Cracking along failed mortar joint.	Max crack width increased 15mm. Otherwise no significant change (NSC) observed.	No significant change	Slight increase in crack width observed. Otherwise no significant change.	Max crack width increased from 15mm to approx. 17mm. Otherwise no significant change.	No significant change	No major change in crack width - approx. 15 - 17mm. Length of crack 1.5m Mortar render debonding from the wall.	Low	2	Unlikely	1	Very Low	2	Low
A3	The Spa	403061	79407

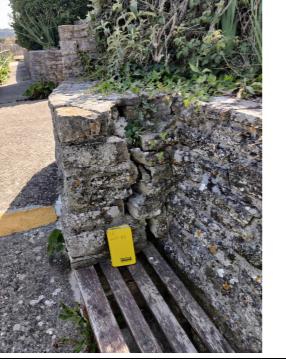
Retaining wall height: 0.8m Retained height: 0.8m Vertical cracking and horizontal displacement of wall. Crack width, 40 - 60mm with loose and missing masonry. Evidence of previous repair attempt with cement mix.	Max crack width 80mm. Max translational movement of masonry (left and right hand side) 50mm. Otherwise no significant change, and low risk.	No significant change	No significant change	Loose masonry to the touch observed. No significant change.	No significant change	Max crack width still approx. 80mm. Max translational movement of masonry (left and right hand side) increased to 55mm from last recorded measurement in October 2023. Cracking also observed on the east end of the bench. Length 0.7m Width 50mm. Retaining wall at the east 1.2m height, depth 0.5m.	Low	2	Unlikely	1	Very Low	2	Low

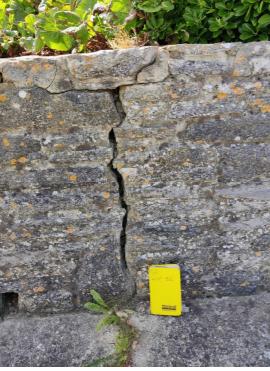
Retaining wall height: 1.0m Retained height: 1.0m Vertical cracking, width up to 30mm. No bowing/bulging of wall face observed. Pavement cracking at base of retaining wall mirroring cracking in retaining wall face.	Surveyed - No significant change.	Vertical cracking, width 40mm	No significant change	No significant change	No significant change	No significant change.	Low	1	Negligible	1	Very Low	1	Low

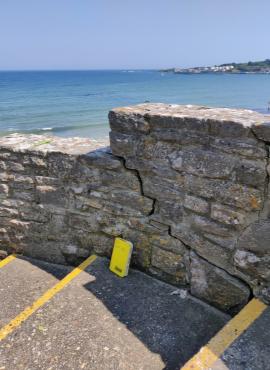
A5	The Spa	403051	79400

Retaining wall height: 0.9m Retained height: 0.2m Vertical and horizontal cracking, crack width up to 30mm. Appears lower section of wall has settled/rotated away from top section, causing failure of mortar joint and cracking in wall.	Surveyed - No significant change.	No significant change	No significant change	Repair to the mortar joints has been made since the last inspection. Risk of failure significantly reduced, however recommended to monitor asset condition in future surveys to ensure repair remains serviceable.	No significant change.	No significant change to the rear face of the wall - repair still holding. Front face of the wall has a crack running from a block below the base of the repair to the ground. Width ranging between 10 - 30mm. Render loose.	Low	1	Negligible	1	Very Low	1	Low
A6	The Spa	403060	79402

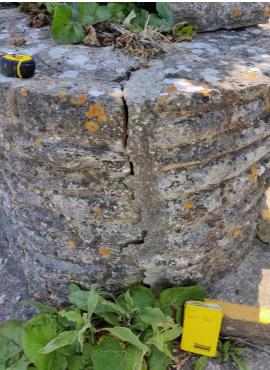
Retaining wall height: 0.9m Retained height: 0.9m Vertical cracking, crack width up to 20mm. Horizontal displacement of right side of wall 10mm from left side. Evidence of previous mortar joint repair, which has since re-failed.	Horizontal displacement of right side of wall increased to 15mm. Otherwise, no significant change, and low risk.	No significant change	No significant change	Horizontal displacement has increased in areas to a max. of 60mm. No significant change in risk profile for asset.	No significant change	No significant change.	Low	2	Unlikely	1	Very Low	2	Low

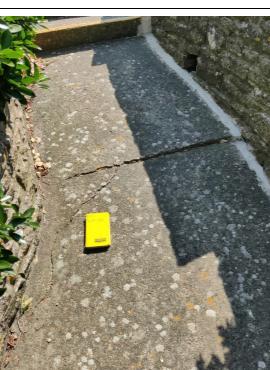
A7	The Spa	403058	79400

Pavement cracking and uneven ground. Differential settlement/transverse cracking in pavement with height up to 10mm. Longitudinal cracking, with width up to 2mm.	Surveyed - No significant change.	No significant change	Differential settlement/transverse cracking in pavement increased from 10mm to 30mm. No significant change to risk rating.	Differential settlement in pavement at maximum, increased from 30mm to 35mm. No significant change in asset risk. <i>Note: Extreme south sloping of pavement in this area, consider risk to pedestrians if this becomes more pronounced.</i>	No significant change	No significant change.	Low	2	Unlikely	1	Very Low	2	Low

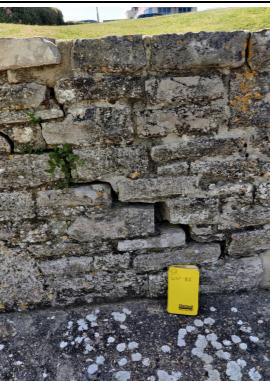
Retaining wall height: 1.0m Retained height: 1.0m Vertical and horizontal cracking, cracking width 30 - 60mm. Length of defect 0.7m. Evidence of minor previous patch repairs with cement mix.	No bowing observed. Surveyed - No significant change.	No significant change At end of wall vertical cracking noted 10-20mm in width	No significant change	Length of defect increased from 0.7m to 0.95m. No significant change in asset condition or risk rating.	No significant change	Length of defect increased to 1.2m. Crack width still approximately 60mm max. No significant change in asset condition or risk rating.	Low	2	Unlikely	1	Very Low	2	Low

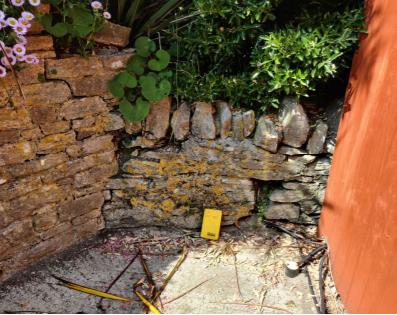
A9	Spa Beach Huts	403028	79367

Retaining wall height: 0.9m Retained height: 0.9m Minor vertical cracking, missing masonry blocks and silted up and damaged back of wall drainage. Damage potentially due to running services through wall, post wall construction.	Surveyed - No significant change.	No significant change	No significant change	No significant change	No significant change	No significant change.	Low	2	Unlikely	1	Very Low	2	Low
A10	Spa Beach Huts	403054	79358

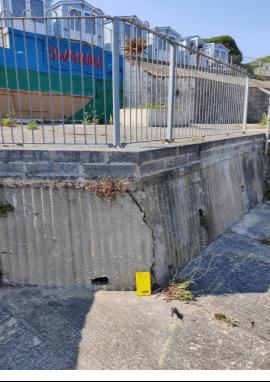
Retaining wall height: 1.25m Retained height: 1.25m Vertical cracking, crack height 0.9m, crack width up to 30mm. Damaged weephole / void at the base of the wall (see left of survey book).	Surveyed - No significant change.	No significant change	No significant change	No significant change	No significant change	No significant change.	Low	2	Unlikely	2	Low	4	Low
A11	Spa Beach Huts	403042	79361

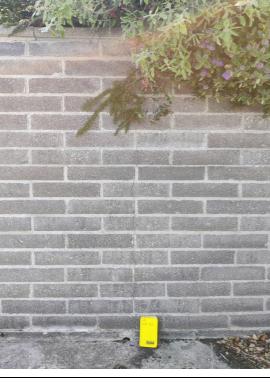
Retaining wall height: 2.15m Retained height 2.15m Hairline vertical cracking full height of the wall, crack width -1mm. Weephole silted up and 2/3 blocked by additional concrete pours, potential from previous remedial works.	Could not survey due to lack of access to mid-terrace. From visual inspection in accessible location, no significant change observed.	No significant change	No significant change Could not survey due to lack of access to mid-terrace. From visual inspection in accessible location, no significant change observed.	Could not survey due to lack of access to mid-terrace. From visual inspection in accessible location, no significant change observed.	Could not survey due to lack of access to mid-terrace. From visual inspection in accessible location, no significant change observed.	Could not survey due to lack of access to mid-terrace. From visual inspection in accessible location, no significant change observed.	Low	1	Negligible	3	High	3	Low

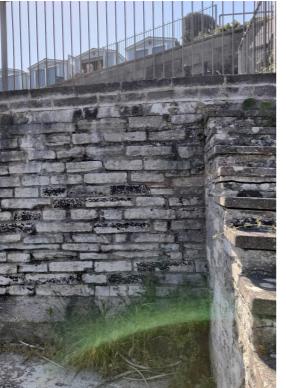
Retaining wall height: 2.55m Retained height: 2.55m Horizontal and vertical cracking. Crack length 1.6m. Typical crack width 3-10mm. Bulging/bowing at the mid span of masonry wall.	Surveyed - No significant change.	No significant change	No significant change	No significant change	No significant change	Crack length still 1.6m Horizontal shear still noted however the top portion has not moved to create an overhang as of yet.	Low	1	Negligible	2	Low	2	Low

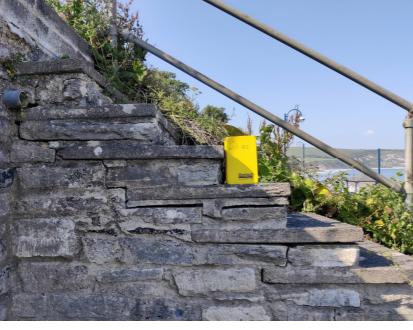
A17	Spa Beach Huts	403062	79383

Retaining wall height: up to 2.2m Retained height: up to 2.5m. Horizontal cracking. Crack length 1.8m. Crack width 3-12mm. Horizontal movement of return wall causing cracking, potentially due to bulging/bowing from the main span.	Surveyed - No significant change.	No significant change	No significant change	No significant change	No significant change	maximum vertical crack width recorded to be 10mm. Horizontal crack width up to 5mm.	Low	1	Negligible	1	Very Low	1	Low	
A18	Spa Beach Huts	403026	79380

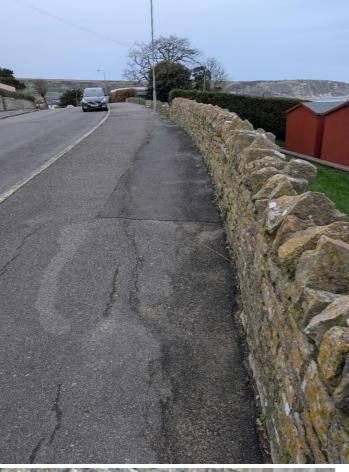
N/A	N/A	N/A	N/A	N/A	De Moulham Road Retaining Wall Observations: - Overturning wall - Longitudinal tension cracking in pavement - Multiple tarmac repairs observed in the area. - Settlement of material adjacent to the retained side of the wall (underlying tarmac repair) - approx. 20-30mm. - Settlement consistent with theory of wall overturning, resulting in void developing behind wall, for subbase/subgrade material to settle into. - Cracking in masonry wall consistent with location of cracks in the pavement, indicating cause/effect of wall on pavement construction. Likely cause of issue: - Poor foundation material, causing differential settlements - Leakage of drainage system in locale causing reduction in strength of the wall formation material.	The pavement has been resurfaced since the last inspection. No cracks present on new surfacing. Area below masonry wall fenced off from the public. Wall has minor cracking and vegetation growing in the mortar render between the blocks. Desiccation noted in the toe area.	Medium	3	Likely	2	Low	6	Medium

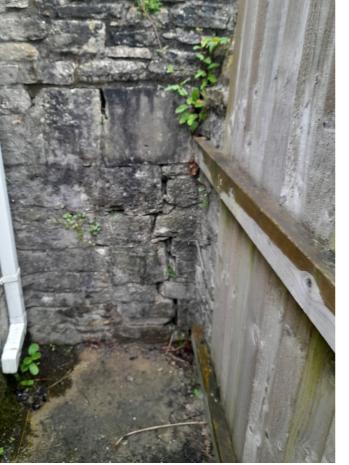
A19	Spa Beach Huts	403063	79367

N/A	N/A	N/A	N/A	N/A	Cracking in wall at base of steps. N/A Retaining wall 2.5m in height. Crack approx. 1m long and width of up to 30mm.	N/A	1	Negligible	2	Low	2	Low

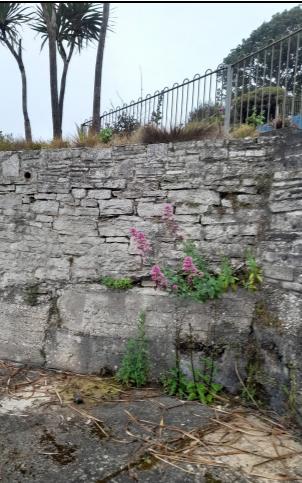
N/A	N/A	N/A	N/A	N/A	N/A	Cracking noted on the south end of the wall with defect A16. Cracking observed within render between blocks. Crack length 1m Crack width up to 20mm.	N/A	1	Negligible	2	Low	2	Low
A21	Spa Beach Huts	403027	79364

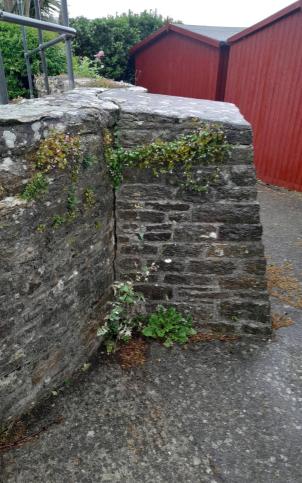
N/A	N/A	N/A	N/A	N/A	N/A	Buttresses on retaining wall adjacent to defect A9 are delaminating from retaining wall. Render is cracked between buttress and wall. Crack width of 30mm. Retaining wall 1.3m height and 1.0m depth.	N/A	2	Unlikely	3	High	6	Medium

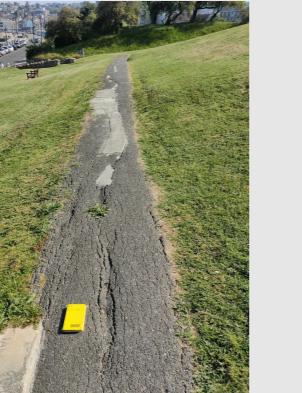
B1	Weather Station Field	403050	79339

Pavement tension cracking, surface deformation and partial collapse. 2no. continuous cracks observed, 3.6m and 11m in length respectively. Multiple patch repairs with asphalt and cement/concrete mix. Ground uneven and with numerous cracks. Crack depths ranging between 5 - 10mm where repairs have not been completed.	Surveyed - No significant change. Slip/trip/fall hazard for members of the public (similar to defect ref. C7). Consider closing off access to footpath, or removing entirely.	Footpath now removed and replaced with grass	No significant change.	No significant change.	No significant change Repair still intact.	No significant change. Bare earth noted on old path location, grass growing in patches.	Low	1	Negligible	1	Very Low	1	Low

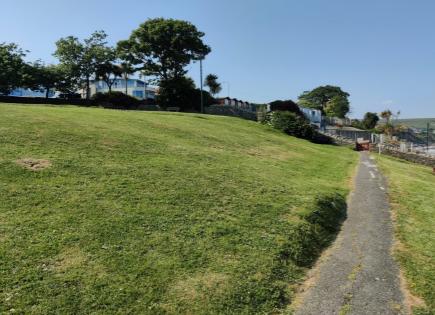
3.16 This is consistent with site observations, which concluded no significant change in asset condition for the defects in the vicinity of BH07, namely B2, B3, and B4.

In the field area to the east of weather station, hummocky ground observed, with tension cracking in slope, bulging of surface.	Surveyed - No significant change.	No significant change	No significant change	At south east corner of field, a BH / inclinometer cap missing, with open pipework exposed. This is likely to cause erroneous recordings with regards to groundwater measurements. Review of data to be undertaken.	BH cap at south east corner has been replaced since last inspection. Rectified.	Bulging slope surface shows no significant change. However, still presents a remedial risk.	Hummocky ground with desiccated ground in areas. Bulging slope surface shows no significant change. However, still presents a remedial risk.	Medium	3	Likely	2	Low	6	Medium

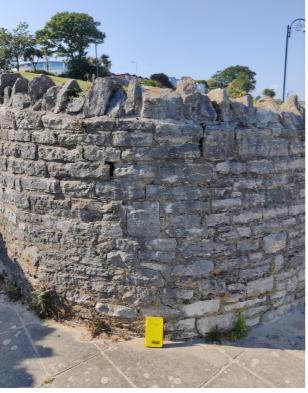
B3	Weather Station Field	403059	79309

Retaining wall height: 1.8m Retained height: 1.8m Vertical and horizontal cracking, crack width between 2 - 20mm, occurring at apex of wall curvature. No bulging or bowing of the wall observed.	Unable to survey position of maximum crack width due to information signage location. Otherwise no significant change observed.	No significant change	No significant change	No significant change	No significant change	Crack width adjacent to warning sign surveyed. Max opening of 35mm. No significant change in condition.	Low	2	Unlikely	2	Low	4	Low	
B4	Weather Station Field	403055	79305

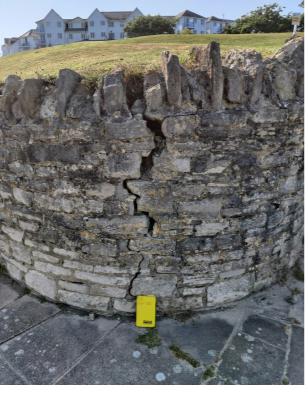
Retaining wall height: 1.8m Retained height: 1.8m Curved wall with 3no. sets of vertical cracking. From south face of retaining wall, cracks are at chainage CH 0, 2.0, and 5.5m. Total length of defect: 5.5m. CH 0m Defect: Vertical cracking, crack width typically 30 - 50mm. Missing blockwork at the head of the wall, with significant voids behind mid span of wall (potentially lost mortar or block work following movement). CH 2.0m Defect: Vertical cracking, max crack width typically 90 - 130mm, increasing with height of wall. Missing blockwork at top of wall. CH 5.5m Defect: Vertical cracking, crack width up to 10mm. Blockwork intact.	Survey of crack dimensions hampered by heras fencing panels, which could not be moved. Could not be surveyed accurately. No significant change in structure compared with previous survey. Maintain heras fencing panel around defect. Continue to monitor regularly.	Heras fencing forming exclusion zone. No direct measurements made, however general observations indicate further movement. Continue to monitor and maintain exclusion.	Heras fencing forming exclusion zone. No direct measurements made, due to presence of fencing panels. Continue to monitor and maintain exclusion zone.	No significant change. Continue to monitor and maintain exclusion zone.	No significant change. Continue to monitor and maintain exclusion zone.	No significant change. Continue to monitor and maintain exclusion zone.	High	3	Likely	3	High	9	High

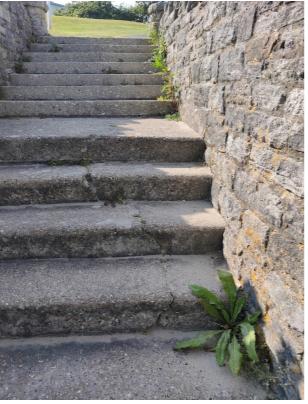
Vertical cracking on footpath/stepped access. Crack length 3m, typical crack width 1-2mm.	Additional cracking observed at bottom left stairs area. Crack widths similar to previous survey.	No significant change	Additional loss of material/concrete from steps, with voids/cracking up to 40-50mm observed. No significant change to risk level currently.	Additional cracking of pavement slabs observed. No significant change to risk profile.	Significant cracking of pavement slabs. Concrete pavers still stable (i.e. no rocking), however continued deterioration of the asset may give cause to a trip hazard. Recommend to continue monitoring. No significant change in geotechnical risk profile.	Concrete pavement slabs still stable (i.e. no rocking), however continued deterioration of the asset may give cause to a trip hazard. Recommend to continue monitoring. No significant change in geotechnical risk profile.	Low	2	Unlikely	1	Very Low	2	Low

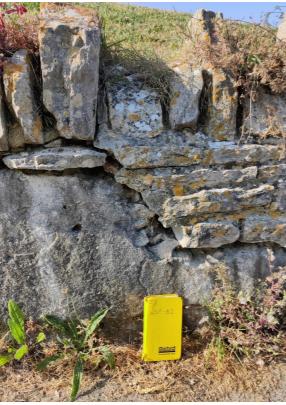
Retaining wall height: 1.0m. Retained height: 1.5m Vertical and horizontal cracking, crack length 0.8m. Typical crack width 40 - 60mm. Minor bowing of the wall at mid height.	Previously identified "minor bowing" appears more akin to shearing of top row of finishing stones of wall span, from the wall below. No significant change in crack widths from previous survey.	No significant change in crack widths Noted to be very wet with water issuing from between cracks	No significant change. No water observed expelling from the wall face, however weather conditions were dry on date of inspection.	Max crack width increased from 60mm to 90mm. Top of wall has sheared further outwards from lower wall. No significant change in risk profile.	Max crack width 90mm - maintained. Top of wall has sheared further outwards from lower wall. Significant water egress from wall face at joint with flag stones. Increased geotechnical risk, however risk profile has been kept same, due to limited exposure risk following installation of exclusion zone at Walron Road north.	Max crack width 90mm. Overhang from top section (shear failure) up to 45mm. No significant change.	Low	2	Unlikely	1	Very Low	2	Low

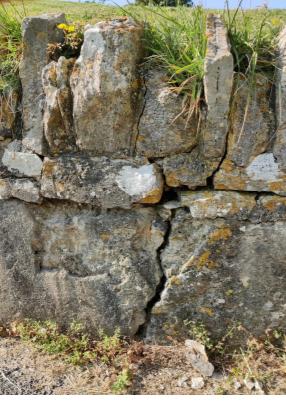
Retaining wall height: 0.9m Retained height: 1.0m. Vertical cracking, from base to top of wall (i.e. 0.9m), crack width between 20 - 40mm.	Surveyed - No significant change.	No significant change	No significant change	No significant change	Significant water egress from wall face at joint with flag stones. Increased geotechnical risk, however risk profile has been kept same, due to limited exposure risk following installation of exclusion zone at Walron Road north.	Vertical crack width measured to be between 20 - 50mm. No water egress noted however this may have been masked by the heavy rainfall present during the monitoring visit.	Low	1	Negligible	1	Very Low	1	Low
B8	Weather Station Field	403026	79304

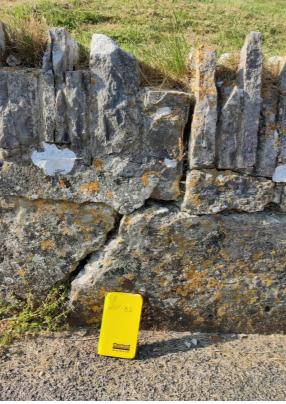
Retaining wall height: 0.85m Retained height: 1m + Vertical and horizontal cracking, the full height of the wall (0.85m), with typical crack width of 20mm. Lower right side (east) of wall translational movement relative to rest of wall (<30mm).	Max crack width increased to up to 40mm. Otherwise no significant change - low risk.	No significant change	No significant change	No significant change	Crack widths measured between 20 - 30mm. No significant change.	Crack widths measured between 20 - 30mm. No significant change.	Low	1	Negligible	1	Very Low	1	Low

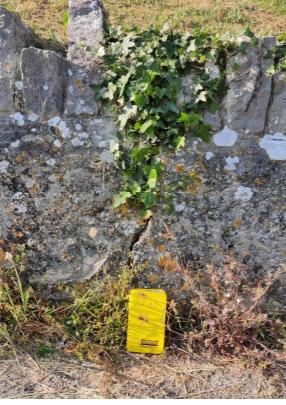
Retaining wall height: 1.0m Retained height: 1.0m Vertical cracking, running full height of the wall. Right of the crack (east side of the wall), 30mm translational movement of the wall relative to the west side. Pavement cracking adjacent to retaining wall observed from base of retaining wall.	Surveyed - No significant change.	No significant change	Crack width observed up to 20mm. No significant change to translation movement or pavement cracking adjacent to the wall.	No significant change	Crack width measured up to 20mm. No significant change.	Crack width measured up to 20mm. No significant change.	Low	1	Negligible	1	Very Low	1	Low

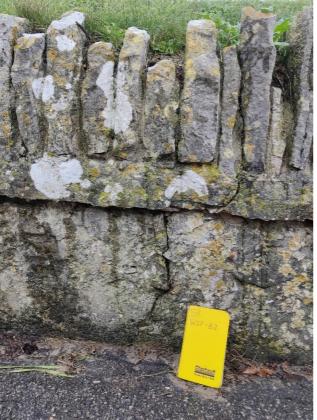
N/A Retaining wall height: 0.9m Retained height: 1.0m. Vertical cracking, from base to top of wall (i.e. 0.9m), crack width up to 10mm.	No significant change	No significant change	No significant change	No significant change	No significant change	Pavement rutting noted at toe of wall. Significant overhang of upper flag stone sections to lower wall. Risk covered under defect Ref. B11.	Low	2	Unlikely	1	Very Low	2	Low

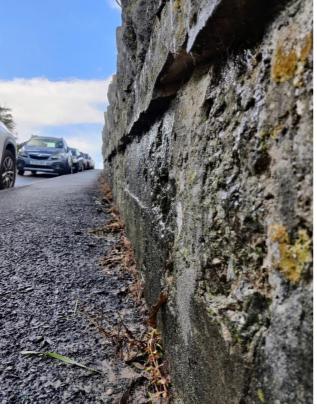
N/A 7.5m length of wall, between defect ref. B6 and B7. Shearing of top span of masonry from base of wall, up to 50mm. Movement in superficial material on retained side of weather station field separating wall at weak/mortar joint location. Risk of collapse over time, and damage to pavement, members of the public, and cars parked on road adjacent to wall. Advise to continue monitoring regularly.	Shearing of top span of masonry from base of wall, increased to 70mm. Evidence of seepage through wall, along extents. Advise to continue monitoring regularly. Further deterioration may require footpath diversion.	Condition of asset as per February 2024 inspection. Lateral extents of the defect has increased from 7.5m to 9m. Advise to continue monitoring - should further degradation to asset condition be observed, a footpath diversion may be required.	Length of defect observed increased from 7.5m to 10m. Significant evidence of seepage egressing from behind the wall, between the upper and lower wall sections. Evidence of spalling of facing material in multiple locations. Continue to monitor, if further degradation occurs, or additional spalling of wall material, consider exclusion zone around affected section and footpath diversion.	Exclusion zone has been erected since previous site walkover over (October 2024), in accordance with report recommendations. Longitudinal cracking + footpath bulge/heaving at locations of worst affected area + max slumping of material above wall. Recommend to maintain exclusion zone and regularly monitoring in accordance with main report recommendations.	Depression noted in the pavement at the toe of the wall. No significant change in wall condition. Recommend to maintain exclusion zone and regularly monitoring in accordance with main report recommendations.	High	3	Likely	3	High	9	High

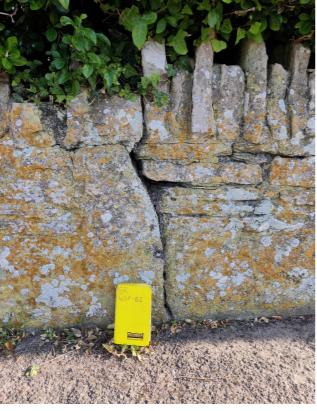
Retaining wall height: 1.0m. Retained height: 1.0m. Vertical cracking, full height of wall, typical crack width 5 - 30mm. Large bushes overhanging back of retaining wall, likely the cause of distress observed in the structure.	Displacement of east side of wall relative to the west up to 30mm. Otherwise no significant change - low risk.	No significant change	No significant change	Typical crack width increased from 30mm to 40mm. No significant change in asset risk.	No significant change	No significant change	Low	2	Unlikely	1	Very Low	2	Low
C2	Sandpit Field	403009	79294

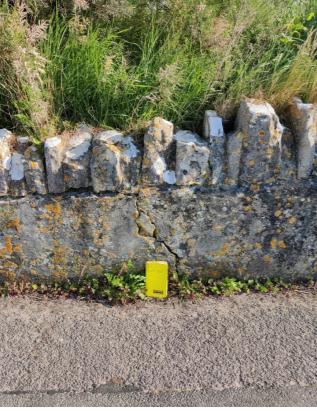
Retaining wall height: 0.8m Retained height: 0.8m Vertical cracking full height of wall, typical crack width 5 - 20mm. Evidence of historic patch repair made previously.	Surveyed - No significant change.	No significant change	No significant change	No significant change	No significant change	No significant change	Low	1	Negligible	1	Very Low	1	Low

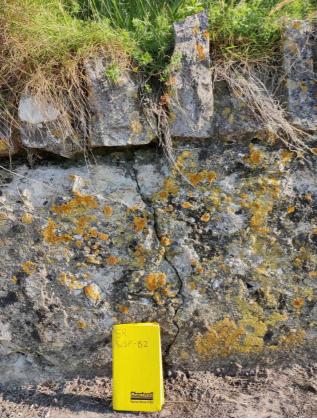
Retaining wall height: 0.95m Retained height 1.0m Vertical cracking, full height of wall, crack width between 1 - 3mm.	Surveyed - No significant change.	No significant change	No significant change	No significant change	No significant change	No significant change	Low	1	Negligible	1	Very Low	1	Low
C4	Sandpit Field	403035	79295

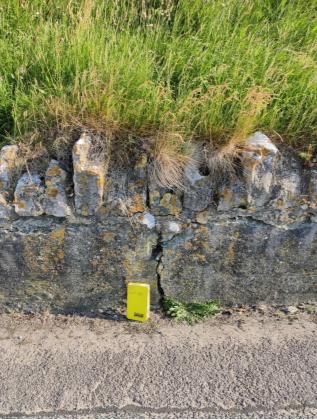
Retaining wall height: 1.0m Retained height: 1.2m Vertical cracking, full height of wall. Crack width 20 - 40mm.	Small void at base of wall due to loss of mortar/masonry. Likely lost from translational movement of the wall. Otherwise no significant change.	No significant change	No significant change	Masonry appears to have been lost / fallen off of wall face in section surrounding the crack (see latest images for comparison). Slight increase in asset risk, however still low due to general condition and retained height.	No significant change	No significant change	Low	2	Unlikely	2	Low	4	Low

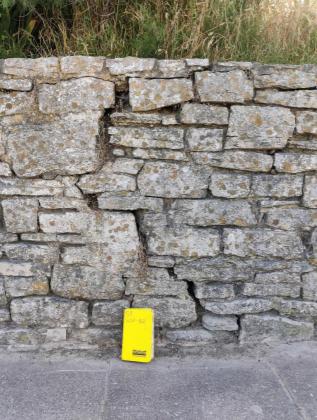
Retaining wall height: 1.25m Retained height 1.25m Vertical and horizontal cracking, typical crack width 20 - 30mm. Transverse movement of the wall, mortar joint failure from masonry blockwork moving apart.	Vertical and horizontal cracking increased from 20-30mm to 40-50mm. Otherwise health of asset unchanged. Low risk.	No significant change	No significant change	No significant change	No significant change	No significant change	Low	2	Unlikely	2	Low	4	Low
C6	Sandpit Field	403054	79280

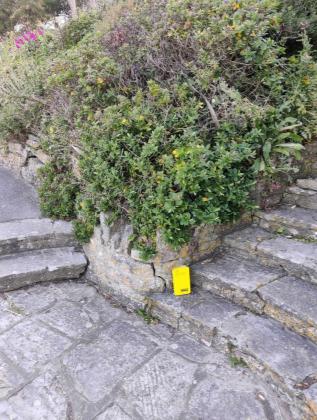
Retaining wall height: 0.6m Retained height: 1.5m+ Vertical cracking full height of the wall. Typical crack width between 10 - 15mm. Overgrown bushes and vegetation acting on the back of the wall the likely cause of deterioration of the retaining structure.	Typical crack width increased to 15-25mm. Otherwise no significant change - low risk.	No significant change	No significant change	No significant change. Asset partially obscured by vegetation.	No significant change. Asset partially obscured by vegetation.	Vegetation cover obscuring asset. Flagstone from wall noted to have fallen onto step above defect. See report for photos. Block approximately 0.4 x 0.4 x 0.1m in size. No significant change to crack.	Low	2	Unlikely	2	Low	4	Low

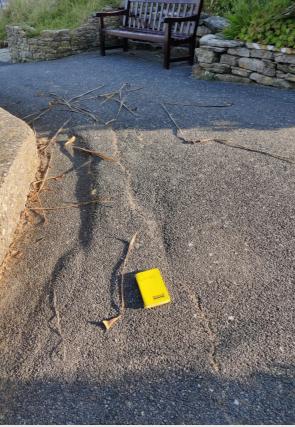
Multiple areas of pavement cracking and surface deformation (one example shown face left). Distress in asphalt behind lower slope retaining walls observed where rotation of lower wall was seen (see defect C13). Additional areas of distress in pavement seen where up slope area is over steepened and not effectively restrained by retaining structure or otherwise, see defect C12.	Defect has been repaired, asphalt has been re-laid in area following slip/trip/fall incident. Bench removed from area. Area to be checked in follow up surveys to ensure defect does not reoccur.	No significant change	No significant change	No significant change Current pavement repair has held.	No significant change.	Pavement repair in good condition. Minor cracking in the surface of the unrepairs section of pavement. Cracks approximately 5mm. Debond noted between pavement repair and unrepairs section.	Low	1	Negligible	1	Very Low	1	Low

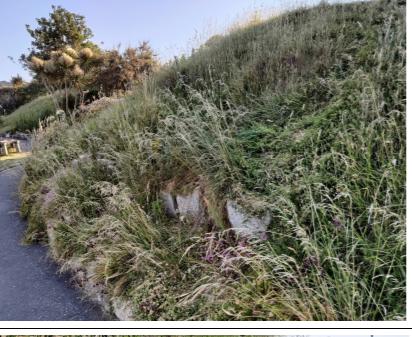
Retaining wall height: 1.3m Retained height 3.0m + 6.1m of terraced masonry blocks which were observed to be overturning with over steepened slope behind. Blocks likely installed to prevent shallow slip failure of material above, however global stability of slope borderline.	Blocks further overturned. Further ravelling of slope material. A 1m section of toe has a paving stone/blockwork missing. Unsupported toe area has an increased risk of slip/localised slope failure. Regular inspection of area recommended to inspect condition. Consider replacing stone/blockwork to provide support to the face.	No significant change	2no. Replacement blockwork paving slabs installed on the base row. Southern one has already overturned with voiding behind the rear face of panel observed. Advise to continue monitoring these slabs. If these significantly overturn or come loose they could present a trip hazard to pedestrians.	Southern paving slab referred to within May 2024 defect schedule has been repaired/reinstated. Continue to monitor, however risk profile remains same from May 2024 inspection.	No significant change. Asset partially obscured by vegetation.	Vegetation cover obscuring asset. No significant change.	Medium	2	Unlikely	3	High	6	Medium

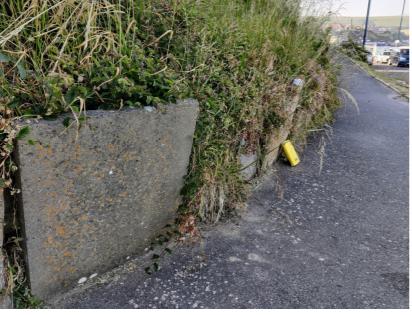
Retaining wall height: 0.6m Retained height: 3m + 7.51m of retaining wall blocks partially overturned at toe of retaining wall. Insufficient embedment of blocks at toe, and over steepened slope behind overloading wall.	Surveyed - No significant change. Slabs appear to have rotated further outward, consider removal or replacement		Further overturning of southern most slab and newly replaced slab observed. Continue to monitor. Consider removal and reinstatement with greater toe embedment.	Southern most slab has been repaired/replaced and levelled. Continue to monitor. No significant change in risk profile.	No significant change. Continue to monitor pavers for movement/displacement.	No significant change. Continue to monitor pavers for movement/displacement.	Low	2	Unlikely	2	Low	4	Low
C10	Sandpit Field	403052	79239

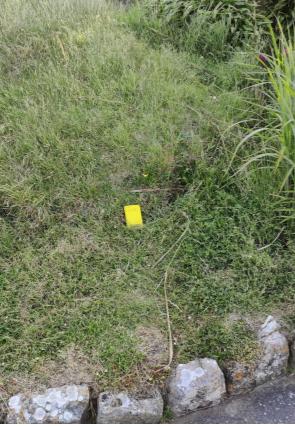
3.1m of tension cracking observed in oversteep section of slope. Width of tension crack approx. 200mm, and 250mm depth in areas.	Tension crack width Otherwise no significant change. Continue to monitor on ongoing basis.	No significant change	No significant change.	No significant change. Due to heavy vegetation, quantifying the crack width of asset difficult. From general visual inspection, asset condition has not changed since previous inspection.	Area de-vegetated following previous inspection circa October 2024. Hummocky ground and tension crack on embankment toe observed, resulting in 200-300mm vertical face of material. Recommend to continue monitoring for further degradation.	Hummocky ground covered in vegetation so tension crack could not be measured. Slight subsidence noted in the pavement above the slope however the condition is generally okay. No significant change to geotechnical risk profile.	Medium	3	Likely	2	Low	6	Medium

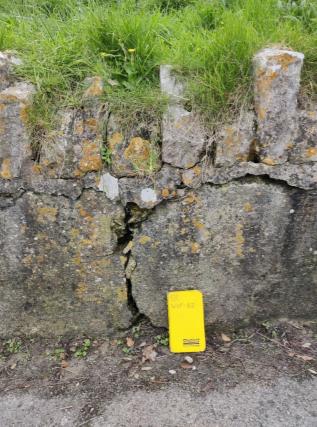
N/A	N/A	N/A	Retaining wall height: 0.9m Retained height 0.9m Vertical cracking, full height of wall, hairline cracking of width up to 2mm.	No significant change	No significant change	No significant change	Low	1	Negligible	1	Very Low	1	Low	
C16	Sandpit Field	403053	79295

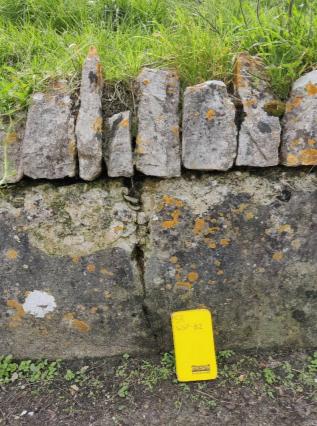
N/A	N/A	N/A	Retaining wall height: 1.0m Retained height 1.0m Vertical cracking, full height of wall, cracking up to 50mm.	No significant change	No significant change	No significant change	Low	1	Negligible	1	Very Low	1	Low

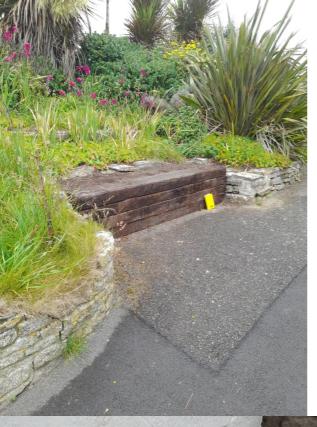
N/A	N/A	N/A	N/A	N/A	N/A	2 new retaining walls installed on the footpath further north of C12. Sleeper retaining wall 1 (Furthest north) Height 0.5m, depth 0.25m, length 2.35m. 4 wooden railway sleepers bolted to the floor and each other in front of stone retaining wall which the client reported as having slipped. Backfilled with soil behind wooden wall. Sleeper retaining wall 2 (Second wall from north) Height 0.4m, depth 0.23m, length 1.84m. 4 wooden railway sleepers bolted to the floor and each other in front of stone retaining wall which the client reported as having slipped. Backfilled with soil behind wooden wall. Wall placed on slabs in the SW corner. A 10mm crack is forming between the wood on the masonry wall.	N/A	N/A	3	Likely	2	Low	6	Medium
C18	Sandpit Field - Gun turret	403046	79255

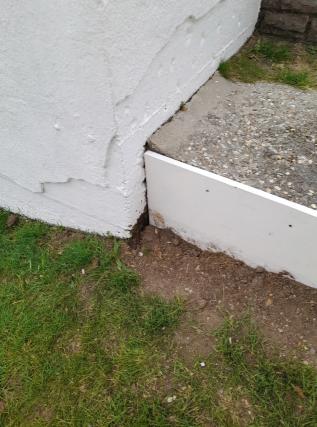
N/A	N/A	N/A	N/A	N/A	N/A	New defect reported by the client on gun turret in sandpit field. Reported as follows - Collapse of buried wall (believed to be supporting tunnel) underground causing a hole to open up and minor subsidence. The hole has been boarded up and the contractor is to return to site and pack stone under the corner of the slab that is now unsupported due to collapsed wall. Desiccation noted on the earth mound above the tunnels.	N/A	N/A	3	Likely	2	Low	6	Medium

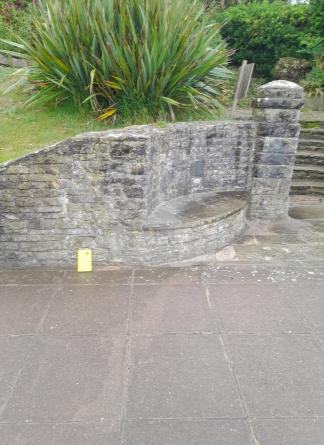
N/A	N/A	N/A	N/A	N/A	N/A	Crack on the road face of the retaining wall around the steps. Crack on the corner of the south wall. Retaining wall dimensions - Height 1.16m, Depth 0.5m Small vertical crack noted on wall face between 2 - 5mm width. Crack on top of wall 10 - 30mm width.	N/A	2	Unlikely	2	Low	4	Low
