TECHNICAL NOTE

DATE:	10 June 2024	CONFIDENTIALITY:	Public
SUBJECT:	Site Monitoring Report – May 2024		
PROJECT:	Swanage Town Council – Shore Road	AUTHOR:	Sam Rhodes
REVIEWER:	Ben Dening	APPROVER:	David Roy

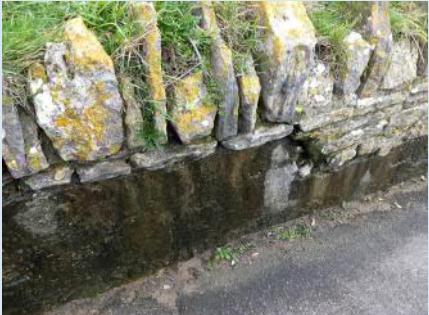
- 3.19 It should be noted that no significant movement was observed in the boundary retaining wall south of Weather Station Field, north of Walrond Road (defect ref. B11).

N/A	7.5m length of wall, between defect ref. B6 and B7: Shearing of top span of masonry from base of wall, up to 50mm. Movement in superficial material on retained side of weather station field separating wall at weak/mortar joint location. Risk of collapse over time, and damage to pavement, members of the public, and cars parked on road adjacent to wall. Advise to continue monitoring regularly.	Shearing of top span of masonry from base of wall, increased to 70mm. Evidence of seepage through wall, along extents. Advise to continue monitoring regularly.	Condition of asset as per February 2024 inspection. Lateral extents of the defect has increased from 7.5m to 9m. Advise to continue monitoring - should further degradation to asset condition be observed, a footpath diversion may be required.	Medium	2	Unlikely	3	High	6	Medium

<ul style="list-style-type: none"> • Continue to monitor regularly. • Further deterioration may require foot path diversion. • Monitor alongside the results of BH07 inclinometer data.
C9	Sandpit Field

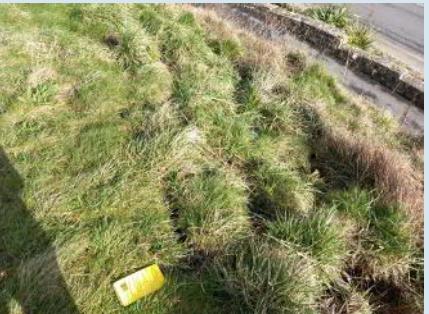
- 2.14 Tension cracking was noted along the full extents of the embankment mid slope, adjacent to defect C12.
- 2.15 Recommendations on defects which require additional intervention measures are detailed within Section 4.

<ul style="list-style-type: none"> • Continue to monitor propagation of tension cracks to the rear of recently planted area (previous bench locations).

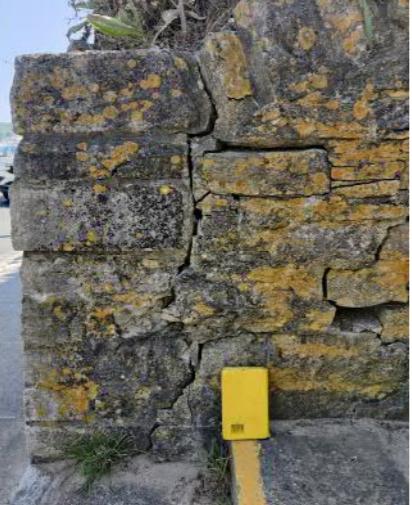
Vertical and horizontal cracking, bulging/horizontal sliding of failing wall section. Crack width 10 - 20mm. Bowing of wall face, up to 40mm. Loose blockwork, missing masonry, loss of mortar between blockwork. Crack length 1.2m wall height 1.2m Retained height 3.0m+.	Crack width increased to 25mm. Bowing of wall face up to 50mm. North facing wall completely sheared from east facing return. Additional bowing/shearing of masonry at bench level adjacent to return wall, with up to 70mm movement. Recommended that area is fenced/closed off. Return wall supports 3.5m of backfill. In the event of total failure, potential to cause significant harm to members of the public.	No significant change Note heras fencing present to separate area from public	No significant change	High	3	Likely	3	High	9	High

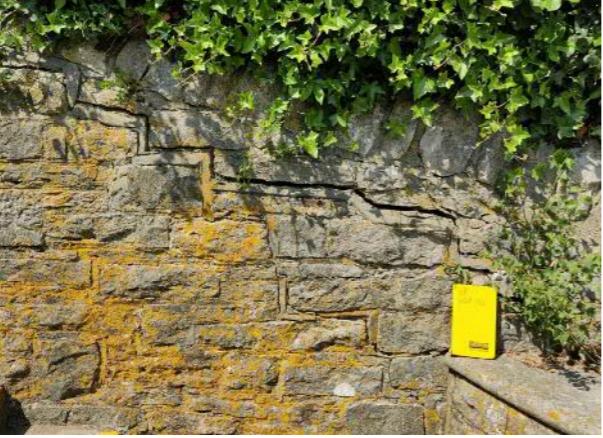
A2	The Spa	403068	79423

Retaining wall height: 1.3m Retained height: 1.3m Horizontal cracking, crack width up to 10mm. Cracking along failed mortar joint.	Max crack width increased 15mm. Otherwise no significant change (NSC) observed.	No significant change	Slight increase increase in crack width observed. Otherwise, no significant change.	Low	2	Unlikely	1	Very Low	2	Low
A3	The Spa	403061	79407

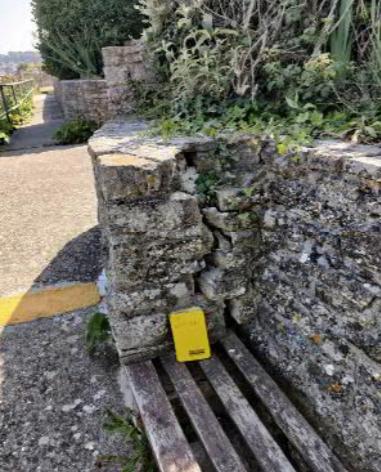
Retaining wall height: 0.8m Retained height: 0.8m Vertical cracking and horizontal displacement of wall. Crack width, 40 - 60mm with loose and missing masonry. Evidence of previous repair attempt with cement mix.	Max crack width 80mm. Max translational movement of masonry (left and right hand side) 50mm. Otherwise no significant change, and low risk.	No significant change	No significant change	Low	2	Unlikely	1	Very Low	2	Low

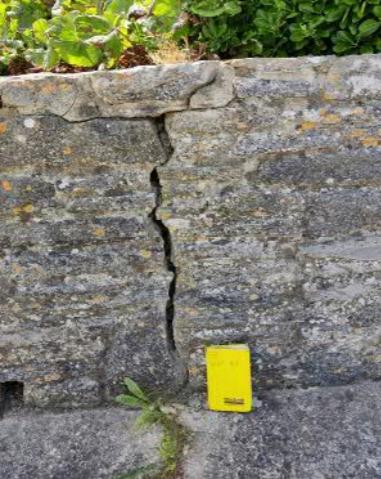
Retaining wall height: 1.0m Retained height: 1.0m Vertical cracking, width up to 30mm. No bowing/bulging of wall face observed. Pavement cracking at base of retaining wall mirroring cracking in retaining wall face.	Surveyed - No significant change.	Vertical cracking, width 40mm	No significant change	Low	1	Negligible	1	Very Low	1	Low
A5	The Spa	403051	79400

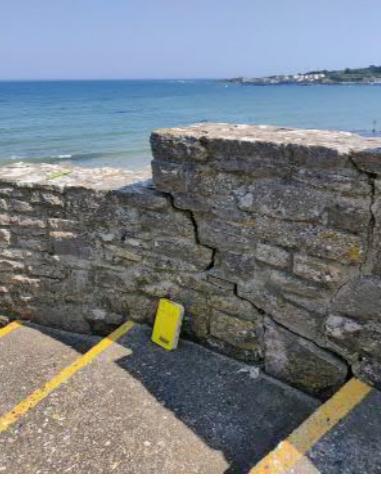
Retaining wall height: 0.9m Retained height: 0.2m Vertical and horizontal cracking, crack width up to 30mm. Appears lower section of wall has settled/rotated away from top section, causing failure of mortar joint and cracking in wall.	Surveyed - No significant change.	No significant change	No significant change	Low	2	Unlikely	2	Low	4	Low

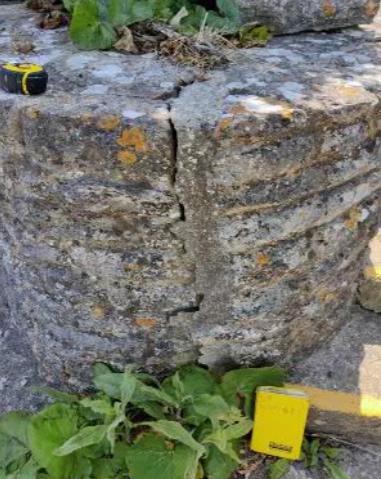
A6	The Spa	403060	79402

Retaining wall height: 0.9m Retained height: 0.9m Vertical cracking, crack width up to 20mm. Horizontal displacement of right side of wall 10mm from left side. Evidence of previous mortar joint repair, which has since re-failed.	Horizontal displacement of right side of wall increased to 15mm. Otherwise, no significant change, and low risk.	No significant change	No significant change	Low	2	Unlikely	1	Very Low	2	Low

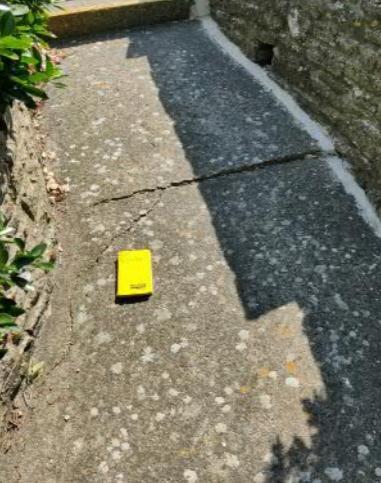
Pavement cracking and uneven ground. Differential settlement/transverse cracking in pavement with height up to 10mm. Longitudinal cracking, with width up to 2mm.	Surveyed - No significant change.	No significant change	Differential settlement/transverse cracking in pavement increased from 10mm to 30mm. No significant change to risk rating.	Low	2	Unlikely	1	Very Low	2	Low
A8	The Spa	403052	79390

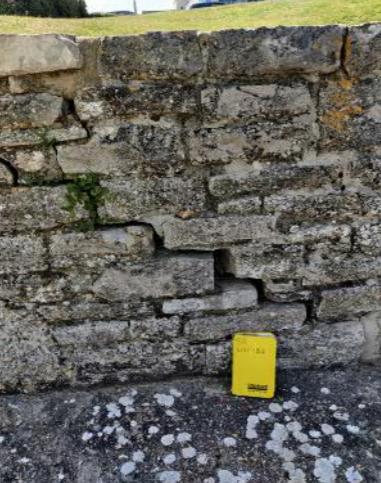
Retaining wall height: 1.0m Retained height: 1.0m Vertical and horizontal cracking, cracking width 30 - 60mm. Length of defect 0.7m. Evidence of minor previous patch repairs with cement mix.	No bowing observed. Surveyed - No significant change.	No significant change At end of wall vertical cracking noted 10-20mm in width	No significant change	Low	2	Unlikely	1	Very Low	2	Low

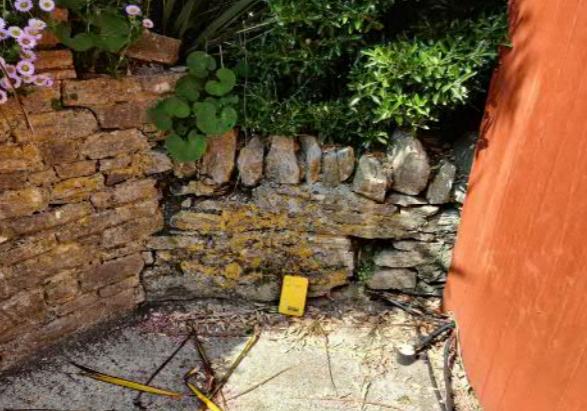
Retaining wall height: 0.9m Retained height: 0.9m Minor vertical cracking, missing masonry blocks and silted up and damaged back of wall drainage. Damage potentially due to running services through wall, post wall construction.	Surveyed - No significant change.	No significant change	No significant change	Low	2	Unlikely	1	Very Low	2	Low
A10	Spa Beach Huts	403054	79358

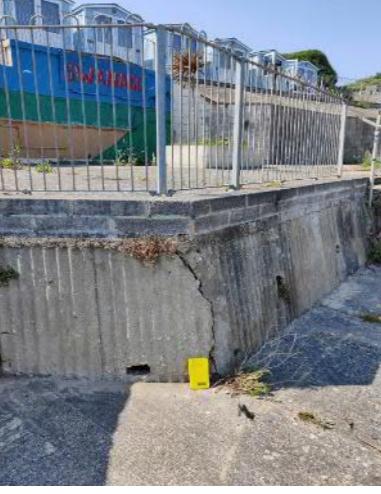
Retaining wall height: 1.25m Retained height: 1.25m Vertical cracking, crack height 0.9m, crack width up to 30mm. Damaged weephole / void at the base of the wall (see left of survey book).	Surveyed - No significant change.	No significant change	No significant change	Low	2	Unlikely	2	Low	4	Low

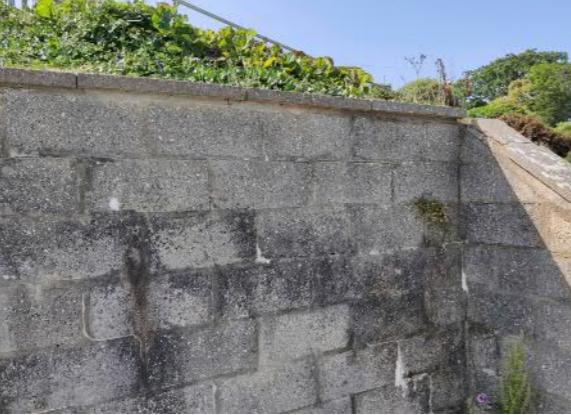
Retaining wall height: 2.15m Retained height: 2.5m Horizontal hairline cracking, crack width 1mm. Cracking located 1.85m from existing ground level. Slight bulging/bowing at the mid span/mid height of retaining wall. Defect length: 8m.	Could not survey due to lack of access to mid-terrace. From visual inspection in accessible location, no significant change observed.	No significant change	No significant change. Could not survey due to lack of access to mid-terrace. From visual inspection in accessible location, no significant change observed.	Low	2	Unlikely	1	Very Low	2	Low

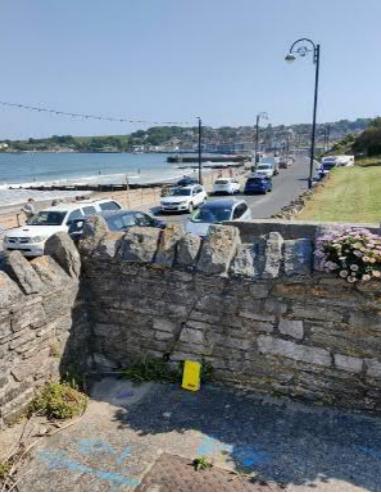
A14	Spa Beach Huts	403062	79353

Retaining wall height: 1.2m Retained height: 0m Vertical and horizontal cracking. Crack length 1.1m, crack width up to 3mm. No loose masonry or missing blockwork. No bulging or bowing of the wall structure.	Surveyed - No significant change.	No significant change	No significant change. Vegetation (flowers) observed to be growing through the cracks in the masonry.	Low	2	Unlikely	1	Very Low	2	Low
A15	Spa Beach Huts	403060	79377

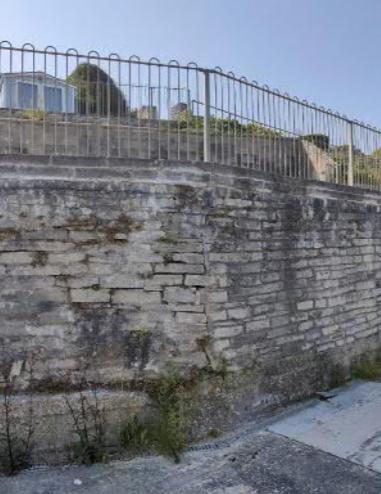
Retaining wall height: 2.55m Retained height: 2.55m Vertical cracking, crack length 1.3m, typical crack width between 3 - 10mm. Bulging/bowing at corner section of masonry wall. Loss of mortar between blockwork.	Horizontal crack width 20mm max. Vertical crack width 20mm max. Otherwise no significant change.	No significant change	No significant change. Water egress / pooling at base of the wall, however origin of this was unconfirmed. No immediate signs of water expelling from the wall face.	Low	2	Unlikely	2	Low	4	Low

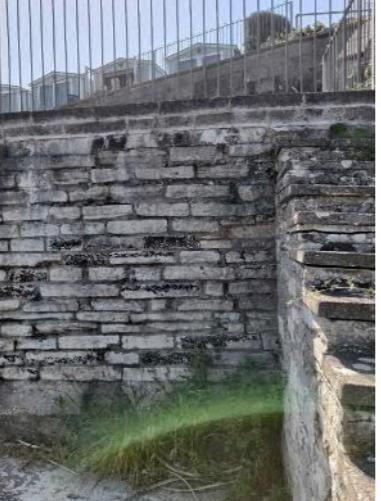
Retaining wall height: 2.55m Retained height: 2.55m Horizontal and vertical cracking. Crack length 1.6m. Typical crack width 3 - 10mm. Bulging/bowing at the mid span of masonry wall.	Surveyed - No significant change.	No significant change	No significant change	Low	1	Negligible	2	Low	2	Low
A17	Spa Beach Huts	403062	79383

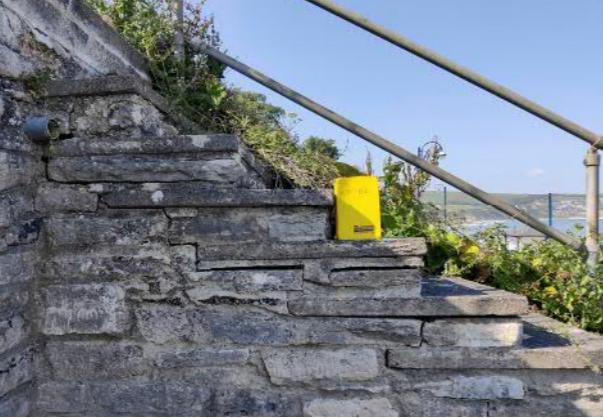
Retaining wall height: up to 2.2m Retained height: up to 2.5m. Horizontal cracking. Crack length 1.8m. Crack width 3 - 12mm. Horizontal movement of return wall causing cracking, potentially due to bulging/bowing from the main span.	Surveyed - No significant change.	No significant change	No significant change	Low	1	Negligible	1	Very Low	1	Low

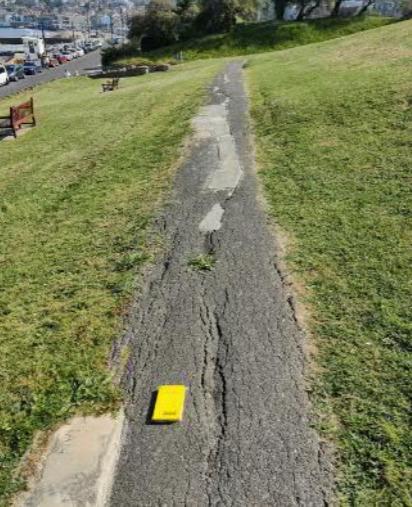
B1	Weather Station Field	403050	79339

Pavement tension cracking, surface deformation and partial collapse. 2no. continuous cracks observed, 3.6m and 11m in length respectively. Multiple patch repairs with asphalt and cement/concrete mix. Ground uneven and with numerous cracks. Crack depths ranging between 5 - 10mm where repairs have not been completed.	Surveyed - No significant change. Slip/trip/fall hazard for members of the public (similar to defect ref. C7). Consider closing off access to footpath, or removing entirely.	Footpath now removed and replaced with grass	No significant change.	Low	1	Negligible	1	Very Low	1	Low

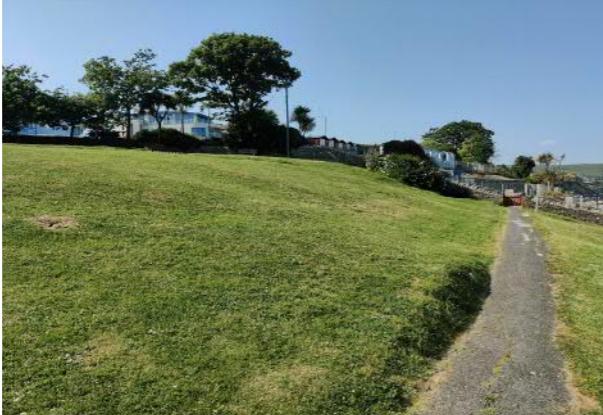
In the field area to the east of weather station, hummocky ground observed, with tension cracking in slope, bulging of surface.	Surveyed - No significant change.	No significant change	No significant change	Medium	3	Likely	2	Low	6	Medium
B3	Weather Station Field	403059	79309

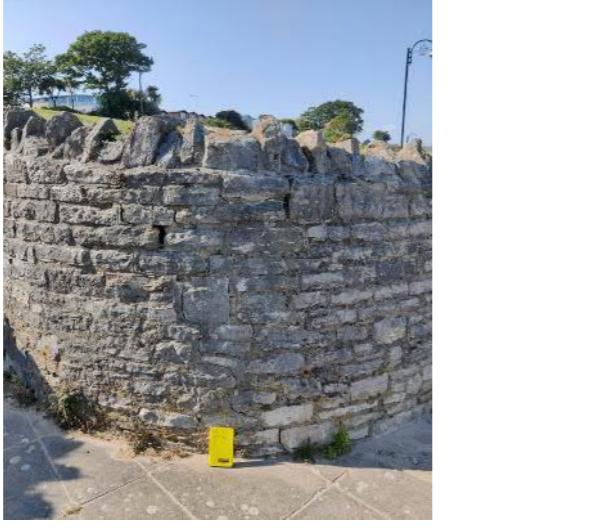
Retaining wall height: 1.8m Retained height: 1.8m Vertical and horizontal cracking, crack width between 2 - 20mm, occurring at apex of wall curvature. No bulging or bowing of the wall observed.	Unable to survey position of maximum crack width due to information signage location. Otherwise no significant change observed.	No significant change	No significant change	Low	2	Unlikely	2	Low	4	Low

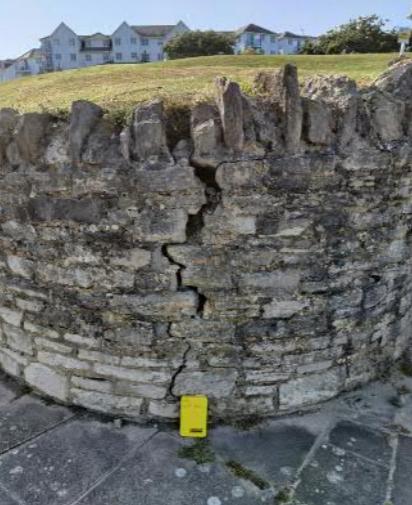
- 3.18 The retaining wall on the corner of Walrond Road and Shore Road (defect ref. B4), has heras fencing panels in place providing an exclusion zone. This has limited the ability to take detailed measurements of the wall, to assess any further movement or displacement of the masonry. Therefore, comparison between the inclinometer data and structural measurements could be made.

Retaining wall height: 1.8m Retained height: 1.8m Curved wall with 3no. sets of vertical cracking. From south face of retaining wall, cracks are at chainage CH 0, 2.0, and 5.5m. Total length of defect: 5.5m. CH 0m Defect: Vertical cracking, crack width typically 30 - 50mm. Missing blockwork at the head of the wall, with significant voids behind mid span of wall (potentially lost mortar or block work following movement). CH 2.0m Defect: Vertical cracking, max crack width typically 90 - 130mm, increasing with height of wall. Missing blockwork at top of wall. CH 5.5m Defect: Vertical cracking, crack width up to 10mm. Blockwork intact.	Survey of crack dimensions hampered by heras fencing panels, which could not be moved. Could not be surveyed accurately. No significant change in structure compared with previous survey. Maintain heras fencing panel around defect. Continue to monitor regularly.	Heras fencing forming exclusion zone. No direct measurements made, however general observations indicate further movement. Continue to monitor and maintain exclusion.	Heras fencing forming exclusion zone. No direct measurements made, due to presence of fencing panels. Continue to monitor and maintain exclusion.	High	3	Likely	3	High	9	High

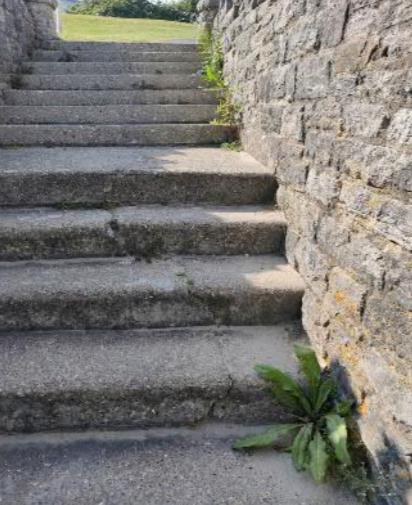
B5	Weather Station Field	403054	79310

Vertical cracking on footpath/stepped access. Crack length 3m, typical crack width 1 - 2mm.	Additional cracking observed at bottom left stairs area. Crack widths similar to previous survey.	No significant change	Additional loss of material/concrete from steps, with voids/cracking up to 40-50mm observed. No significant change to risk level currently.	Low	2	Unlikely	1	Very Low	2	Low

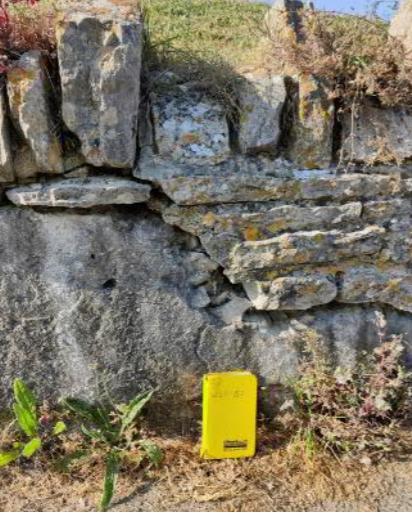
Retaining wall height: 1.0m. Retained height: 1.5m Vertical and horizontal cracking, crack length 0.8m. Typical crack width 40 - 60mm. Minor bowing of the wall at mid height.	Previously identified "minor bowing" appears more akin to shearing of top row of finishing stones of wall span, from the wall below. No significant change in crack widths from previous survey.	No significant change in crack widths Noted to be very wet with water issuing from between cracks	No significant change. No water observed expelling from the wall face, however weather conditions were dry on date of inspection.	Low	1	Negligible	1	Very Low	1	Low

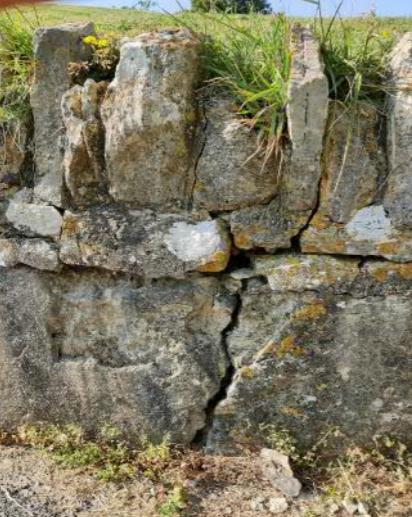
B7	Weather Station Field	403034	79304

Retaining wall height: 0.9m Retained height: 1.0m. Vertical cracking, from base to top of wall (i.e. 0.9m), crack width between 20 - 40mm.	Surveyed - No significant change.	No significant change	No significant change	Low	1	Negligible	1	Very Low	1	Low

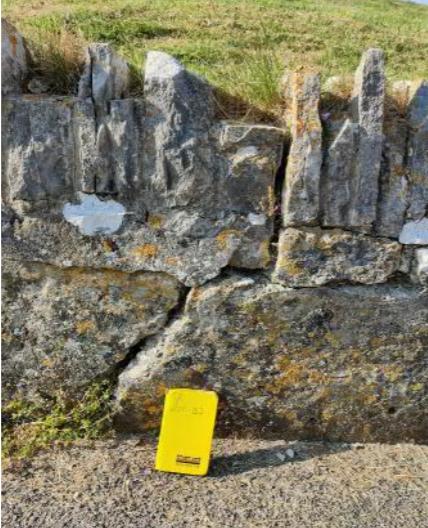
Retaining wall height: 0.85m Retained height: 1m + Vertical and horizontal cracking, the full height of the wall (0.85m), with typical crack width of 20mm. Lower right side (east) of wall translational movement relative to rest of wall.	Max crack width increased to up to 40mm. Otherwise no significant change - low risk.	No significant change	No significant change	Low	1	Negligible	1	Very Low	1	Low
B9	Weather Station Field	403017	79304

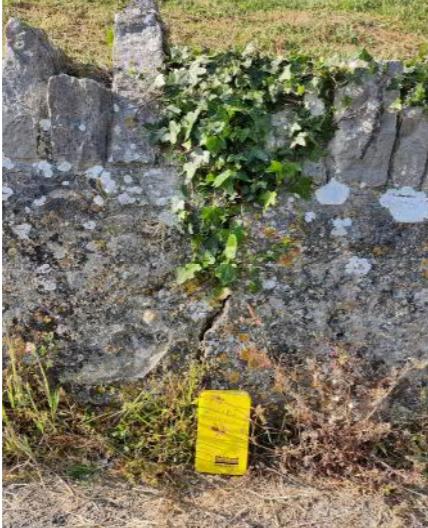
Retaining wall height: 1.0m Retained height: 1.0m Vertical cracking, running full height of the wall. Right of the crack (east side of the wall), 30mm translational movement of the wall relative to the west side. Pavement cracking adjacent to retaining wall observed from base of retaining wall.	Surveyed - No significant change.	No significant change	Crack width observed up to 20mm. No significant change to translation movement or pavement cracking adjacent to the wall.	Low	1	Negligible	1	Very Low	1	Low

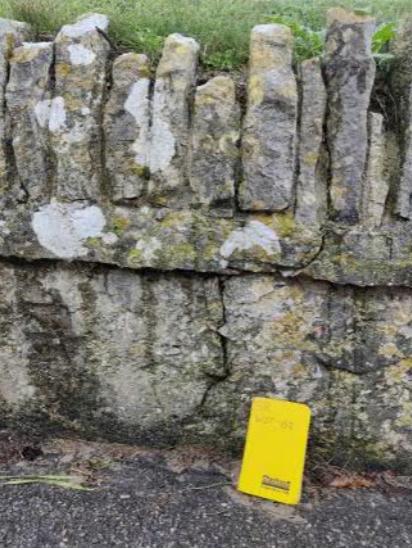
N/A	Retaining wall height: 0.9m Retained height: 1.0m. Vertical cracking, from base to top of wall (i.e. 0.9m), crack width up to 10mm.	No significant change	No significant change	Low	2	Unlikely	1	Very Low	2	Low
B11	Weather Station Field	403040	79304

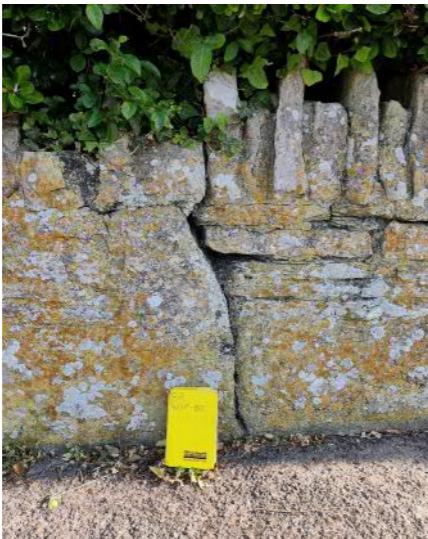
Retaining wall height: 1.0m. Retained height: 1.0m Vertical cracking, full height of wall, typical crack width 5 - 30mm. Large bushes overhanging back of retaining wall, likely the cause of distress observed in the structure.	Displacement of east side of wall relative to the west up to 30mm. Otherwise no significant change - low risk.	No significant change	No significant change	Low	2	Unlikely	1	Very Low	2	Low
C2	Sandpit Field	403009	79294

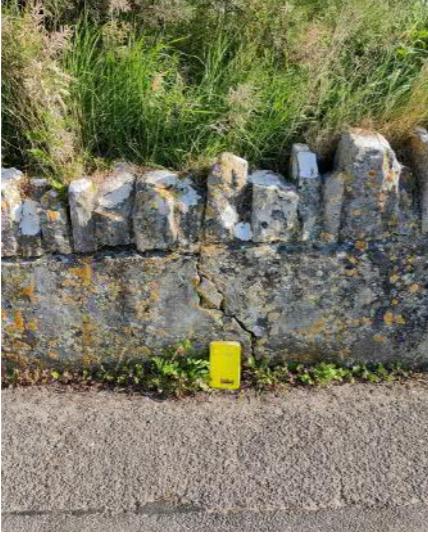
Retaining wall height: 0.8m Retained height: 0.8m Vertical cracking full height of wall, typical crack width 5 - 20mm. Evidence of historic patch repair made previously.	Surveyed - No significant change.	No significant change	No significant change	Low	1	Negligible	1	Very Low	1	Low

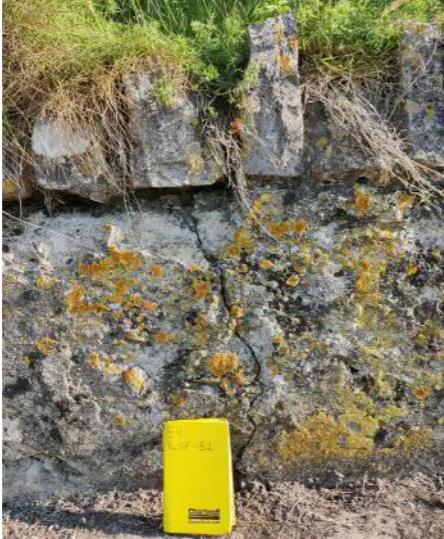
Retaining wall height: 0.95m Retained height 1.0m Vertical cracking, full height of wall, crack width between 1 - 3mm.	Surveyed - No significant change.	No significant change	No significant change	Low	1	Negligible	1	Very Low	1	Low
C4	Sandpit Field	403035	79295

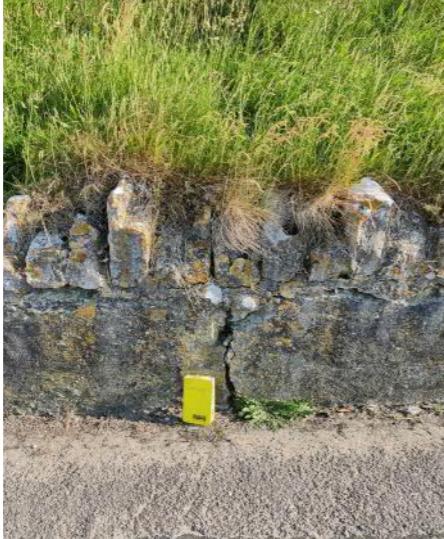
Retaining wall height: 1.0m Retained height: 1.2m Vertical cracking, full height of wall. Crack width 20 - 40mm.	Small void at base of wall due to loss of mortar/masonry. Likely lost from translational movement of the wall. Otherwise no significant change.	No significant change	No significant change	Low	1	Negligible	1	Very Low	1	Low

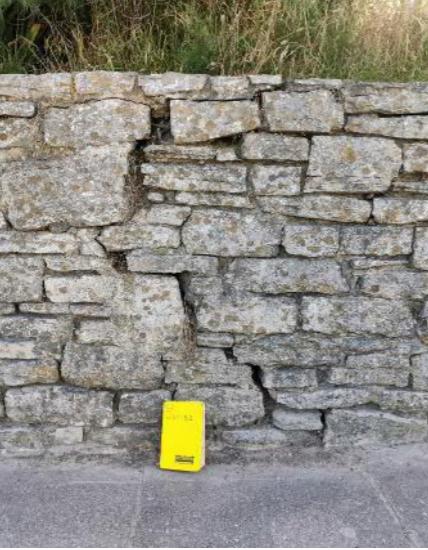
Retaining wall height: 1.25m Retained height 1.25m Vertical and horizontal cracking, typical crack width 20 - 30mm. Transverse movement of the wall, mortar joint failure from masonry blockwork moving apart.	Vertical and horizontal cracking increased from 20-30mm to 40-50mm. Otherwise health of asset unchanged. Low risk.	No significant change	No significant change	Low	2	Unlikely	2	Low	4	Low
C6	Sandpit Field	403054	79280

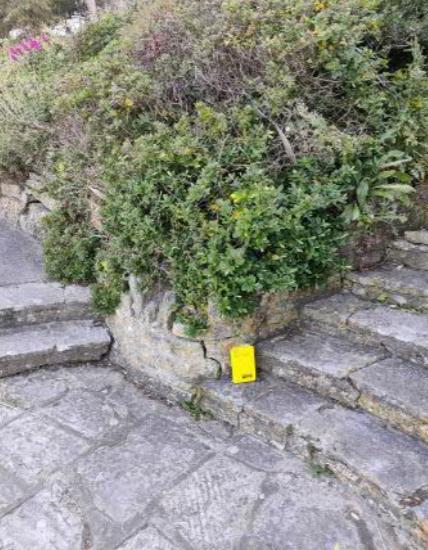
Retaining wall height: 0.6m Retained height: 1.5m+ Vertical cracking full height of the wall. Typical crack width between 10 - 15mm. Overgrown bushes and vegetation acting on the back of the wall the likely cause of deterioration of the retaining structure.	Typical crack width increased to 15-25mm. Otherwise no significant change - low risk.	No significant change	No significant change	Low	2	Unlikely	2	Low	4	Low

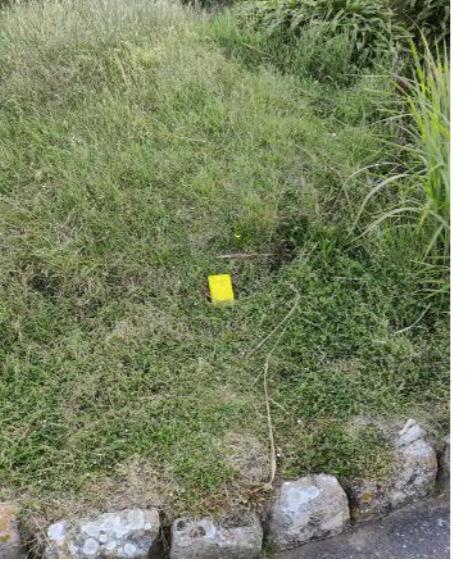
3 l.m of tension cracking observed in oversteep section of slope. Width of tension crack approx 200mm, and 250mm depth in areas.	Tension crack width Otherwise no significant change. Continue to monitor on ongoing basis.	No significant change	No significant change.	Medium	3	Likely	2	Low	6	Medium
C11	Sandpit Field	403055	79235

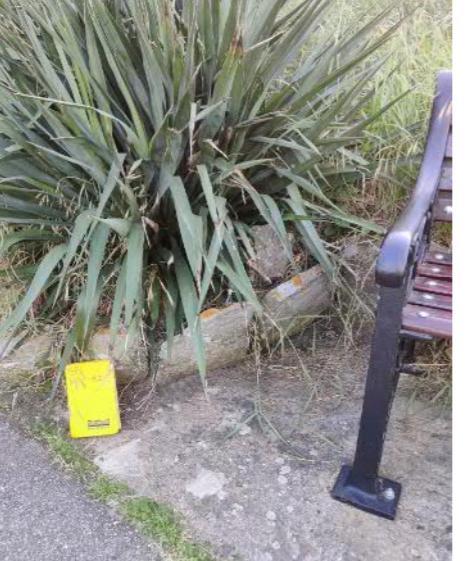
Retaining wall height: 0.3m Retained height: 3m+ 2 lm section of retaining wall at the rear of benches, has overturned by 30 degrees from vertical. Large overgrown vegetation acting immediately behind the rear of wall, likely cause of issue.	Overturning of retaining wall increased to 45 degrees from vertical. Low risk, however continue to monitor. Risk of causing hazards related to slips/trip/falls, particularly adjacent to bench + pedestrian walkway.	Evidence of increased tilt - continue to monitor.	Evidence of increased tilt compared to Feb 2024	Low	2	Unlikely	1	Very Low	2	Low

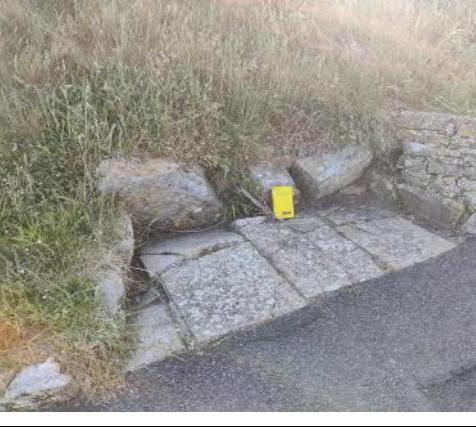
3no. Failed retaining wall which use to house benches. Retaining wall height: 0.6m Retained height 2.5 - 3.5m + Masonry wall fully overturned and collapse of the main wall span. Partial collapse of the return walls either side of each retaining wall. Bulging and hummocking of stone slab at ground level, and signs of distress in adjacent asphalt where retaining walls have failed, indicating greater/deeper global failure occurring.	2nd/Middle retaining wall: - Increased ravelling of shallow material observed. -Shallow slip developing above overturned masonry. Considering heras fencing, cordoning off. Retaining Walls 1 + 3: Surveyed - No significant change observed.	Infilled with sleepers and planting - tension cracking noted above this section and above adjacent retaining walls. Continue to monitor. It is advised that the remaining bench is removed in this section.	Remaining bench has been removed. In addition to Feb 2024 observations, footway adjacent to the bench area has been re-paved. Tension cracking in the slope above the bench areas still observed - advise to continue monitoring.	Medium	3	Likely	2	Low	6	Medium

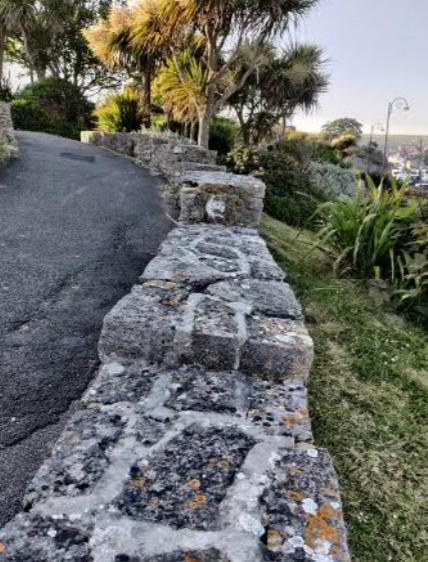
Retaining wall height: 1.0m Retained height: 0.3m Minor tilt/overturning observed in section of masonry wall. Area of overturning matches asphalt repairs and scarring work indicating link between the two. Defect length 22 lm.	Surveyed - No significant change.	No significant change. Footway resurfaced.	No significant change.	Low	2	Unlikely	2	Low	4	Low
C14	Sandpit Field	403039	79146

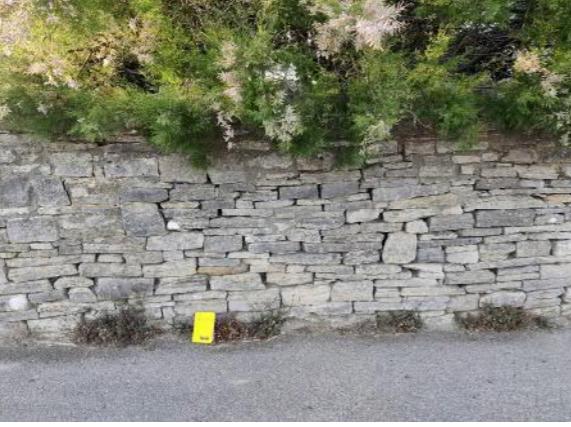
Retaining wall height: 1.25m Retained height: 1.25m Lack of mortar joints connecting this section of wall, therefore potential reconstruction of wall section with dry stone wall technique. Mid height bulging/bowing of the wall likely due to large bushes/trees directly overhanging the back of the wall. Defect length approx 6 lm.	Significant bow in the wall, due to large bushes/trees directly overhanging back of the wall. Bow/overturn measured as 7 degrees to the vertical. Recommended that trees are coppiced, to remove load from back of the wall, and limit damage to wall without killing tree. Killing or removing the tree would cause the decay/rotting of root system, which is likely providing some integrity to the wall structure.	No significant change.	Tree behind affected area of wall has been coppiced, reducing load on the back of the wall. No change to the condition of the wall. Reduction in risk rating considered due to removal of tree/load from rear face of wall.	Medium	2	Unlikely	2	Low	4	Low

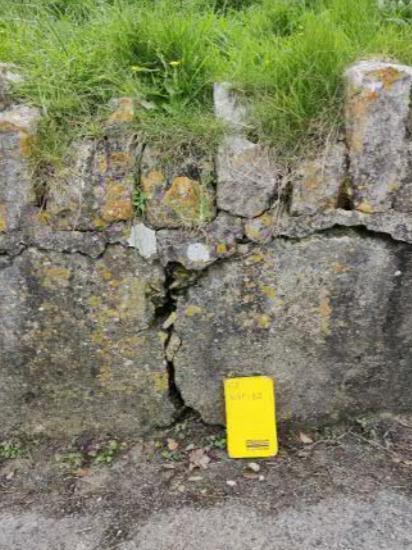
Retaining wall height: 0.9m Retained height 0.9m Vertical cracking, full height of wall, hairline cracking of width up to 2mm.	N/A	1	Negligible	1	Very Low	1	Low
C16	Sandpit Field	403053	79295

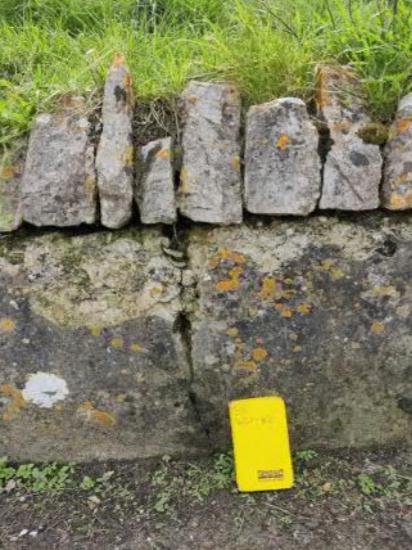
Retaining wall height: 1.0m Retained height 1.0m Vertical cracking, full height of wall, cracking up to 50mm.	N/A	1	Negligible	1	Very Low	1	Low
