TECHNICAL NOTE

DATE:	20 November 2023	CONFIDENTIALITY:	Public
SUBJECT:	Site Monitoring Report – October 2023		
PROJECT:	Swanage Town Council – Shore Road	AUTHOR:	Sam Rhodes
REVIEWER:	Ben Ward	APPROVER:	David Roy

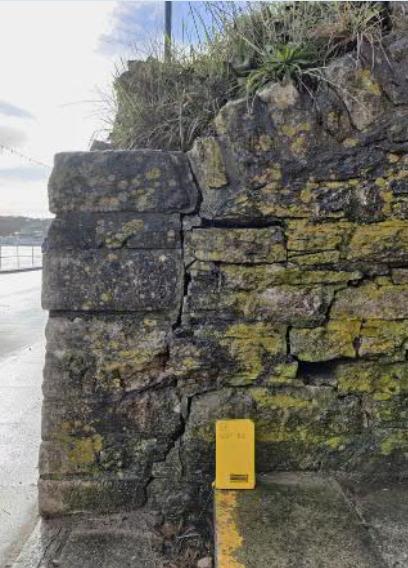
Crack width increased to 25mm. Vertical and horizontal cracking, bulging/horizontal sliding of failing wall section. Crack width 10 - 20mm. Bowing of wall face, up to 40mm. Loose blockwork, missing masonry, loss of mortar between blockwork. Crack length 1.2m wall height 1.2m Retained height 3.0m+.	Bowing of wall face up to 50mm. North facing wall completely sheared from east facing return. Additional bowing/shearing of masonry at bench level adjacent to return wall, with up to 70mm movement. Recommended that area is fenced/closed off. Return wall supports 3-5m of backfill. In the event of total failure, potential to cause significant harm to members of the public.	Medium	3	Likely	3	High	9	High

<ul style="list-style-type: none"> • Area immediately adjacent to wall and bench fenced/closed off; and • Should asset show signs of further deterioration, consideration should be given to closing the pedestrian access from Shore Road to reduce foot traffic through this high-risk area.
B1	Weather Station Field

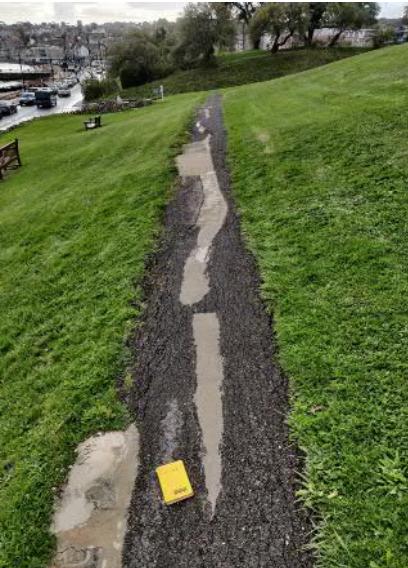
B1	Weather Station Field	403050	79339	B1	B1		Pavement tension cracking, surface deformation and partial collapse. 2no. continuous cracks observed, 3.6m and 11m in length respectively. Multiple patch repairs with asphalt and cement/concrete mix. Ground uneven and with numerous cracks. Crack depths ranging between 5 - 10mm where repairs have not been completed.	Surveyed - No significant change. Slip/trip/fall hazard for members of the public (similar to defect ref. C7). Consider closing off access to footpath, or removing entirely.	Medium	3 Likely	2 Low	2 Low	6 Medium	6 Medium

<ul style="list-style-type: none"> • Following the slip/trip/fall incident at similar defect (ref. C7) in Sandpit Field footpaths, it is recommended that footpath access be closed off. • If this is unfeasible, minor works to remove or resurface the pavement in this area could reduce risk of further slips/trips/falls incident.
B4	Weather Station Field

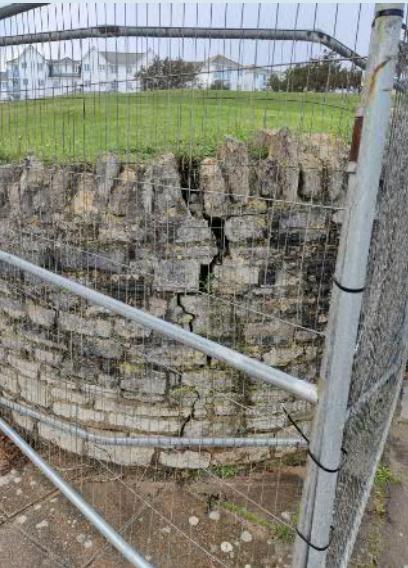
Retaining wall height: 1.8m Retained height: 1.8m Curved wall with 3 no. sets of vertical cracking. From south face of retaining wall, cracks are at chainage CH 0, 2.0, and 5.5m. Total length of defect: 5.5m. CH 0m Defect: Vertical cracking, crack width typically 30 - 50mm. Missing blockwork at the head of the wall, with significant voids behind mid span of wall (potentially lost mortar or block work following movement). CH 2.0m Defect: Vertical cracking, max crack width typically 90 - 130mm, increasing with height of wall. Missing blockwork at top of wall. CH 5.5m Defect: Vertical cracking, crack width up to 10mm. Blockwork intact.	Survey of crack dimensions hampered by heras fencing panels, which could not be moved. Could not be surveyed accurately. No significant change in structure compared with previous survey. Maintain heras fencing panel around defect. Continue to monitor regularly.	High	3	Likely	3	High	9	High

<ul style="list-style-type: none"> • Retaining wall at the southeast corner of Weather Station field should continue be fenced off using temporary Heras panels; and • Should asset show signs of further deterioration, consideration should be given to extending the radius of Heras fencing panels around the defect.

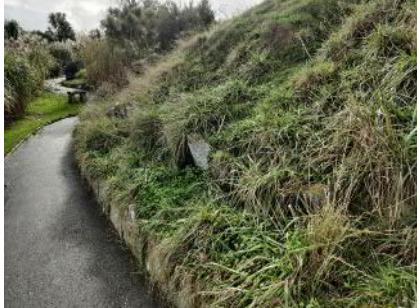
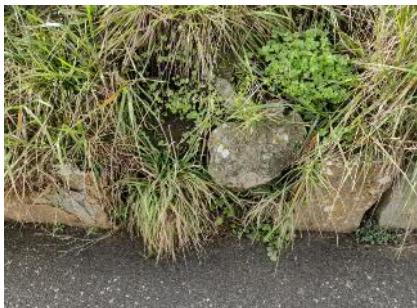
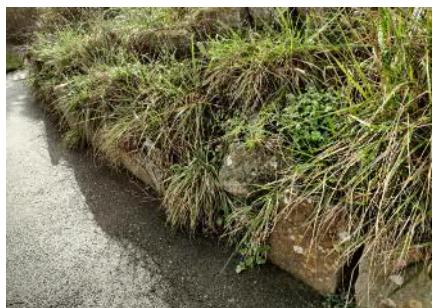
Retaining wall height: 1.3m Retained height 3.0m + 6m of terraced masonry blocks which were observed to be overturning with over steepened slope behind. Blocks likely installed to prevent shallow slip failure of material above, however global stability of slope borderline.	Blocks further overturned. Further ravelling of slope material. A 1m section of toe has a paving stone/blockwork missing. Unsupported toe area has an increased risk of slip/localised slope failure. Regular inspection of area recommended to inspect condition. Consider replacing stone/blockwork to provide support to the face.	Low	2 Unlikely	3 High	6 Medium

<ul style="list-style-type: none"> • A 1m section of the slope toe was observed to have blockwork missing, leaving the toe of the slope unsupported in this area. It is recommended that new masonry is installed to prevent further erosion/voiding at the toe, causing progressive collapse. • Should installation of new masonry not be possible at this time, the section of exposed toe should be buttressed with blockwork to support exposed slope face.
C12	Sandpit Field

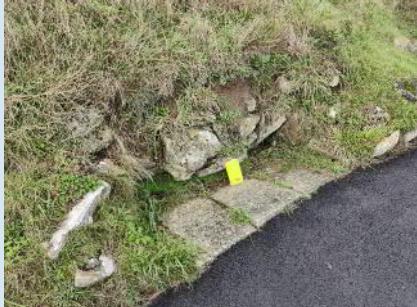
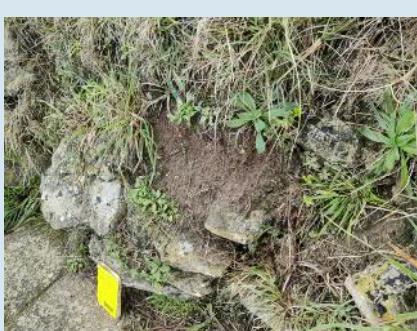
3no. Failed retaining wall which use to house benches. Retaining wall height: 0.6m Retained height 2.5 - 3.5m + Masonry wall fully overturned and collapse of the main wall span. Partial collapse of the return walls either side of each retaining wall. Bulging and hummocking of stone slab at ground level, and signs of distress in adjacent asphalt where retaining walls have failed, indicating greater/deeper global failure occurring.	2nd/Middle retaining wall: - Increased ravelling of shallow material observed. -Shallow slip developing above overturned masonry. Considering heras fencing, cordoning off. Retaining Walls 1 + 3: Surveyed - No significant change observed.	Medium	3	Likely	2	Low	6	Medium

<ul style="list-style-type: none"> • Middle (2nd) retaining wall was seen to have overturned further, with increased ravelling of shallow surface material from above. A shallow slip was also observed, on the slope above. It is recommended that heras fencing is installed to run parallel with the asphalt pavement, preventing pedestrian access to the high-risk area.

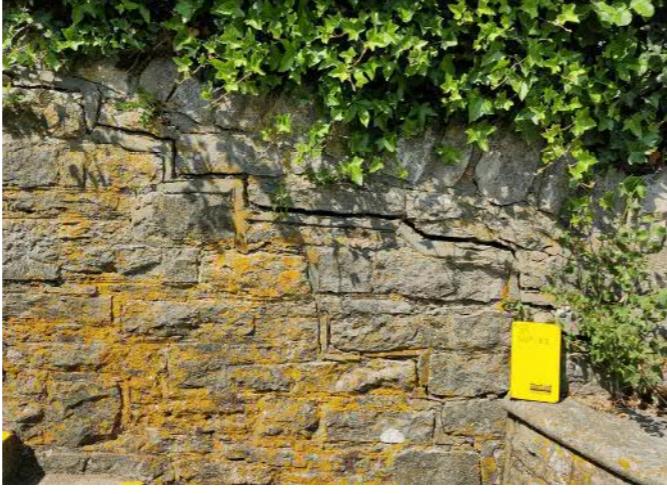
A2	The Spa	403068	79423	A2	A2

Retaining wall height: 1.3m Retained height: 1.3m Horizontal cracking, crack width up to 10mm. Cracking along failed mortar joint.	Max crack width increased 15mm. Otherwise no significant change (NSC) observed.	Low	2	Unlikely	1	Very Low	2	Low
A3	The Spa	403061	79407	A3	A3

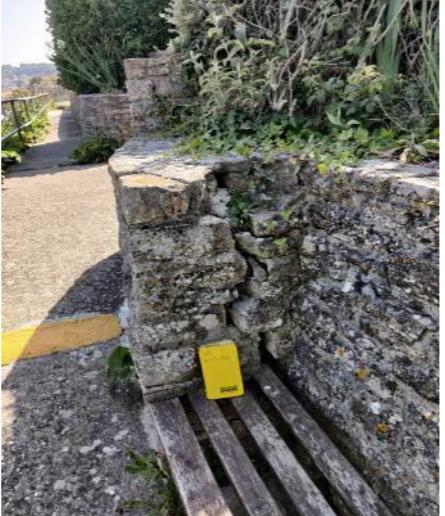
Retaining wall height: 0.8m Retained height: 0.8m Vertical cracking and horizontal displacement of wall. Crack width, 40 - 60mm with loose and missing masonry. Evidence of previous repair attempt with cement mix.	Max crack width 80mm. Max translational movement of masonry (left and right hand side) 50mm. Otherwise no significant change, and low risk.	Low	2	Unlikely	1	Very Low	2	Low

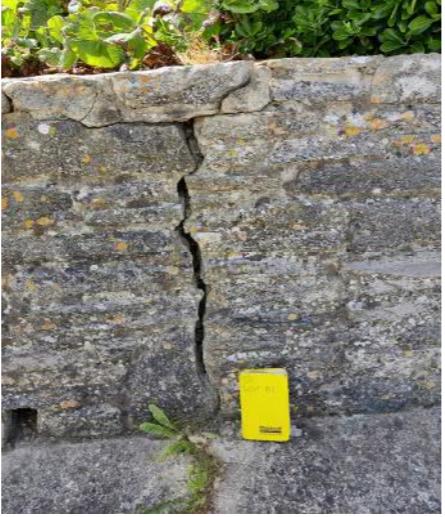
Retaining wall height: 1.0m Retained height: 1.0m Vertical cracking, width up to 30mm. No bowing/bulging of wall face observed. Pavement cracking at base of retaining wall mirroring cracking in retaining wall face.	Surveyed - No significant change.	Low	1	Negligible	1	Very Low	1	Low
A5	The Spa	403051	79400	A5	A5

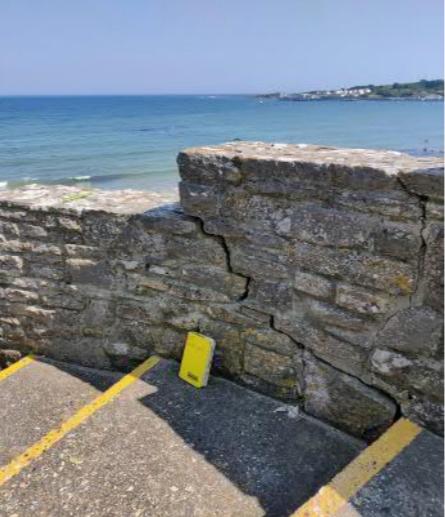
Retaining wall height: 0.9m Retained height: 0.2m Vertical and horizontal cracking, crack width up to 30mm. Appears lower section of wall has settled/rotated away from top section, causing failure of mortar joint and cracking in wall.	Surveyed - No significant change.	Low	2	Unlikely	2	Low	4	Low

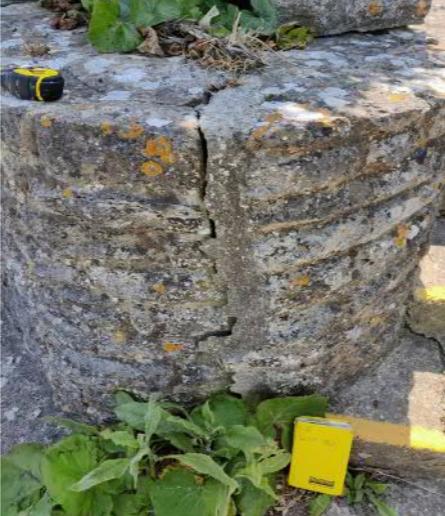
A6	The Spa	403060	79402	A6	A6

Retaining wall height: 0.9m Retained height: 0.9m Vertical cracking, crack width up to 20mm. Horizontal displacement of right side of wall 10mm from left side. Evidence of previous mortar joint repair, which has since re-failed.	Horizontal displacement of right side of wall increased to 15mm. Otherwise, no significant change, and low risk.	Low	2	Unlikely	1	Very Low	2	Low

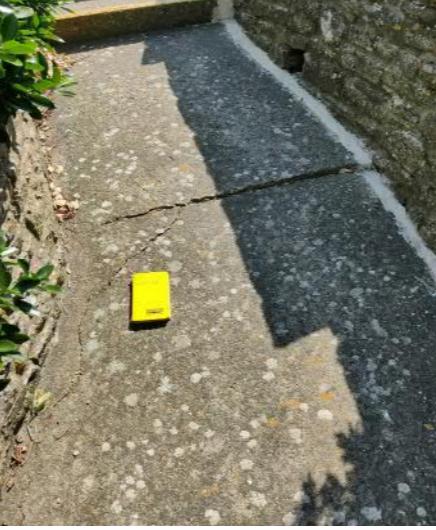
Pavement cracking and uneven ground. Differential settlement/transverse cracking in pavement with height up to 10mm. Longitudinal cracking, with width up to 2mm.	Surveyed - No significant change.	Low	2	Unlikely	1	Very Low	2	Low
A8	The Spa	403052	79390	A8	A8

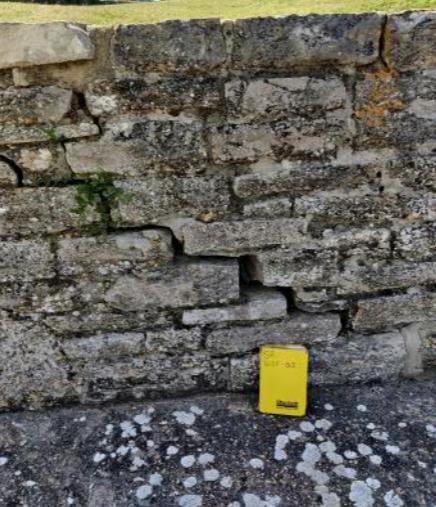
Retaining wall height: 1.0m Retained height: 1.0m Vertical and horizontal cracking, cracking width 30 - 60mm. Length of defect 0.7m. Evidence of minor previous patch repairs with cement mix.	No bowing observed. Surveyed - No significant change.	Low	2	Unlikely	1	Very Low	2	Low

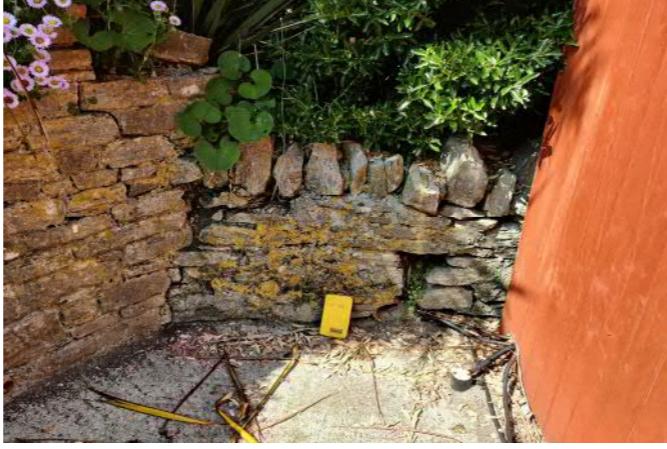
Retaining wall height: 0.9m Retained height: 0.9m Minor vertical cracking, missing masonry blocks and silted up and damaged back of wall drainage. Damage potentially due to running services through wall, post wall construction.	Surveyed - No significant change.	Low	2	Unlikely	1	Very Low	2	Low
A10	Spa Beach Huts	403054	79358	A10	A10

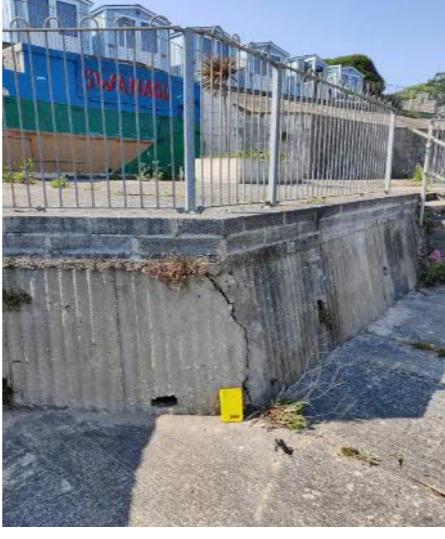
Retaining wall height: 1.25m Retained height: 1.25m Vertical cracking, crack height 0.9m, crack width up to 30mm. Damaged weephole / void at the base of the wall (see left of survey book).	Surveyed - No significant change.	Low	2	Unlikely	2	Low	4	Low

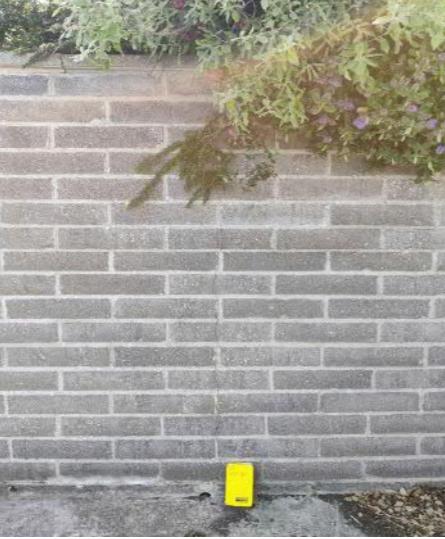
Retaining wall height: 2.15m Retained height 2.15m Hairline vertical cracking full height of the wall, crack width ~1mm. Weephole silted up and 2/3 blocked by additional concrete pours, potential from previous remedial works.	Could not survey due to lack of access to mid-terrace. From visual inspection in accessible location, no significant change observed.	Low	1 Negligible	3 High	3 Low			
A12	Spa Beach Huts	403050	79369	A12	A12

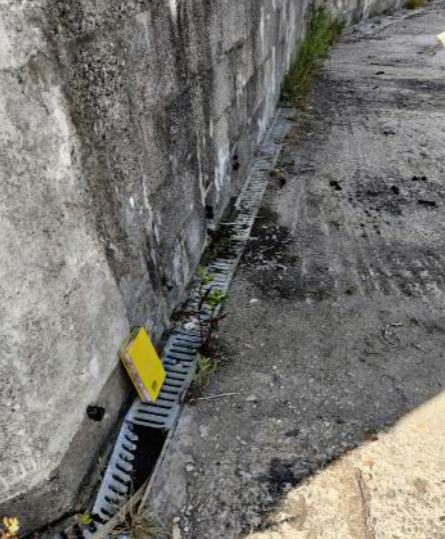
Delapidated aco surface water drainage system. Drainage gratings broken, and invert fully silted up for the full length of the retaining wall.	Could not survey due to lack of access to mid-terrace. From visual inspection in accessible location, no significant change observed.	Low	3 Likely	1 Very Low	3 Low

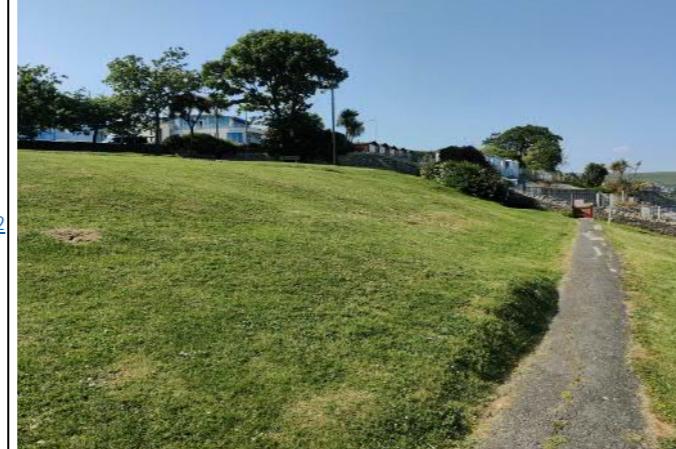
In the field area to the east of weather station, hummocky ground observed, with tension cracking in slope, bulging of surface.	Surveyed - No significant change.	Medium	3	Likely	2	Low	6	Medium	
B3	Weather Station Field	403059	79309	B3	B3

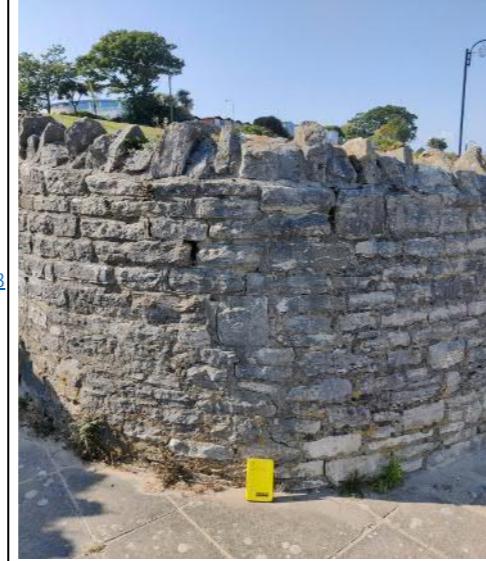
Retaining wall height: 1.8m Retained height: 1.8m Vertical and horizontal cracking, crack width between 2 - 20mm, occurring at apex of wall curvature. No bulging or bowing of the wall observed.	Unable to survey position of maximum crack width due to information signage location. Otherwise no significant change observed.	Low	2	Unlikely	2	Low	4	Low

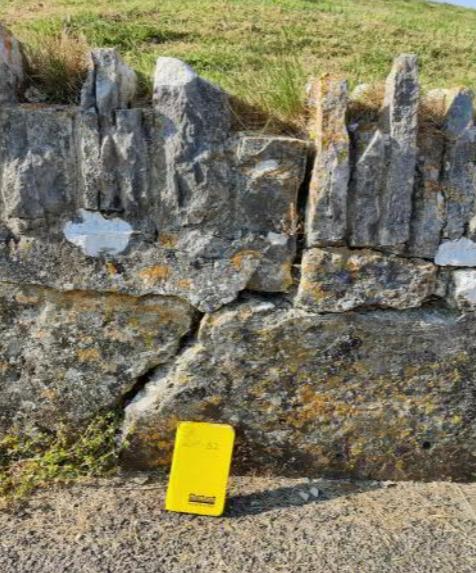
Retaining wall height: 0.85m Retained height: 1m + Vertical and horizontal cracking, the full height of the wall (0.85m), with typical crack width of 20mm. Lower right side (east) of wall translational movement relative to rest of wall.	Max crack width increased to up to 40mm. Otherwise no significant change - low risk.	Low	1 Negligible	1 Very Low	1 Very Low	1 Low		
B9	Weather Station Field	403017	79304	B9	B9

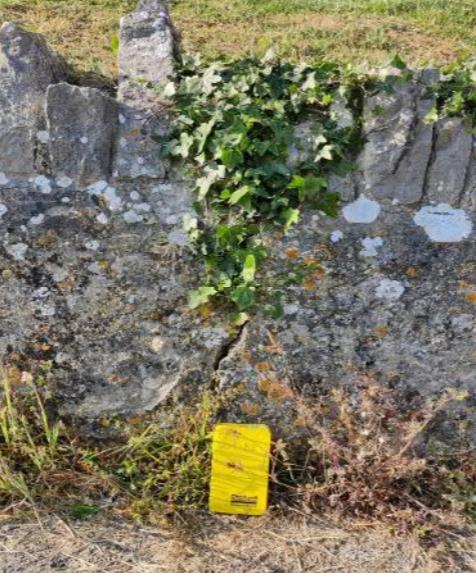
Retaining wall height: 1.0m Retained height: 1.0m Vertical cracking, running full height of the wall. Right of the crack (east side of the wall), 30mm translational movement of the wall relative to the west side. Pavement cracking adjacent to retaining wall observed from base of retaining wall.	Surveyed - No significant change.	Low	1 Negligible	1 Very Low	1 Very Low	1 Low

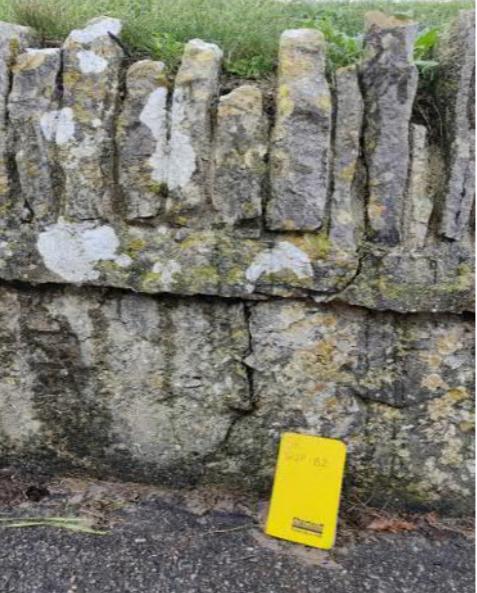
N/A Retaining wall height: 0.9m Retained height: 1.0m. Vertical cracking, from base to top of wall (i.e. 0.9m), crack width up to 10mm.	N/A	2 Unlikely	1 Very Low	1 Very Low	1 Very Low	2 Low	
B11	Weather Station Field	403040	79304	N/A	B11

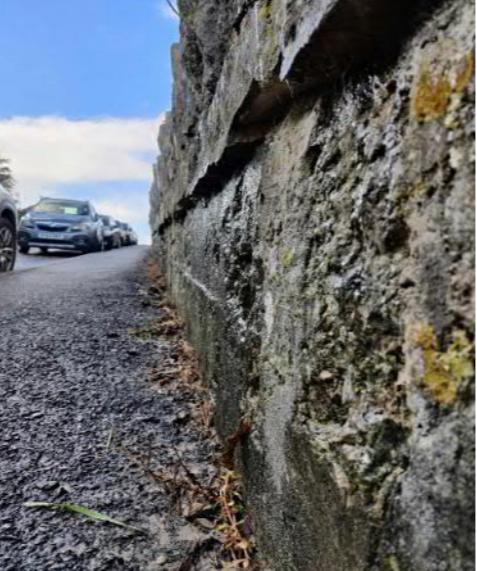
N/A 7.5m length of wall, between defect ref. B6 and B7: Shearing of top span of masonry from base of wall, up to 50mm. Movement in superficial material on retained side of weather station field separating wall at weak/mortar joint location. Risk of collapse over time, and damage to pavement, members of the public, and cars parked on road adjacent to wall. Advise to continue monitoring regularly.	N/A	2 Unlikely	3 High	3 High	6 Medium

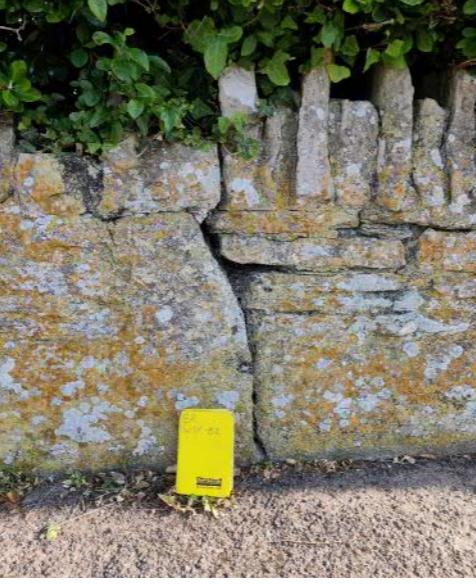
Retaining wall height: 1.0m. Retained height: 1.0m Vertical cracking, full height of wall, typical crack width 5 - 30mm. Large bushes overhanging back of retaining wall, likely the cause of distress observed in the structure.	Displacement of east side of wall relative to the west up to 30mm. Otherwise no significant change - low risk.	Low	2	Unlikely	1	Very Low	2	Low
C2	Sandpit Field	403009	79294	C2	C2

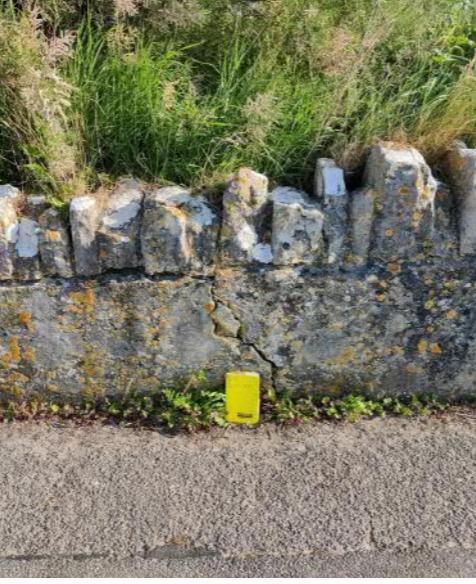
Retaining wall height: 0.8m Retained height: 0.8m Vertical cracking full height of wall, typical crack width 5 - 20mm. Evidence of historic patch repair made previously.	Surveyed - No significant change.	Low	1	Negligible	1	Very Low	1	Low

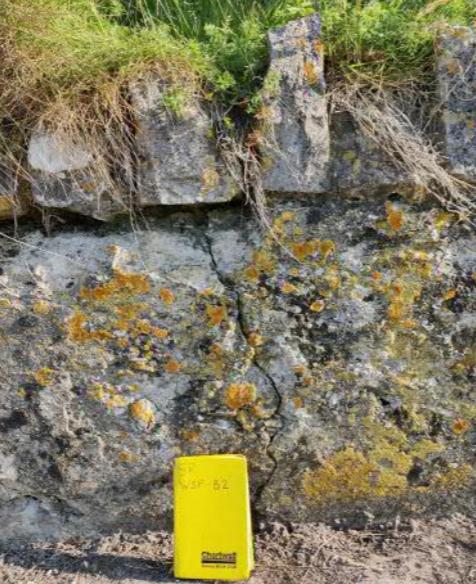
Retaining wall height: 0.95m Retained height 1.0m Vertical cracking, full height of wall, crack width between 1 - 3mm.	Surveyed - No significant change.	Low	1 Negligible	1 Very Low	1 Very Low	1 Low	1 Low	
C4	Sandpit Field	403035	79295	C4	C4

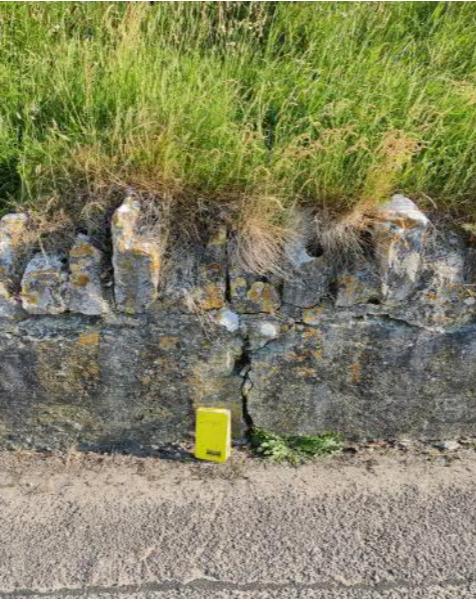
Retaining wall height: 1.0m Retained height: 1.2m Vertical cracking, full height of wall. Crack width 20 - 40mm.	Small void at base of wall due to loss of mortar/masonry. Likely lost from translational movement of the wall. Otherwise no significant change.	Low	1 Negligible	1 Very Low	1 Very Low	1 Low	1 Low

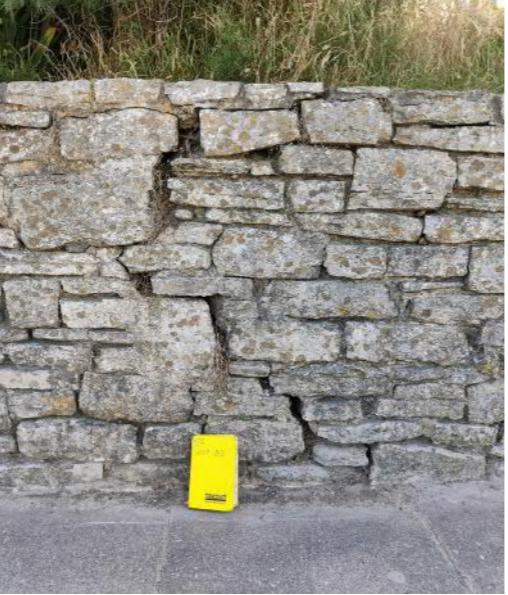
Retaining wall height: 1.25m Retained height 1.25m Vertical and horizontal cracking, typical crack width 20 - 30mm. Transverse movement of the wall, mortar joint failure from masonry blockwork moving apart.	Vertical and horizontal cracking increased from 20-30mm to 40-50mm. Otherwise health of asset unchanged. Low risk.	Low	2	Unlikely	2	Low	4	Low
C6	Sandpit Field	403054	79280	C6	C6

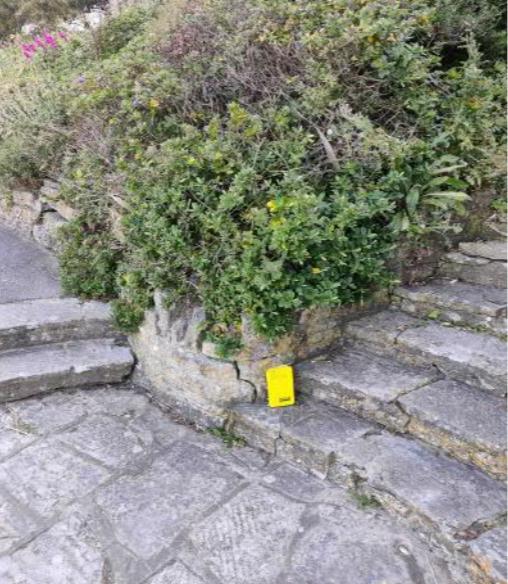
Retaining wall height: 0.6m Retained height: 1.5m+ Vertical cracking full height of the wall. Typical crack width between 10 - 15mm. Overgrown bushes and vegetation acting on the back of the wall the likely cause of deterioration of the retaining structure.	Typical crack width increased to 15-25mm. Otherwise no significant change - low risk.	Low	2	Unlikely	2	Low	4	Low

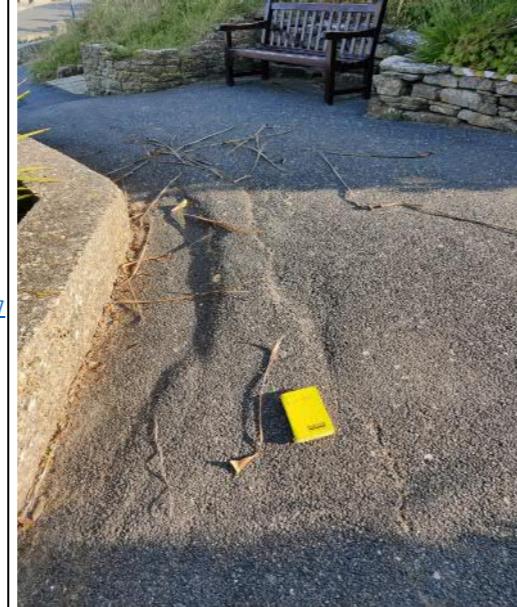
Multiple areas of pavement cracking and surface deformation (one example shown face left). Distress in asphalt behind lower slope retaining walls observed where rotation of lower wall was seen (see defect C13). Additional areas of distress in pavement seen where up slope area is oversteepened and not effectively restrained by retaining structure or otherwise, see defect C12.	Defect has been repaired, asphalt has been relaid in area following slip/trip/fall incident. Bench removed from area. Area to be checked in follow up surveys to ensure defect does not reoccur.	Medium	1 Negligible	1 Very Low	1 Low

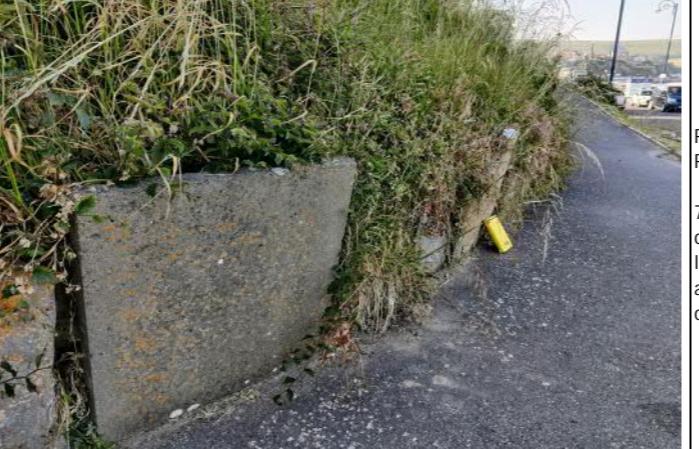
Retaining wall height: 0.6m Retained height: 3m + 7.5 lm of retaining wall blocks partially overturned at toe of retaining wall. Insufficient embedment of blocks at toe, and oversteepened slope behind overloading wall.	Surveyed - No significant change.	Low	2	Unlikely	2	Low	4	Low	
C10	Sandpit Field	403052	79239	C10	C10

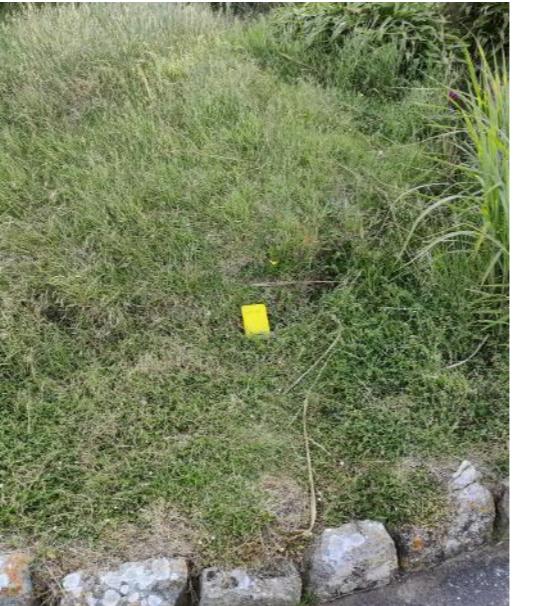
3 lm of tension cracking observed in oversteep section of slope. Width of tension crack approx 200mm, and 250mm depth in areas.	Tension crack width Otherwise no significant change. Continue to monitor on ongoing basis.	Medium	3	Likely	2	Low	6	Medium

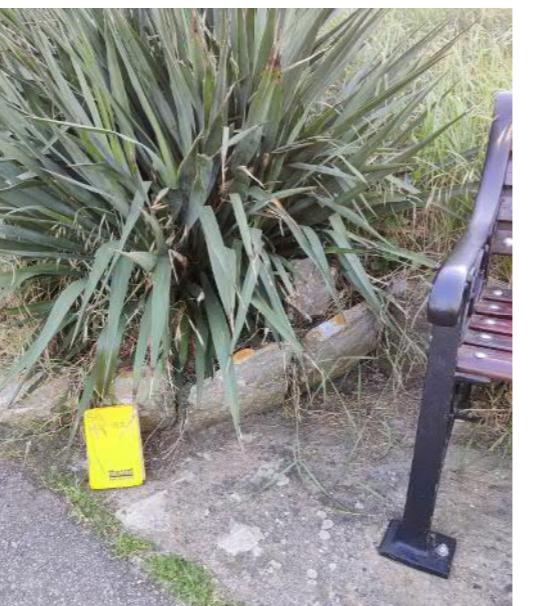
Retaining wall height: 0.3m Retained height: 3m+ 2 lm section of retaining wall at the rear of benches, has overturned by 30 degrees from vertical. Large overgrown vegetation acting immediately behind the rear of wall, likely cause of issue.	Overshooting of retaining wall increased to 45 degrees from vertical. Low risk, however continue to monitor. Risk of causing hazards related to slips/trip/falls, particularly adjacent to bench + pedestrian walkway.	Low	2	Unlikely	1	Very Low	2	Low

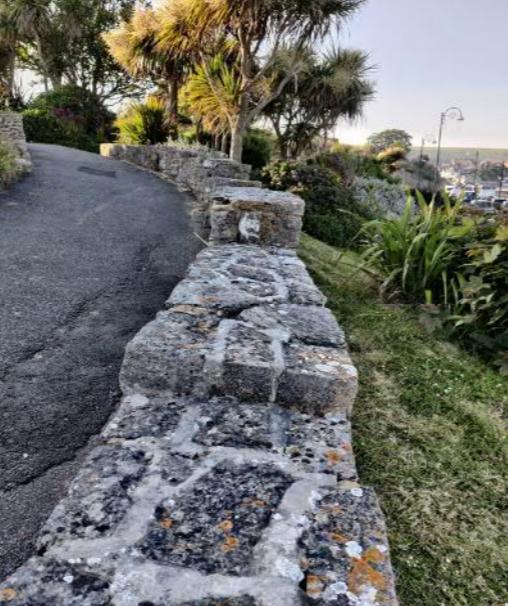
Retaining wall height: 1.0m Retained height: 0.3m Minor tilt/overturning observed in section of masonry wall. Area of overturning matches asphalt repairs and scarring work indicating link between the two. Defect length 22 lm.	Surveyed - No significant change.	Low	2	Unlikely	2	Low	4	Low
C14	Sandpit Field	403039	79146	C14	C14

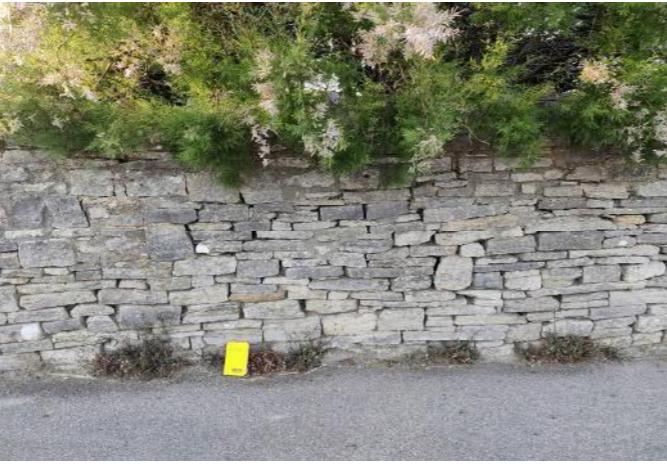
Retaining wall height: 1.25m Retained height: 1.25m Lack of mortar joints connecting this section of wall, therefore potential reconstruction of wall section with dry stone wall technique. Mid height bulging/bowing of the wall likely due to large bushes/trees directly overhanging the back of the wall. Defect length approx 6 lm.	Significant bow in the wall, due to large bushes/trees directly overhanging back of the wall. Bow/overturn measured as 7 degrees to the vertical. Recommended that trees are coppiced, to remove load from back of the wall, and limit damage to wall without killing tree. Killing or removing the tree would cause the decay/rotting of root system, which is likely providing some integrity to the wall structure.	Low	3	Likely	2	Low	6	Medium
