# TECHNICAL NOTE

<b>DATE:</b>	06 November 2024	<b>CONFIDENTIALITY:</b>	Public
<b>SUBJECT:</b>	Site Monitoring Report – October 2024		
<b>PROJECT:</b>	Swanage Town Council – Shore Road	<b>AUTHOR:</b>	Sam Rhodes
<b>REVIEWER:</b>	Ben Ward	<b>APPROVER:</b>	David Roy

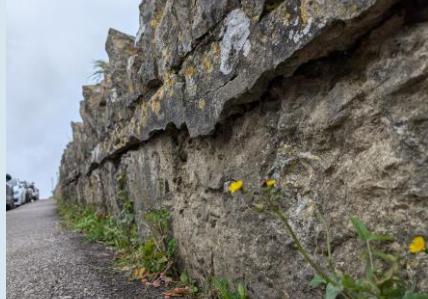
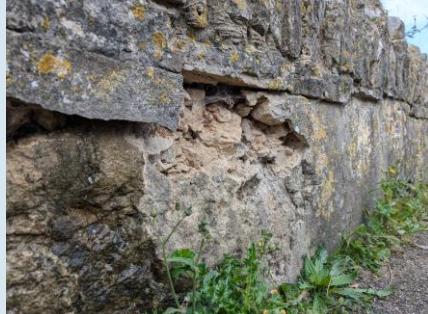
Defect Ref.	Defect Location	Defect Photo	Recommended Mitigation Measure
B11	Weather Station Field

- The defect failure mechanism is a shear failure between the lower wall and the upper coping stones, currently over a nine linear metre section of the wall;

- If failure occurs, upper wall section would impact pedestrian footpath, with the potential to cause harm to pedestrians and damage adjacent parked cars;

- No additional significant movement was measured during the October 2024 inspection, however a large volume of groundwater egressing through the crack in the wall was observed, and additional spalling of concrete facing material.

- Based on these observations we have reclassified the risk as “High”.
- It is recommended that weekly inspections of this defect are undertaken, between WSPs quarterly visits. The risk of asset degradation is greatest during periods of high rainfall, therefore it is recommended to undertake these inspections following such events.

- If further degradation in asset condition is observed, in particular, increased lateral movement of the upper coping stones, it is recommended to extend the barriers already in place at the corner of Walrond Road and Shore Road (for defect B4), to cordon off the area.

<ul style="list-style-type: none"> <li>Continue to monitor regularly (weekly), or after significant rainfall events.</li> <li>If further deterioration is observed, in particular increased lateral movement of the upper coping stones, the defect may require cordoning off.</li> <li>This may also require closure of the foot path, and parking restrictions adjacent to footway.</li> <li>Monitor alongside the results of BH07 inclinometer data.</li> <li>Additional commentary provided within Section 4.3.</li> </ul>
C12	Sandpit Field

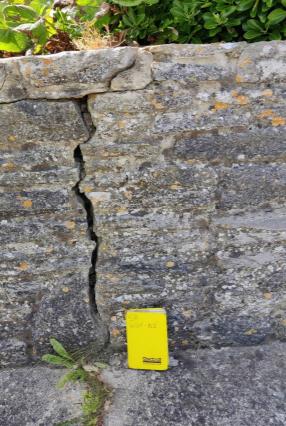
Retaining wall height: 1.0m Retained height: 1.0m  Vertical cracking, width up to 30mm. No bowing/bulging of wall face observed.  Pavement cracking at base of retaining wall mirroring cracking in retaining wall face.	Surveyed - No significant change.	Vertical cracking, width 40mm	No significant change	No significant change	Low	1	Negligible	1	Very Low	1	Low
A5	The Spa	403051	79400

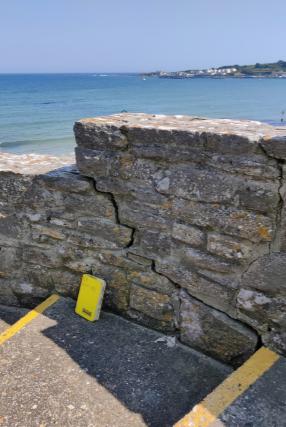
Retaining wall height: 0.9m Retained height: 0.2m  Vertical and horizontal cracking, crack width up to 30mm.  Appears lower section of wall has settled/rotated away from top section, causing failure of mortar joint and cracking in wall.	Surveyed - No significant change.	No significant change	No significant change	Repair to the mortar joints has been made since the last inspection.  Risk of failure significantly reduced, however recommended to monitor asset condition in future surveys to ensure repair remains serviceable.	Low	1	Negligible	1	Very Low	1	Low

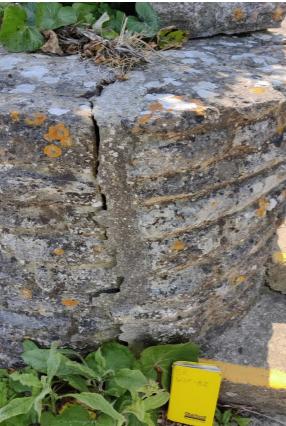
A6	The Spa	403060	79402

Retaining wall height: 0.9m Retained height: 0.9m  Vertical cracking, crack width up to 20mm.  Horizontal displacement of right side of wall 10mm from left side.  Evidence of previous mortar joint repair, which has since re-failed.	Horizontal displacement of right side of wall increased to 15mm.  Otherwise, no significant change, and low risk.	No significant change	No significant change	Horizontal displacement has increased in areas to a max. of 60mm.  No significant change in risk profile for asset.	Low	2	Unlikely	1	Very Low	2	Low

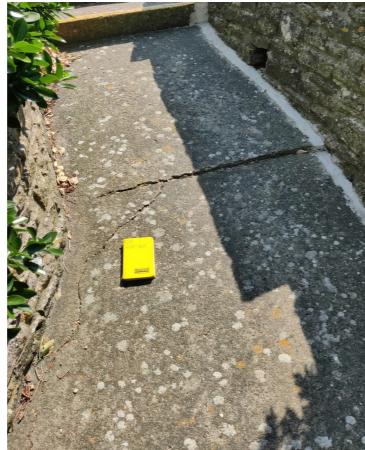
Pavement cracking and uneven ground. Differential settlement/transverse cracking in pavement with height up to 10mm. Longitudinal cracking, with width up to 2mm.	Surveyed - No significant change.	No significant change	Differential settlement/transverse cracking in pavement increased from 10mm to 30mm. No significant change to risk rating.	Differential settlement in pavement at maximum, increased from 30mm to 35mm. <i>Note: Extreme south sloping of pavement in this area, consider risk to pedestrians if this becomes more pronounced.</i>	Low	2	Unlikely	1	Very Low	2	Low

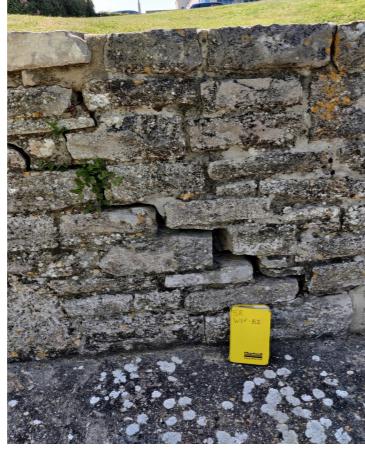
A8	The Spa	403052	79390

Retaining wall height: 1.0m Retained height: 1.0m Vertical and horizontal cracking, cracking width 30 - 60mm. Length of defect 0.7m. Evidence of minor previous patch repairs with cement mix.	No bowing observed. Surveyed - No significant change.	No significant change At end of wall vertical cracking noted 10-20mm in width	No significant change	Length of defect increased from 0.7m to 0.95m. No significant change in asset condition or risk rating.	Low	2	Unlikely	1	Very Low	2	Low

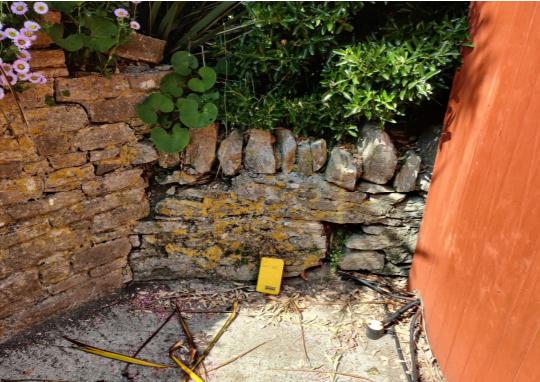
Retaining wall height: 0.9m Retained height: 0.9m  Minor vertical cracking, missing masonry blocks and silted up and damaged back of wall drainage.  Damage potentially due to running services through wall, post wall construction.	Surveyed - No significant change.	No significant change	No significant change	No significant change	Low	2	Unlikely	1	Very Low	2	Low
A10	Spa Beach Huts	403054	79358

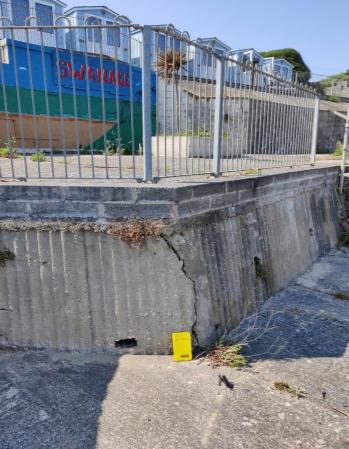
Retaining wall height: 1.25m Retained height: 1.25m  Vertical cracking, crack height 0.9m, crack width up to 30mm.  Damaged weephole / void at the base of the wall (see left of survey book).	Surveyed - No significant change.	No significant change	No significant change	No significant change	Low	2	Unlikely	2	Low	4	Low

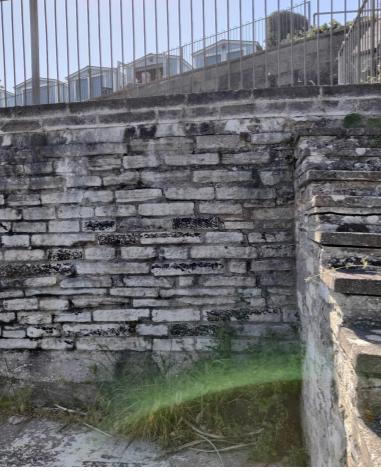
Retaining wall height: 2.55m Retained height: 2.55m  Horizontal and vertical cracking. Crack length 1.6m. Typical crack width 3 - 10mm.  Bulging/bowing at the mid span of masonry wall.	Surveyed - No significant change.	No significant change	No significant change	No significant change	Low	1	Negligible	2	Low	2	Low
A17	Spa Beach Huts	403062	79383

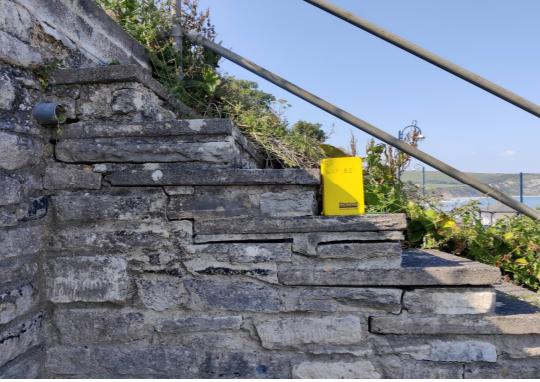
Retaining wall height: up to 2.2m Retained height: up to 2.5m.  Horizontal cracking. Crack length 1.8m. Crack width 3 - 12mm.  Horizontal movement of return wall causing cracking, potentially due to bulging/bowing from the main span.	Surveyed - No significant change.	No significant change	No significant change	No significant change	Low	1	Negligible	1	Very Low	1	Low

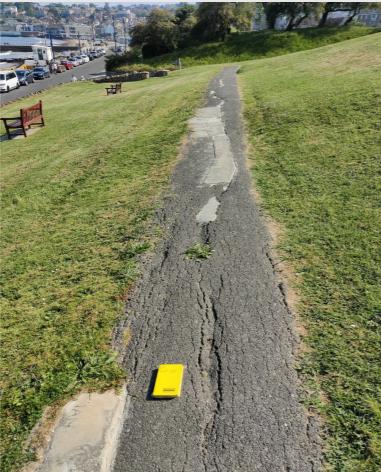
B1	Weather Station Field	403050	79339

Pavement tension cracking, surface deformation and partial collapse.  2no. continuous cracks observed, 3.6m and 11m in length respectively.  Multiple patch repairs with asphalt and cement/concrete mix.  Ground uneven and with numerous cracks. Crack depths ranging between 5 - 10mm where repairs have not been completed.	Surveyed - No significant change.  Slip/trip/fall hazard for members of the public (similar to defect ref. C7). Consider closing off access to footpath, or removing entirely.	Footpath now removed and replaced with grass	No significant change.	No significant change.	Low	1	Negligible	1	Very Low	1	Low

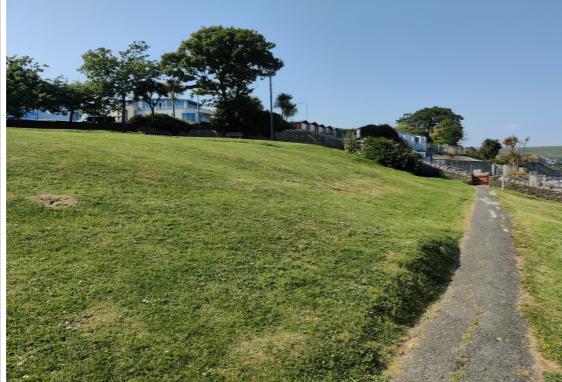
In the field area to the east of weather station, hummocky ground observed, with tension cracking in slope, bulging of surface.	Surveyed - No significant change.	No significant change	No significant change	At south east corner of field, a BH / inclinometer cap missing, with open pipework exposed. This is likely to cause erroneous recordings with regards to groundwater measurements. Review of data to be undertaken.	Medium	3	Likely	2	Low	6	Medium

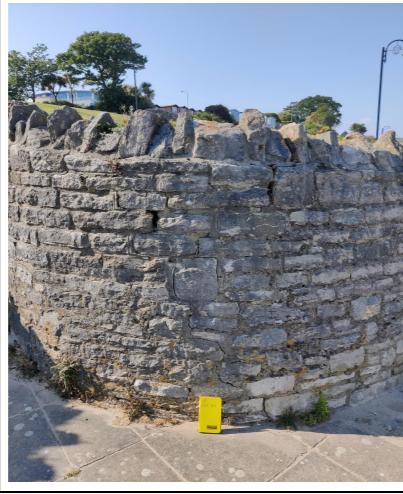
B3	Weather Station Field	403059	79309

Retaining wall height: 1.8m Retained height: 1.8m  Vertical and horizontal cracking, crack width between 2 - 20mm, occurring at apex of wall curvature.  No bulging or bowing of the wall observed.	Unable to survey position of maximum crack width due to information signage location.  Otherwise no significant change observed.	No significant change	No significant change	No significant change	Low	2	Unlikely	2	Low	4	Low

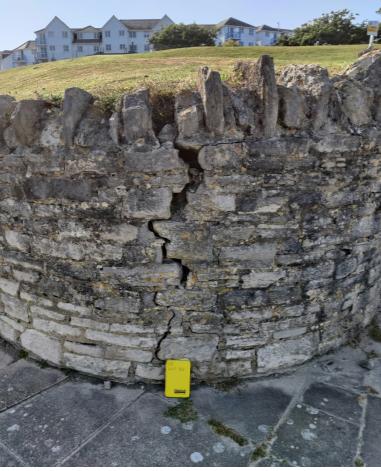
Retaining wall height: 1.8m Retained height: 1.8m  Curved wall with 3no. sets of vertical cracking. From south face of retaining wall, cracks are at chainage CH 0, 2.0, and 5.5m. Total length of defect: 5.5m.  CH 0m Defect: Vertical cracking, crack width typically 30 - 50mm. Missing blockwork at the head of the wall, with significant voids behind mid span of wall (potentially lost mortar or block work following movement).  CH 2.0m Defect: Vertical cracking, max crack width typically 90 - 130mm, increasing with height of wall. Missing blockwork at top of wall.  CH 5.5m Defect: Vertical cracking, crack width up to 10mm. Blockwork intact.		Survey of crack dimensions hampered by heras fencing panels, which could not be moved. Could not be surveyed accurately.  No significant change in structure compared with previous survey.	Heras fencing forming exclusion zone. No direct measurements made, however general observations indicate further movement.  Continue to monitor and maintain exclusion.	Heras fencing forming exclusion zone. No direct measurements made, due to presence of fencing panels.  Continue to monitor and maintain exclusion zone.	No significant change.  Continue to monitor and maintain exclusion zone.	High	3	Likely	3	High	9	High

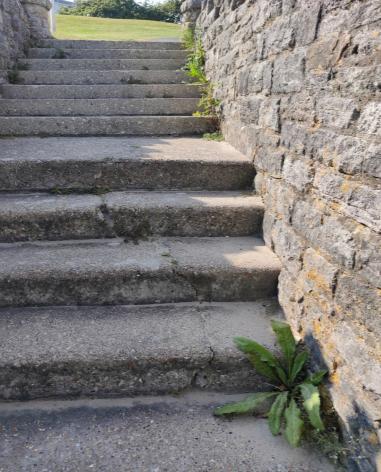
B5	Weather Station Field	403054	79310

Vertical cracking on footpath/stepped access.  Crack length 3m, typical crack width 1 - 2mm.		Additional cracking observed at bottom left stairs area.  Crack widths similar to previous survey.	No significant change	Additional loss of material/concrete from steps, with voids/cracking up to 40-50mm observed.  No significant change to risk level currently.	Additional cracking of pavement slabs observed.  No significant change to risk profile.	Low	2	Unlikely	1	Very Low	2	Low

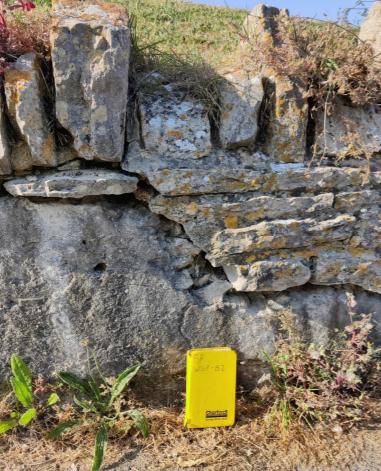
Retaining wall height: 1.0m. Retained height: 1.5m  Vertical and horizontal cracking, crack length 0.8m. Typical crack width 40 - 60mm.  Minor bowing of the wall at mid height.	Previously identified "minor bowing" appears more akin to shearing of top row of finishing stones of wall span, from the wall below.  No significant change in crack widths from previous survey.	No significant change in crack widths  Noted to be very wet with water issuing from between cracks	No significant change.  No water observed expelling from the wall face, however weather conditions were dry on date of inspection.	Max crack width increased from 60mm to 90mm.  Top of wall has sheared further outwards from lower wall.  No significant change in risk profile.	Low	2	Unlikely	1	Very Low	2	Low

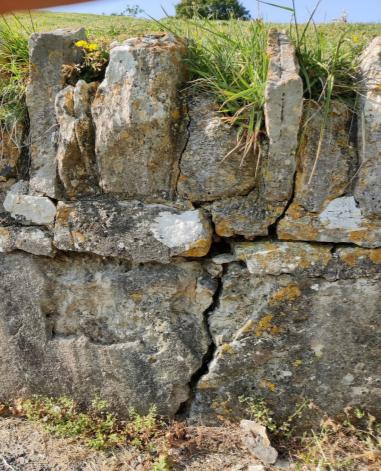
B7	Weather Station Field	403034	79304

Retaining wall height: 0.9m Retained height: 1.0m.  Vertical cracking, from base to top of wall (i.e. 0.9m), crack width between 20 - 40mm.	Surveyed - No significant change.	No significant change	No significant change	No significant change	Low	1	Negligible	1	Very Low	1	Low

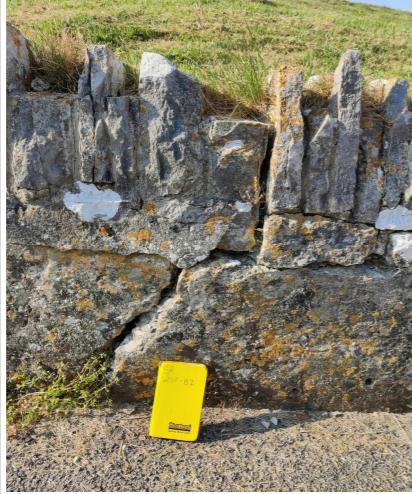
Retaining wall height: 0.85m Retained height: 1m +  Vertical and horizontal cracking, the full height of the wall (0.85m), with typical crack width of 20mm.  Lower right side (east) of wall translational movement relative to rest of wall (<30mm).	Max crack width increased to up to 40mm.  Otherwise no significant change - low risk.	No significant change	No significant change	No significant change	Low	1	Negligible	1	Very Low	1	Low

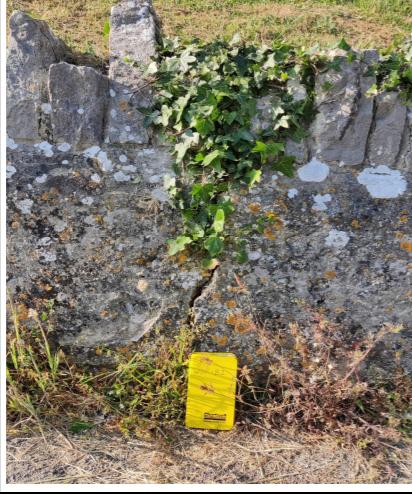
B9	Weather Station Field	403017	79304

Retaining wall height: 1.0m Retained height: 1.0m  Vertical cracking, running full height of the wall. Right of the crack (east side of the wall), 30mm translational movement of the wall relative to the west side.  Pavement cracking adjacent to retaining wall observed from base of retaining wall.	Surveyed - No significant change.	No significant change	Crack width observed up to 20mm.  No significant change to translation movement or pavement cracking adjacent to the wall.	No significant change	Low	1	Negligible	1	Very Low	1	Low

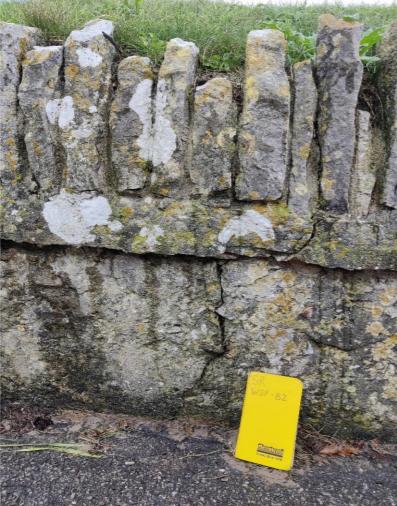
N/A	Retaining wall height: 0.9m Retained height: 1.0m.  Vertical cracking, from base to top of wall (i.e. 0.9m), crack width up to 10mm.	No significant change	No significant change	No significant change	Low	2	Unlikely	1	Very Low	2	Low
B11	Weather Station Field	403040	79304

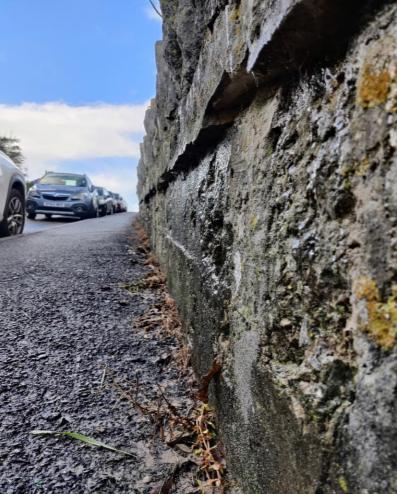
N/A	7.5m length of wall, between defect ref. B6 and B7:  Shearing of top span of masonry from base of wall, up to 50mm. Movement in superficial material on retained side of weather station field separating wall at weak/mortar joint location.  Risk of collapse over time, and damage to pavement, members of the public, and cars parked on road adjacent to wall.  Advise to continue monitoring regularly.	Shearing of top span of masonry from base of wall, increased to 70mm.  Evidence of seepage through wall, along extents.  Advise to continue monitoring regularly. Further deterioration may require foot path diversion.  Advise to continue monitoring regularly.	Condition of asset as per February 2024 inspection.  Lateral extents of the defect has increased from 7.5m to 9m.  Advise to continue monitoring - should further degradation to asset condition be observed, a footpath diversion may be required.	Length of defect observed increased from 7.5m to 10m.  Significant evidence of seepage egressing from behind the wall, between the upper and lower wall sections.  Evidence of spalling of facing material in multiple locations.  Continue to monitor, if further degradation occurs, or additional spalling of wall material, consider exclusion zone around affected section and footpath diversion.	Medium	3	Likely	3	High	9	High

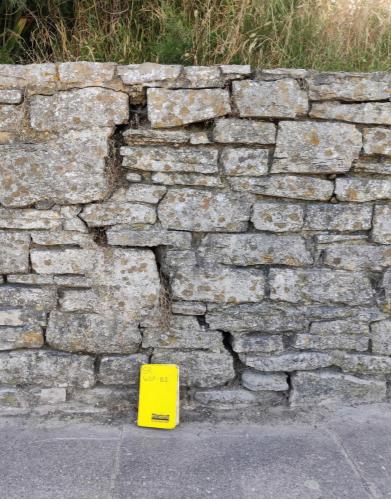
Retaining wall height: 1.25m Retained height 1.25m  Vertical and horizontal cracking, typical crack width 20 - 30mm.  Transverse movement of the wall, mortar joint failure from masonry blockwork moving apart.	Vertical and horizontal cracking increased from 20-30mm to 40-50mm.  Otherwise health of asset unchanged. Low risk.	No significant change	No significant change	No significant change	Low	2	Unlikely	2	Low	4	Low

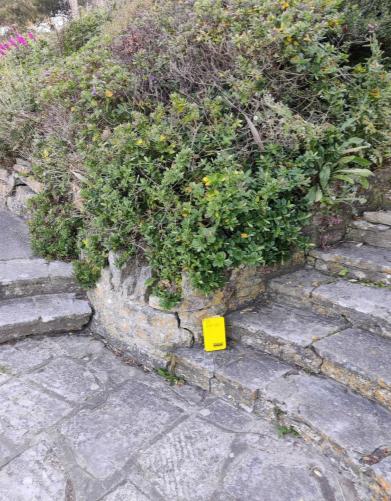
C6	Sandpit Field	403054	79280

Retaining wall height: 0.6m Retained height: 1.5m+  Vertical cracking full height of the wall. Typical crack width between 10 - 15mm. Overgrown bushes and vegetation acting on the back of the wall the likely cause of deterioration of the retaining structure.	Typical crack width increased to 15-25mm.  Otherwise no significant change - low risk.	No significant change	No significant change	No significant change.  Asset partially obscured by vegetation.	Low	2	Unlikely	2	Low	4	Low

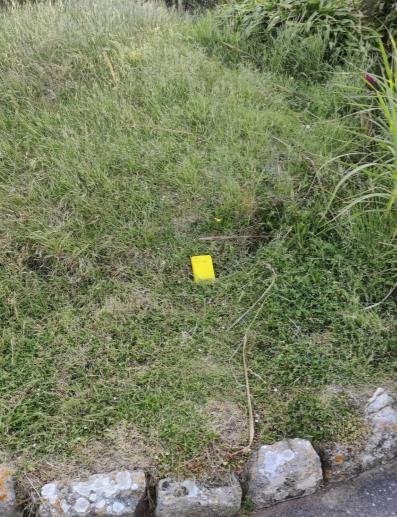
31m of tension cracking observed in oversteep section of slope. Width of tension crack approx 200mm, and 250mm depth in areas.	Tension crack width  Otherwise no significant change.  Continue to monitor on ongoing basis.	No significant change	No significant change	No significant change.  Due to heavy vegetation, quantifying the crack width of asset difficult. From general visual inspection, asset condition has not changed since previous inspection.	Medium	3	Likely	2	Low	6	Medium

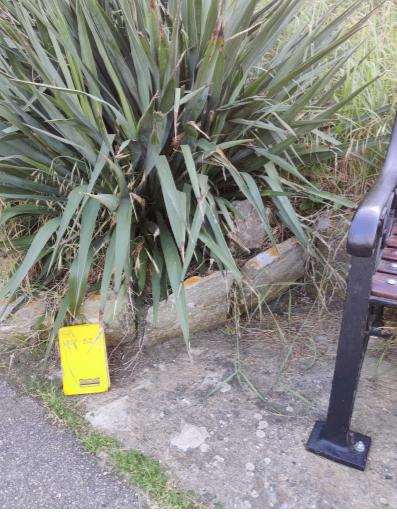
C11	Sandpit Field	403055	79235

Retaining wall height: 0.3m Retained height: 3m+  21m section of retaining wall at the rear of benches, has overturned by 30 degrees from vertical.  Large overgrown vegetation acting immediately behind the rear of wall, likely cause of issue.	Overturning of retaining wall increased to 45 degrees from vertical.  Low risk, however continue to monitor. Risk of causing hazards related to slips/trip/falls, particularly adjacent to bench + pedestrian walkway.	Evidence of increased tilt - continue to monitor.	Evidence of increased tilt compared to Feb 2024	No significant change	Low	2	Unlikely	1	Very Low	2	Low
C12	Sandpit Field	403055	79202

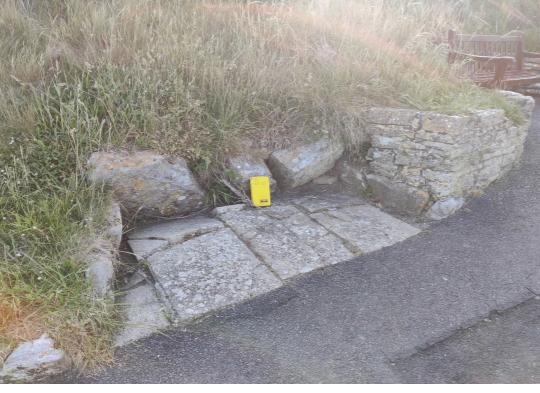
3no. Failed retaining wall which used to house benches.  Retaining wall height: 0.6m Retained height 2.5 - 3.5m +  Masonry wall fully overturned and collapse of the main wall span. Partial collapse of the return walls either side of each retaining wall.  Bulging and hummocking of stone slab at ground level, and signs of distress in adjacent asphalt where retaining walls have failed, indicating greater/deeper global failure occurring.	2nd/Middle retaining wall:  - Increased ravelling of shallow material observed.  -Shallow slip developing above overturned masonry.  Considering heras fencing, cordoning off.  Retaining Walls 1 + 3:  Surveyed - No significant change observed.	Infilled with sleepers and planting - tension cracking noted above this section and above adjacent retaining walls.  Continue to monitor.  It is advised that the remaining bench is removed in this section.	Remaining bench has been removed.  In addition to Feb 2024 observations, footway adjacent to the bench area has been re-paved.  Tension cracking in the slope above the bench areas still observed - advise to continue monitoring.	No significant change from May 2024 inspection.  Continue to monitor top slope, as there is still significant signs of slope distress.	Medium	3	Likely	2	Low	6	Medium

<ul style="list-style-type: none"> <li>Continue to monitor propagation of tension cracks to the rear of recently planted area (previous bench locations).</li> </ul>

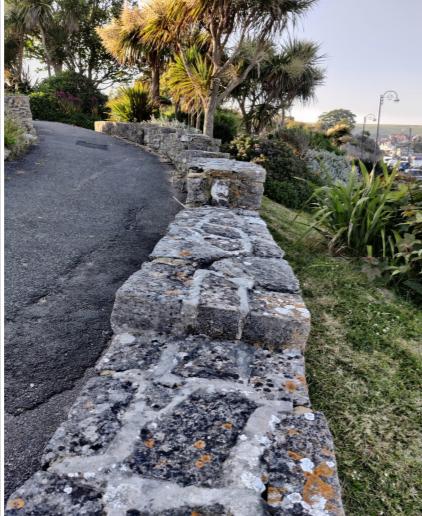
Retaining wall height: 1.0m Retained height: 0.3m  Minor tilt/overturning observed in section of masonry wall. Area of overturning matches asphalt repairs and scarring work indicating link between the two.  Defect length 22 lm.	Surveyed - No significant change.	No significant change. Footway resurfaced.	No significant change.	No significant change.	Low	2	Unlikely	2	Low	4	Low
C14	Sandpit Field	403039	79146

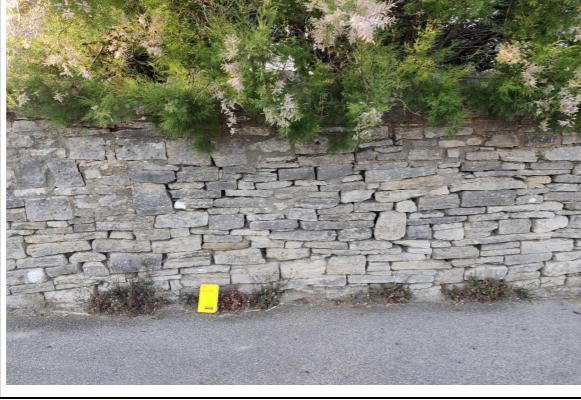
Retaining wall height: 1.25m Retained height: 1.25m  Lack of mortar joints connecting this section of wall, therefore potential reconstruction of wall section with dry stone wall technique.  Mid height bulging/bowing of the wall likely due to large bushes/trees directly overhanging the back of the wall.  Defect length approx 6 lm.	Significant bow in the wall, due to large bushes/trees directly overhanging back of the wall. Bow/overturn measured as 7 degrees to the vertical.  Recommended that trees are coppiced, to remove load from back of the wall, and limit damage to wall without killing tree. Killing or removing the tree would cause the decay/rotting of root system, which is likely providing some integrity to the wall structure.	No significant change.	Tree behind affected area of wall has been coppiced, reducing load on the back of the wall.  No change to the condition of the wall.  Reduction in risk rating considered due to removal of tree/load from rear face of wall.	No significant change.	Low	1	Negligible	2	Low	2	Low

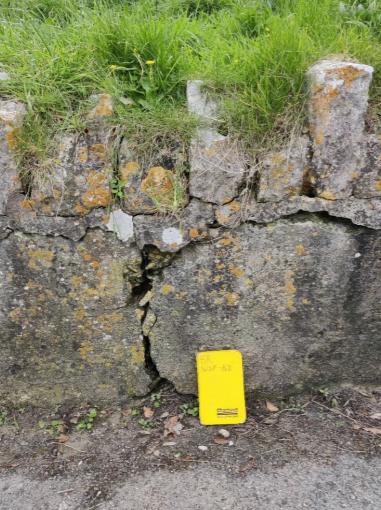
N/A	N/A	N/A	Retaining wall height: 0.9m Retained height 0.9m Vertical cracking, full height of wall, hairline cracking of width up to 2mm.	No significant change	Low	1	Negligible	1	Very Low	1	Low
C16	Sandpit Field	403053	79295

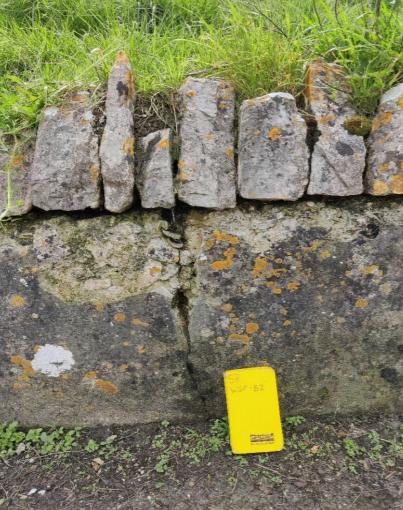
N/A	N/A	N/A	Retaining wall height: 1.0m Retained height 1.0m Vertical cracking, full height of wall, cracking up to 50mm.	No significant change	Low	1	Negligible	1	Very Low	1	Low
