TECHNICAL NOTE

DATE:	28 November 2025	CONFIDENTIALITY:	Public
SUBJECT:	Site Monitoring Report – October 2025		
PROJECT:	Swanage Town Council – Shore Road	AUTHOR:	Sam Horner
REVIEWER:	Ben Ward	APPROVER:	David Roy

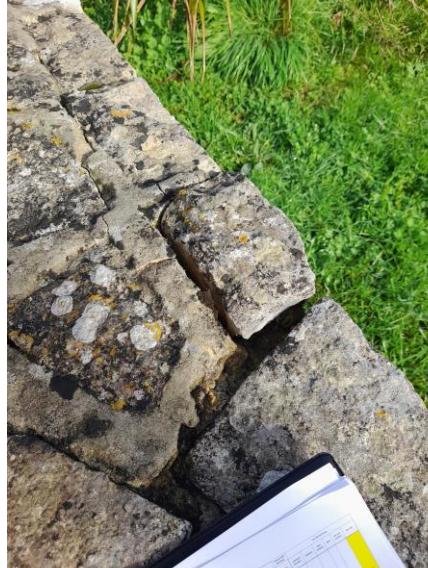
C13	Sandpit Field	403057	79207		Retaining wall height: 1.0m Retained height: 0.3m Minor tilt/overturning observed in section of masonry wall. Area of overturning matches asphalt repairs and scarring work indicating link between the two. Defect length 22 lm.	Surveyed - No significant change.	No significant change. Footway resurfaced.	No significant change.	No significant change.	Small longitudinal crack in top step of masonry wall. Crack width 10mm wide and 1.1m long. Pavement surfacing still in good condition.	No change in crack dimensions. Pavement surfacing still in good condition.	Low	2	Unlikely	2	Low	4	Low	
C14	Sandpit Field	403039	79146		Retaining wall height: 1.25m Retained height: 1.25m Lack of mortar joints connecting this section of wall, therefore potential reconstruction of wall section with dry stone wall technique. Mid height bulging/bowing of the wall likely due to large bushes/trees directly overhanging the back of the wall. Defect length approx. 6 lm.	Significant bow in the wall, due to large bushes/trees directly overhanging back of the wall. Bow/overturn measured as 7 degrees to the vertical. Recommended that trees are coppiced, to remove load from back of the wall, and limit damage to wall without killing tree. Killing or removing the tree would cause the decay/rotting of root system, which is likely providing some integrity to the wall structure.	No significant change.	Tree behind affected area of wall has been coppiced, reducing load on the back of the wall. No change to the condition of the wall. Reduction in risk rating considered due to removal of tree/load from rear face of wall.	No significant change.	No significant change.	No significant change.	No significant change.	Low	1	Negligible	2	Low	2	Low

<ul style="list-style-type: none"> It is recommended that the top layer of blocks on the wall are checked to see if any are loose. Loose blocks should be reset using new mortar or removed to prevent accidentally being knocked and falling to the area below.

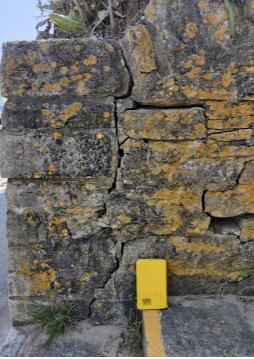
Vertical and horizontal cracking, bulging/horizontal sliding of failing wall section. Crack width 10 - 20mm. Bowing of wall face, up to 40mm. Loose blockwork, missing masonry, loss of mortar between blockwork. Crack length 1.2m wall height 1.2m Retained height 3.0m+.	Crack width increased to 25mm. Bowing of wall face up to 50mm. North facing wall completely sheared from east facing return. Additional bowing/shearing of masonry at bench level adjacent to return wall, with up to 70mm movement. Recommended that area is fenced/closed off. Return wall supports 3.5m of backfill. In the event of total failure, potential to cause significant harm to members of the public.	No significant change Note heras fencing present to separate area from public	No significant change	No significant change	No significant change	No significant change. As noted in 2024, Heras fencing prevents measurement of the cracks.	No significant change. As noted in 2024, Heras fencing prevents measurement of the cracks.	High	3	Likely	3	High	9	High

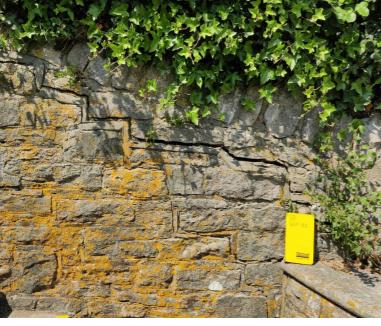
Retaining wall height: 1.3m Retained height: 1.3m Horizontal cracking, crack width up to 10mm. Cracking along failed mortar joint.	Max crack width increased 15mm. Otherwise no significant change (NSC) observed.	No significant change	Slight increase in crack width observed. Otherwise, no significant change.	Max crack width increased from 15mm to approx. 17mm. Otherwise no significant change.	No significant change	No major change in crack width - approx. 15 - 17mm. Length of crack 1.5m Mortar render debonding from the wall.	No significant change.	Low	2	Unlikely	1	Very Low	2	Low
A3	The Spa	403061	79407

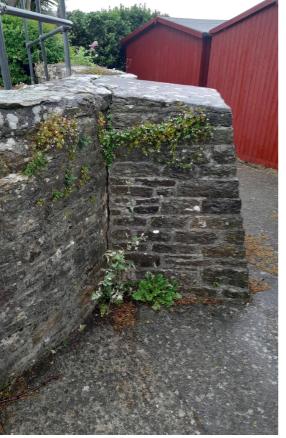
N/A	N/A	N/A	N/A	N/A	N/A	Buttresses on retaining wall adjacent to defect A9 are delaminating from retaining wall. Render is cracked between buttress and wall. Crack width of 30mm. Retaining wall 1.3m height and 1.0m depth.	No significant change.	Medium	2	Unlikely	3	High	6	Medium	
A22	Spa Beach Huts	403064	79377

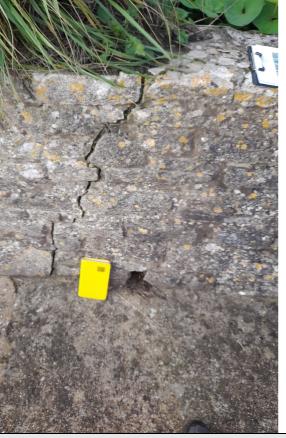
N/A	N/A	N/A	N/A	N/A	N/A	Vertical cracking observed in wall. Widths <10mm. Cracking in place of mortar between blocks. Retaining wall height = 0.9m. Retaining wall depth = 0.4m.	N/A	2	Unlikely	1	Very Low	2	Low		
B1	Weather Station Field	403050	79339

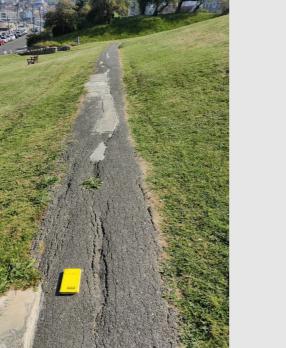
Pavement tension cracking, surface deformation and partial collapse. 2no. continuous cracks observed, 3.6m and 11m in length respectively. Multiple patch repairs with asphalt and cement/concrete mix. Ground uneven and with numerous cracks. Crack depths ranging between 5 - 10mm where repairs have not been completed.	Surveyed - No significant change. Slip/trip/fall hazard for members of the public (similar to defect ref. C7). Consider closing off access to footpath, or removing entirely.	Footpath now removed and replaced with grass	No significant change.	No significant change.	No significant change.	No significant change. Repair still intact.	No significant change. Bare earth noted on old path location, grass growing in patches.	No significant change. More grass cover over bare earth. Occasional bare earth.	Low	1	Negligible	1	Very Low	1	Low

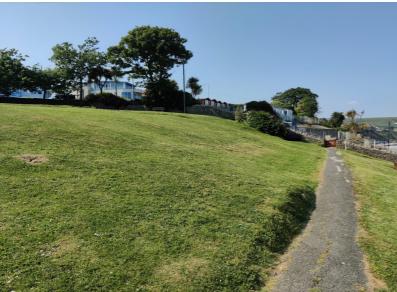
In the field area to the east of weather station, hummocky ground observed, with tension cracking in slope, bulging of surface.	Surveyed - No significant change.	No significant change	No significant change	At south east corner of field, a BH / inclinometer cap missing, with open pipework exposed. This is likely to cause erroneous recordings with regards to groundwater measurements. Review of data to be undertaken.	BH cap at south east corner has been replaced since last inspection. Rectified.	Bulging slope surface shows no significant change. However, still presents a remedial risk.	Hummocky ground with desiccated ground in areas. Bulging slope surface shows no significant change. However, still presents a remedial risk.	Medium	3	Likely	2	Low	6	Medium

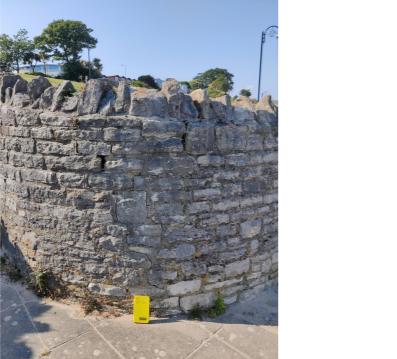
Retaining wall height: 1.8m Retained height: 1.8m Vertical and horizontal cracking, crack width between 2 - 20mm, occurring at apex of wall curvature. No bulging or bowing of the wall observed.	Unable to survey position of maximum crack width due to information signage location. Otherwise no significant change observed.	No significant change	No significant change	No significant change	No significant change	Crack width adjacent to warning sign surveyed. Max opening of 35mm.	No significant change in condition.	Low	2	Unlikely	2	Low	4	Low
B4	Weather Station Field	403055	79305

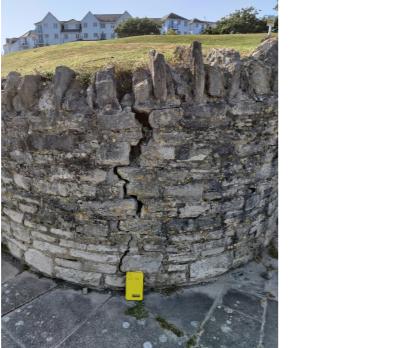
Retaining wall height: 1.8m Retained height: 1.8m Curved wall with 3+ sets of vertical cracking. From south face of retaining wall, cracks are at change CH 0, 2.0, and 5.5m. Total length of defect: 5.5m. CH 0m Defect: Vertical cracking, crack width typically 30 - 50mm. Missing blockwork at the head of the wall, with significant voids behind mid span of wall (potentially lost mortar or block work following movement). CH 2.0m Defect: Vertical cracking, max crack width typically 90 - 130mm, increasing with height of wall. Missing blockwork at top of wall. CH 5.5m Defect: Vertical cracking, crack width up to 10mm. Blockwork intact.	Survey of crack dimensions hampered by heras fencing panels, which could not be moved. Could not be surveyed accurately. No significant change in structure compared with previous survey. Maintain heras fencing panel around defect. Continue to monitor regularly.	Heras fencing forming exclusion zone. No direct measurements made, however general observations indicate further movement. Continue to monitor and maintain exclusion.	Heras fencing forming exclusion zone. No direct measurements made, due to presence of fencing panels. Continue to monitor and maintain exclusion zone.	No significant change. Continue to monitor and maintain exclusion zone.	No significant change. Continue to monitor and maintain exclusion zone.	No significant change. Continue to monitor and maintain exclusion zone.	No significant change. Continue to monitor and maintain exclusion zone.	High	3	Likely	3	High	9	High

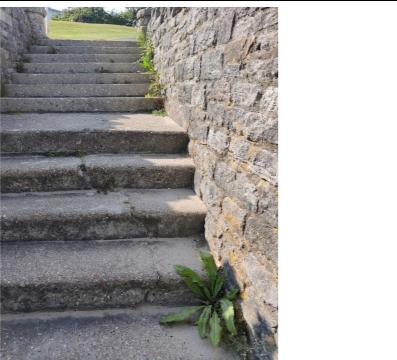
Vertical cracking on footpath/stepped access. Crack length 3m, typical crack width 1-2mm.	Additional cracking observed at bottom left stairs area. Crack widths similar to previous survey.	No significant change	Additional loss of material/concrete from steps, with voids/cracking up to 40-50mm observed. No significant change to risk level currently.	Additional cracking of pavement slabs observed. No significant change to risk profile.	Significant cracking of pavement slabs. Concrete pavers still stable (i.e. no rocking), however continued deterioration of the asset may give cause to a trip hazard. Recommend to continue monitoring. No significant change in geotechnical risk profile.	Concrete pavement slabs still stable (i.e. no rocking), however continued deterioration of the asset may give cause to a trip hazard. Recommend to continue monitoring. No significant change in geotechnical risk profile.	Concrete pavement slabs still stable (i.e. no rocking), however continued deterioration of the asset may give cause to a trip hazard. Recommend to continue monitoring. No significant change in geotechnical risk profile.	Low	2	Unlikely	1	Very Low	2	Low

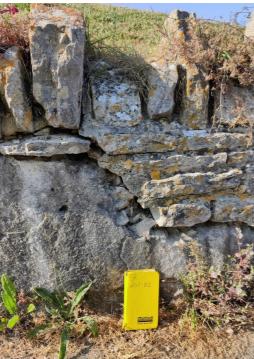
Retaining wall height: 1.0m. Retained height: 1.5m Vertical and horizontal cracking, crack length 0.8m. Typical crack width 40 - 60mm. Minor bowing of the wall at mid height.	Previously identified "minor bowing" appears more akin to shearing of top row of finishing stones of wall span, from the wall below. No significant change in crack width from previous survey.	No significant change in crack widths Noted to be very wet with water issuing from between cracks	No significant change. No water observed expelling from the wall face, however weather conditions were dry on date of inspection.	Max crack width increased from 60mm to 90mm. Top of wall has sheared further outwards from lower wall.	Max crack width 90mm - maintained. Top of wall has sheared further outwards from lower wall.	Max crack width 90mm. Significant water egress from wall face at joint with flag stones. Increased geotechnical risk, however risk profile has been kept same, due to limited exposure risk following installation of exclusion zone at Walron Road north.	Max crack width 90mm. Overhang from top section (shear failure) up to 45mm. No significant change.	No significant change. Crack widths and overhang not increased.	Low	2	Unlikely	1	Very Low	2	Low

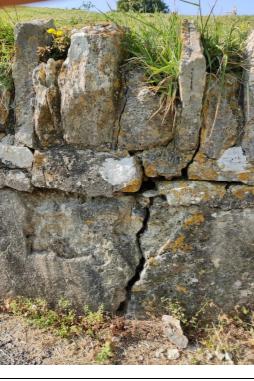
Retaining wall height: 0.9m Retained height: 1.0m. Vertical cracking, from base to top of wall (i.e. 0.9m), crack width between 20 - 40mm.	Surveyed - No significant change.	No significant change	No significant change	No significant change	Significant water egress from wall face at joint with flag stones. Increased geotechnical risk, however risk profile has been kept same, due to limited exposure risk following installation of exclusion zone at Walron Road north.	Vertical crack width measured to be between 20 - 50mm. No water egress noted however this may have been masked by the heavy rainfall present during the monitoring visit.	No significant change. Crack widths still similar. Water egress noted in February 2025 not observed on dry day either.	Low	1	Negligible	1	Very Low	1	Low	
B8	Weather Station Field	403026	79304

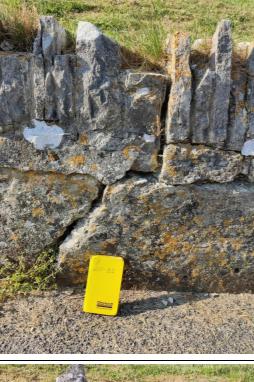
Retaining wall height: 0.85m Retained height: 1m + Vertical and horizontal cracking, the full height of the wall (0.85m), with typical crack width of 20mm. Lower right side (east) of wall translational movement relative to rest of wall (<30mm).	Max crack width increased to up to 40mm. Otherwise no significant change - low risk.	No significant change	No significant change	No significant change	Crack widths measured between 20 - 30mm. No significant change.	Crack widths measured between 20 - 30mm. No significant change. No increase in crack width measured.	Low	1	Negligible	1	Very Low	1	Low

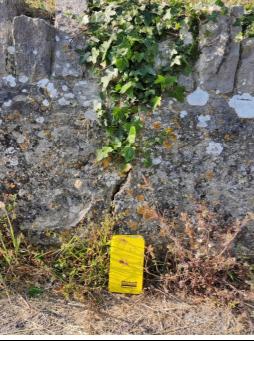
Retaining wall height: 1.0m Retained height: 1.0m Vertical cracking, running full height of the wall. Right of the crack (east side of the wall), 30mm translational movement of the wall relative to the west side. Pavement cracking adjacent to retaining wall observed from base of retaining wall.	Surveyed - No significant change.	No significant change	Crack width observed up to 20mm. No significant change to translation movement or pavement cracking adjacent to the wall.	No significant change	Crack width measured up to 20mm. No significant change.	No significant change. No increase in crack width measured.	Low	1	Negligible	1	Very Low	1	Low

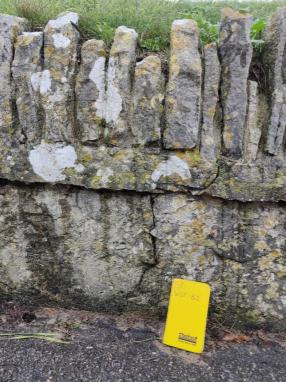
N/A Retaining wall height: 0.9m Retained height: 1.0m. Vertical cracking, from base to top of wall (i.e. 0.9m), crack width up to 10mm.	No significant change	No significant change	No significant change	No significant change	No significant change Significant overhang of upper flag stone sections to lower wall. Risk covered under defect Ref. B11.	Pavement rutting noted at toe of wall. No significant change in the condition of the wall.	No significant change.	Low	2	Unlikely	1	Very Low	2	Low

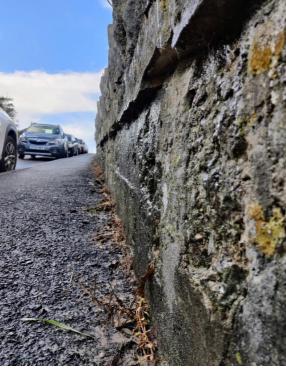
N/A 7.5m length of wall, between defect ref. B6 and B7. Shearing of top span of masonry from base of wall, up to 50mm. Movement in superficial material on retained side of weather station field separating wall at weak/mortar joint location. Risk of collapse over time, and damage to pavement, members of the public, and cars parked on road adjacent to wall. Advise to continue monitoring regularly.	Condition of asset as per February 2024 inspection. Shearing of top span of masonry from base of wall, increased to 70mm. Evidence of seepage through wall, along extents. Advise to continue monitoring regularly. Further deterioration may required foot path diversion.	Length of defect observed increased from 7.5m to 10m. Significant evidence of seepage egressing from behind the wall, between the upper and lower wall sections. Evidence of spalling of facing material in multiple locations. Continue to monitor, if further degradation occurs, or additional spalling of wall material, consider exclusion zone around affected section and footpath diversion.	Exclusion zone has been erected since previous site walkover over (October 2024), in accordance with report recommendations. Longitudinal cracking + footpath bulge/heaving at locations of worst affected area + max slumping of material above wall. Recommend to maintain exclusion zone and regularly monitoring in accordance with main report recommendations.	Depression noted in the pavement at the toe of the wall. No significant change in wall condition. Recommend to maintain exclusion zone and regularly monitoring in accordance with main report recommendations.	No significant change. All June 2025 observations still apply. Recommend to maintain exclusion zone and regularly monitoring in accordance with main report recommendations.	High	3	Likely	3	High	9	High

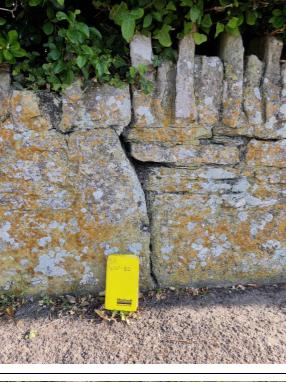
Retaining wall height: 1.0m. Retained height: 1.0m. Vertical cracking, full height of wall, typical crack width 5 - 30mm. Large bushes overhanging back of retaining wall, likely the cause of distress observed in the structure.	Displacement of east side of wall relative to the west up to 30mm. Otherwise no significant change - low risk.	No significant change	No significant change	Typical crack width increased from 30mm to 40mm. No significant change in asset risk.	No significant change	No significant change	No significant change in wall condition. Wall lower down the slope measured to be 20 - 30mm in front of the upper wall. Continue to monitor.	Low	2	Unlikely	1	Very Low	2	Low
C2	Sandpit Field	403009	79294

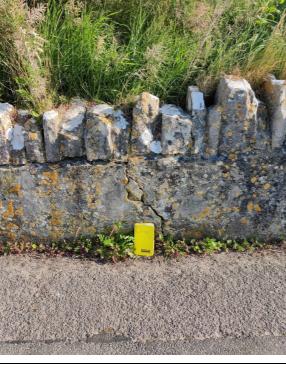
Retaining wall height: 0.8m Retained height: 0.8m Vertical cracking full height of wall, typical crack width 5 - 20mm. Evidence of historic patch repair made previously.	Surveyed - No significant change.	No significant change	No significant change	No significant change	No significant change	No significant change	No significant change	Low	1	Negligible	1	Very Low	1	Low

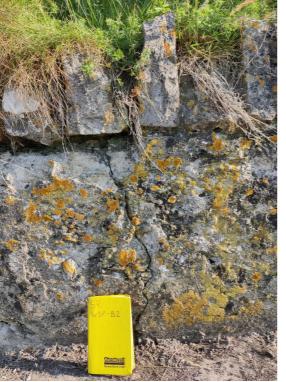
Retaining wall height: 0.95m Retained height 1.0m Vertical cracking, full height of wall, crack width between 1 - 3mm.	Surveyed - No significant change.	No significant change	No significant change	No significant change	No significant change	No significant change	No significant change	Low	1	Negligible	1	Very Low	1	Low

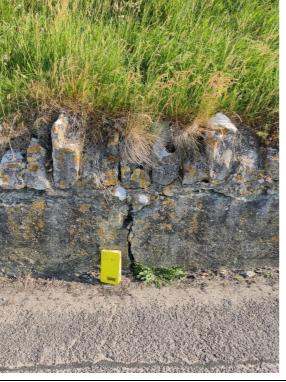
Retaining wall height: 1.0m Retained height: 1.2m Vertical cracking, full height of wall. Crack width 20 - 40mm. Otherwise no significant change.	Small void at base of wall due to loss of mortar/masonry. Likely lost from translational movement of the wall.	No significant change	No significant change	Masonry appears to have been lost / fallen off of wall face in section surrounding the crack (see latest images for comparison). Slight increase in asset risk, however still low due to general condition and retained height.	No significant change	No significant change	No significant change	No significant change	Low	2	Unlikely	2	Low	4	Low
C5	Sandpit Field	403058	79290

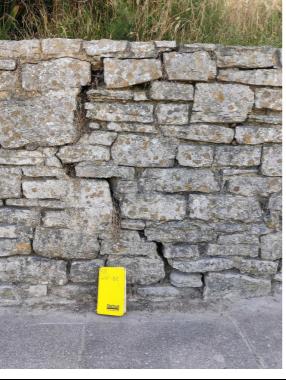
Retaining wall height: 1.25m Retained height 1.25m Vertical and horizontal cracking, typical crack width 20 - 30mm. Transverse movement of the wall, mortar joint failure from masonry blockwork moving apart. Otherwise health of asset unchanged. Low risk.	Vertical and horizontal cracking increased from 20-30mm to 40-50mm.	No significant change	No significant change	No significant change	No significant change	No significant change	No significant change	Increase in crack widths measured, latest measurements between 40 - 60mm. Wall appears in good condition despite crack increase.	Low	2	Unlikely	2	Low	4	Low

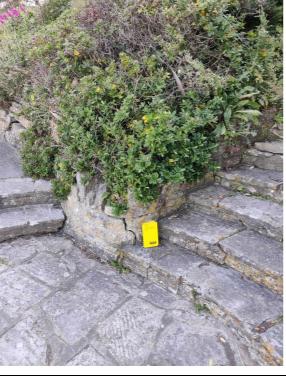
Retaining wall height: 0.6m Retained height: 1.5m+ Vertical cracking full height of the wall. Typical crack width between 10 - 15mm. Overgrown bushes and vegetation acting on the back of the wall the likely cause of deterioration of the retaining structure. Otherwise no significant change - low risk.	Typical crack width increased to 15-25mm.	No significant change	No significant change	No significant change. Asset partially obscured by vegetation.	No significant change. Asset partially obscured by vegetation.	Vegetation cover obscuring asset. Flagstone from wall noted to have fallen onto step above defect. See report for photos. Block approximately 0.4 x 0.4 x 0.1m in size.	Vegetation cover obscuring asset. No significant change to crack. Block noted in the June 2025 inspections has been moved up the steps.	Low	2	Unlikely	2	Low	4	Low

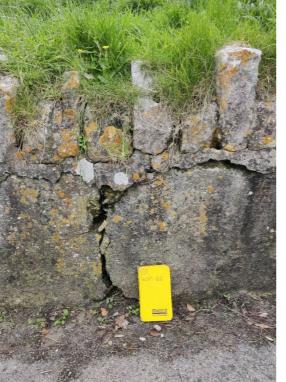
N/A	N/A	N/A	Retaining wall height: 0.9m Retained height 0.9m Vertical cracking, full height of wall, hairline cracking of width up to 2mm.	No significant change	No significant change	No significant change	Vertical crack width measured up to 70mm. No significant change in risk profile.	Low	1	Negligible	1	Very Low	1	Low

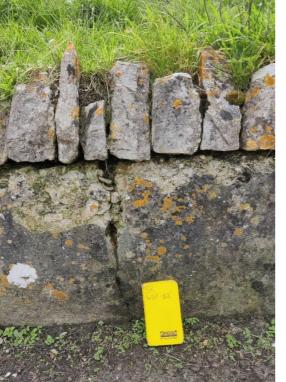
N/A	N/A	N/A	Retaining wall height: 1.0m Retained height 1.0m Vertical cracking, full height of wall, cracking up to 50mm.	No significant change	No significant change	No significant change	No significant change	Low	1	Negligible	1	Very Low	1	Low
C17	Sandpit Field	403503	9208

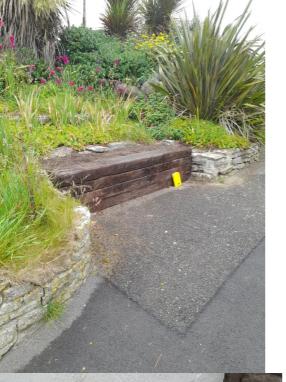
N/A	N/A	N/A	N/A	N/A	2 new retaining walls installed on the footpath further north of C12. Sleeper retaining wall 1 (Furthest north) Height 0.5m, depth 0.25m, length 2.35m. 4 wooden railway sleepers bolted to the floor and each other in front of stone retaining wall which the client reported as having slipped. Backfilled with soil behind wooden wall. Wall placed on slabs in the SW corner.	No significant change in new retaining walls.	Medium	3	Likely	2	Low	6	Medium	
C18	Sandpit Field - Gun turret	403046	79255

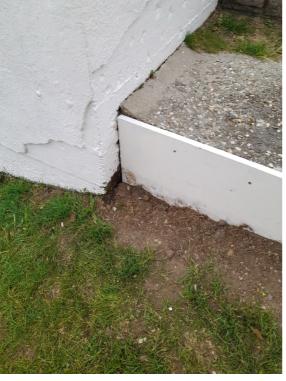
N/A	N/A	N/A	N/A	N/A	New defect reported by the client on gun turret in sandpit field. Reported as follows - Collapse of buried wall (believed to be supporting tunnel) underground causing a hole to open up and minor subsidence. The hole has been boarded up and the contractor is to return to site and pack stone under the corner of the slab that is now unsupported due to collapsed wall. Desiccation noted on the earth mound above the tunnels.	No significant change. Desiccation previously observed is forming small tension cracks in the bank. Tension cracking observed between fill and structure, minimal risk to public safety due to low height earthwork.	Medium	3	Likely	2	Low	6	Medium

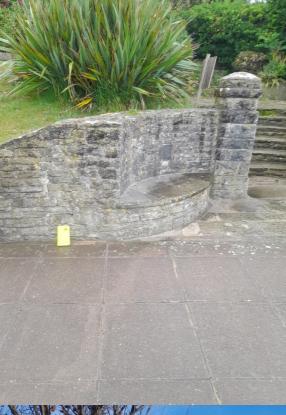
N/A	N/A	N/A	N/A	N/A	N/A	Crack on the road face of the retaining wall around the steps. Crack on the corner of the south wall. Retaining wall dimensions - Height 1.16m, Depth 0.5m Small vertical crack noted on wall face between 2 - 5mm width. Crack on top of wall 10 - 30mm width.	No significant change.	Low	2	Unlikely	2	Low	4	Low

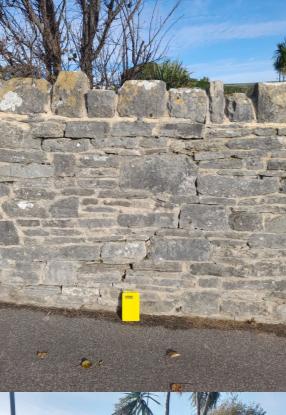
N/A	N/A	N/A	N/A	N/A	N/A	Vertical cracking observed across full height of retaining wall. Cracking in place between blocks where render is no longer present. Mortar debond. No overhang observed. Wall height = 1.6m. Wall Depth = 0.4m. Crack width <10mm.	N/A	2	Unlikely	2	Low	4	Low	
C21	Sandpit Field	403058	79166

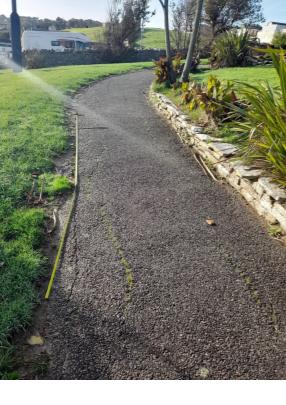
N/A	N/A	N/A	N/A	N/A	N/A	10m of surface cracking observed in the tarmac pavement within sandpit field. 1 to 2 parallel cracks observed along the whole length. Cracks only in surface of the pavement. Minor subsidence also observed.	N/A	1	Negligible	2	Low	2	Low
