SWANAGE SEAFRONT

Ground Stabilisation Feasibility Study

OUR REF. NO. 70094760-GEO-REV001

DATE: SEPTEMBER 2022

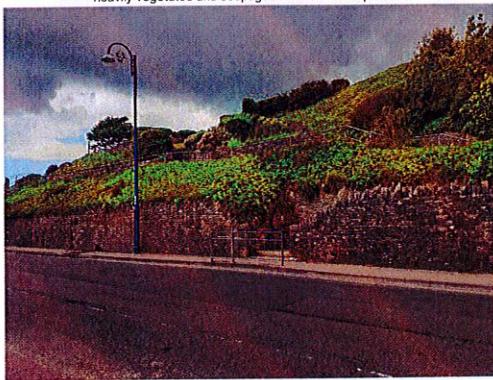
P1: The Spa. Eastern retaining wall (=1.5-2m high) and steps looking southwest from Shore Road. Note slopes heavily vegetated and seepage marks from weep holes.

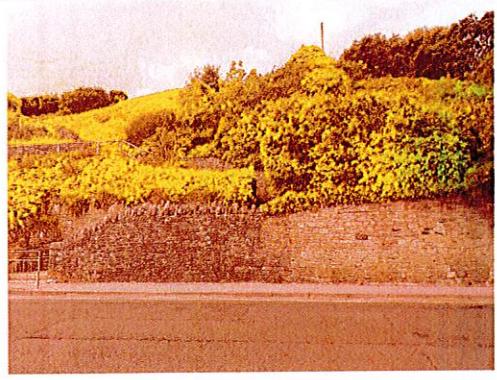
P2: The Spa. Eastern retaining wall (=1.5-2m high) and steps looking west from Shore Road. Northern site boundary at centre of photograph. The retaining wall on the right hand side (yellowish-light brown colour) is outside the site boundary.

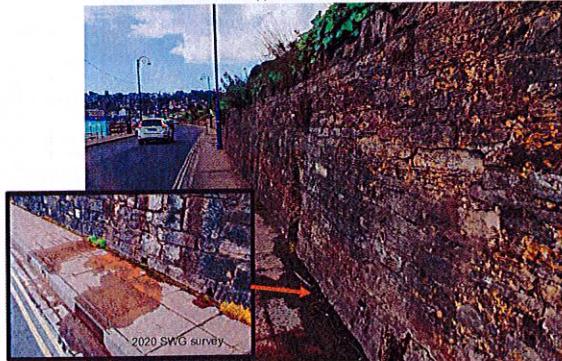
P3: The Spa. Eastern retaining wall (=1.5-2.0m high) looking south from Shore Road. Retaining wall showing evident drainage issues, related to blockage by vegetation growth and/or sediments. Horizontal cracking is noted along the upper one-third of the wall.

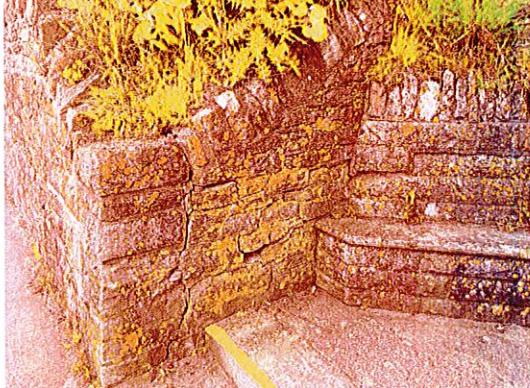
P4: The Spa. Retaining wall (0.5-1.0m high) showing a vertical crack and minor tilting eastwards. Looking southwest.

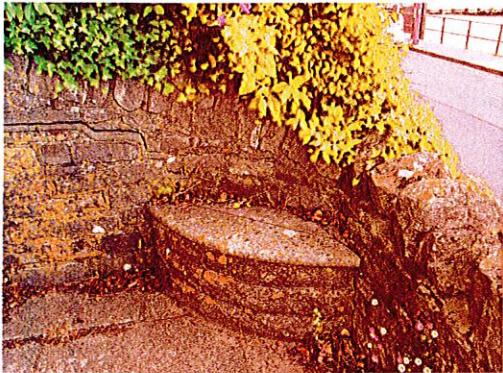
P5: The Spa. Retaining wall (1-1.5 m high) showing a subhorizontal becoming oblique crack along the upper portion. Heavily vegetated area behind and over the wall. Looking northeast.

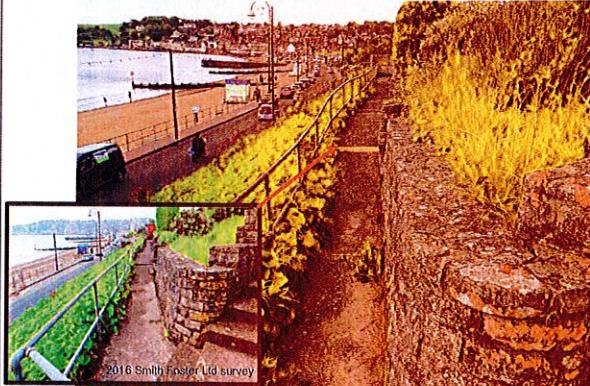
P7: The Spa. Steep vegetated bank (left) and displaced concrete footpath with uneven surface. The hand rail is slightly bent. Cracks on footpath have been covered with concrete painted with yellow colour. Looking south.

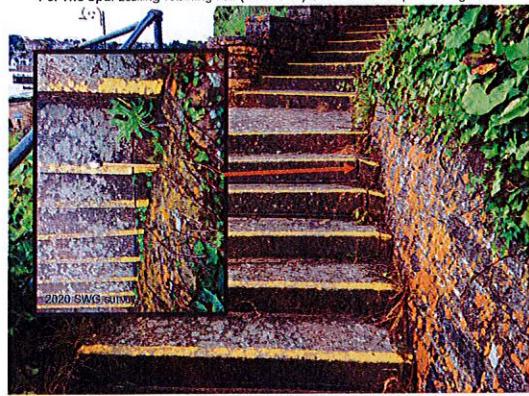
P6: The Spa. Leaning retaining wall (westwards) and cracks in steps. Looking south.

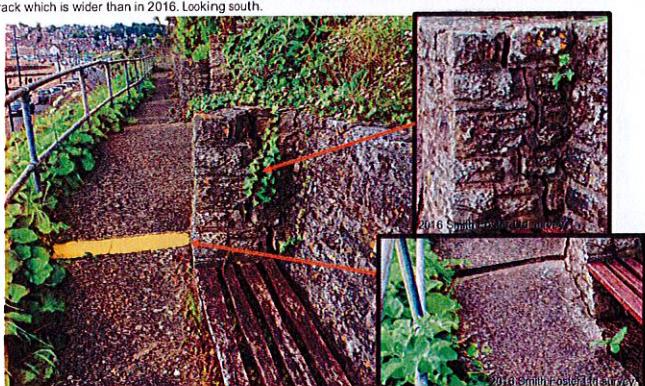
P8: The Spa. Steep vegetated bank (left) and displaced concrete footpath with uneven surface. The hand rail is slightly bent. Cracks on footpath have been covered with concrete painted with yellow colour. Retaining wall showing a vertical crack which is wider than in 2016. Looking south.

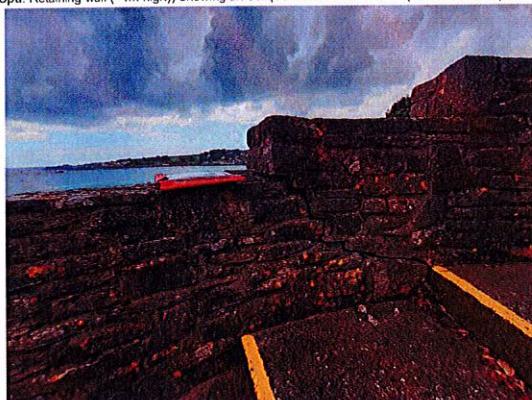
P9: The Spa. Retaining wall (=1m high) showing an oblique crack across mortar (weaker material). Looking south.

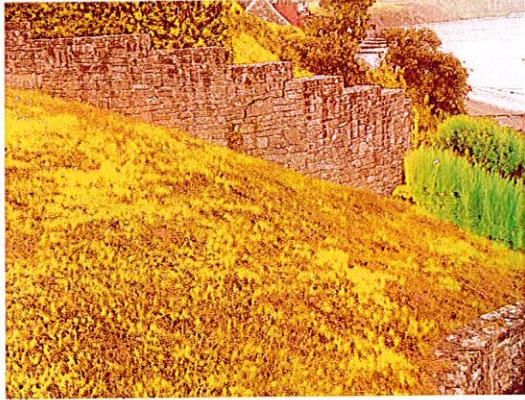
P10: The Spa. Retaining wall (=1.25m high) defining the northern site extents with an oblique crack. Looking north.

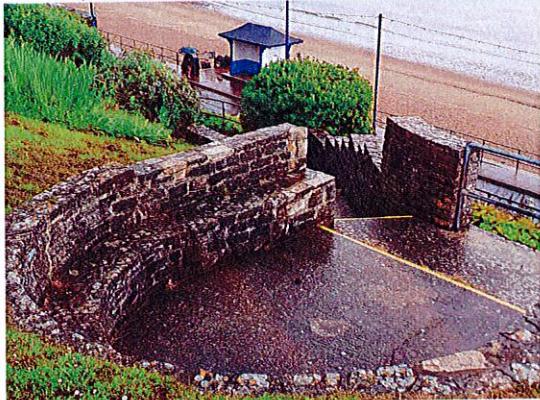
P11: The Spa. Steps and retaining walls showing some minor cracking. Looking northeast.

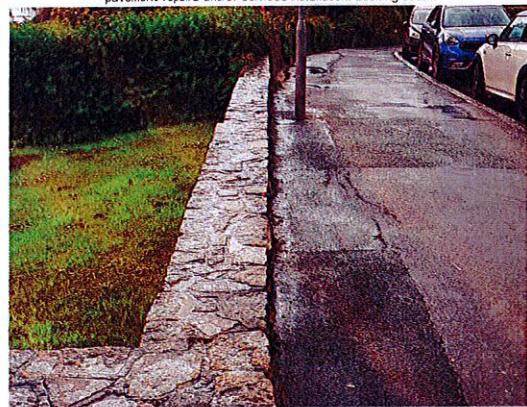
P14: The Spa. Retaining wall supporting De Moulham Road and defining the western site boundary. Evidence of recent pavement repairs and/or services installation. Looking south.

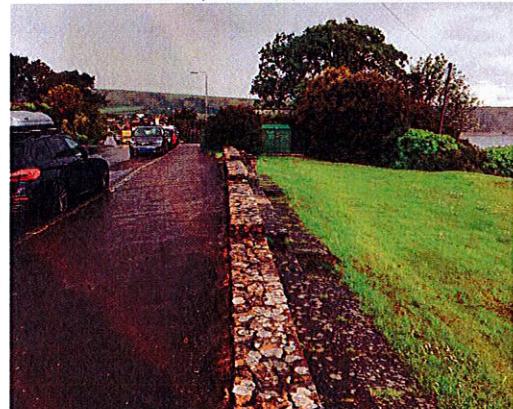
P16: The Spa. Grassed slope gently sloping eastwards. Retaining wall supporting De Moulham Road and defining the western site boundary. Pavement (left) is uneven. Looking north.

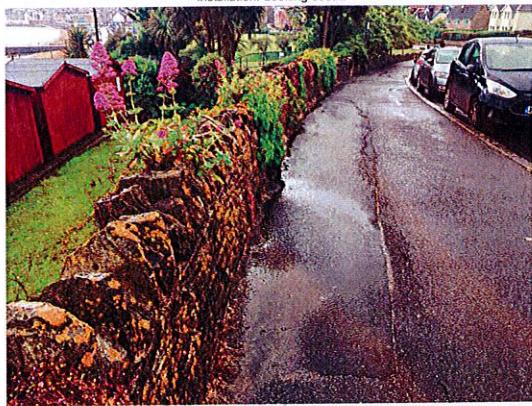
P17: Spa Beach Huts. Retaining wall ($\approx 1.5-2$ m high) supporting De Moulham Road and defining the western site boundary. Retaining wall clearly leaning eastwards and evidence of recent pavement repairs and/or services installation. Looking south.

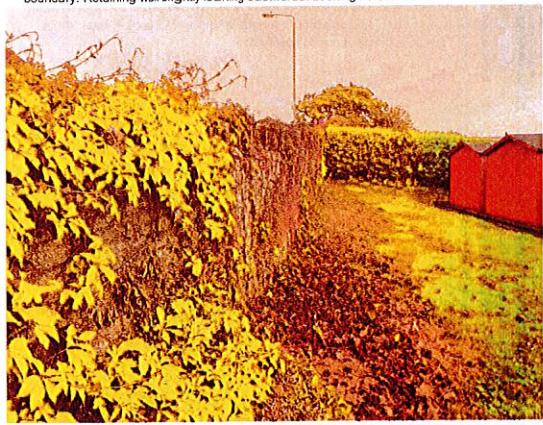
P18: Spa Beach Huts. Retaining wall ($\approx 1.5-2$ m high) supporting De Moulham Road and defining the western site boundary. Retaining wall slightly leaning eastwards. Looking north from within the site area.

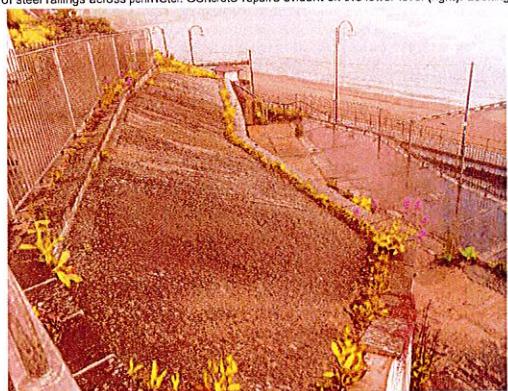
P20: Spa Beach Huts. Concrete slabs with repairs sloping eastwards and supported by a retaining wall (≈ 2.25 m high). Presence of steel railings across perimeter. Concrete repairs evident on the lower level (right). Looking northeast.

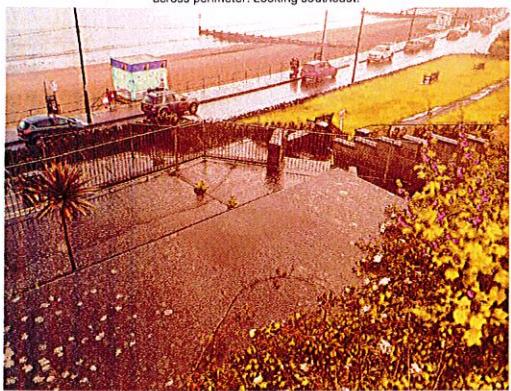
P21: Spa Beach Huts. Concrete slabs with cracks and some minor repairs covering the ground surface on lower level (left). A concrete block retaining wall with steps is present to the right hand side. Presence of steel railings across perimeter. Looking southeast.

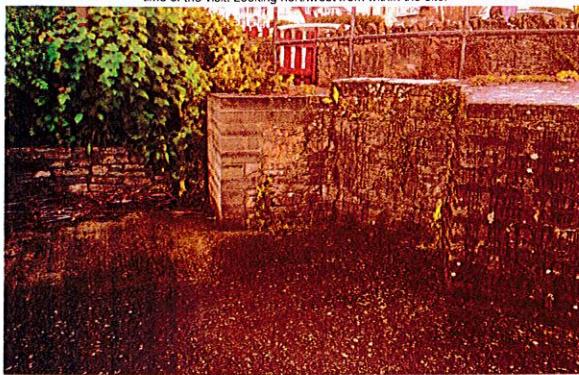
P23: Spa Beach Huts. General aspect of retaining walls with various retained heights ($\approx 0.5\text{--}1.5$ m high) along the western section. Partial reconstruction of existing masonry wall made of natural stone blocks using prefabricated concrete blocks noted at the centre of the image. Seepage on the walls is due to heavy down pour occurring at the time of the visit. Looking northwest from within the site.

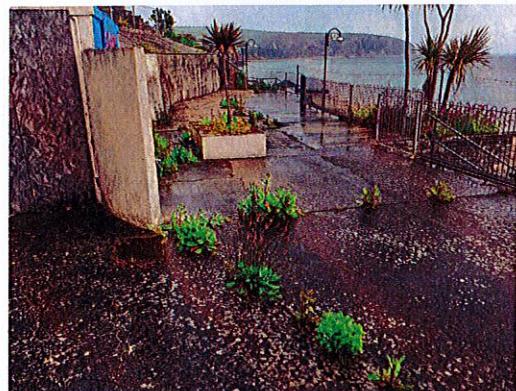
P22: Spa Beach Huts. Concrete slabs with cracks and construction joints, and some minor concrete repairs. A retaining wall (≈ 2.5 m high) is supporting the slope in front of the huts. Presence of steel railings across perimeter. Looking northeast.

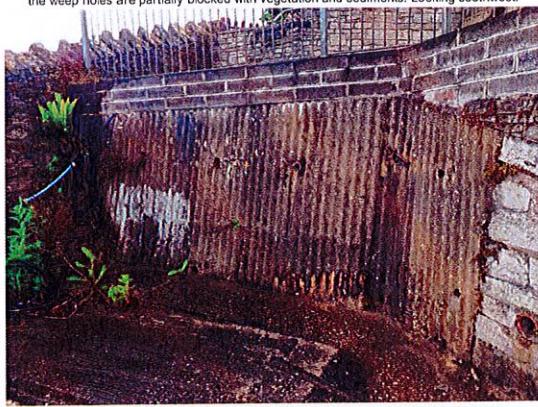
P25: Spa Beach Huts. Retaining wall (≈ 2.5 m high) located in front of the huts. The wall is comprised of prefabricated concrete blocks (top) natural stone blocks (right), and concrete with wavy patterns vertically oriented (left) forming the main body of the structure. This is indicative of different construction and/or repair stages. Some of the weep holes are partially blocked with vegetation and sediments. Looking southwest.

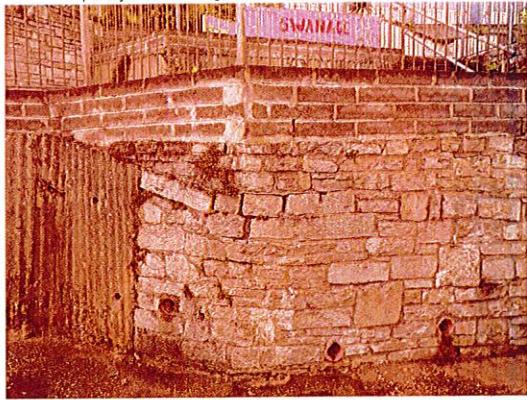
P26: Spa Beach Huts. Retaining wall (≈ 2.5 m high) located in front of the huts. The wall is comprised of prefabricated concrete blocks (top) natural stone blocks (right), and concrete with wavy patterns vertically oriented (left) forming the main body of the structure. This is indicative of different construction and/or repair stages. Some of the weepholes are partially blocked with vegetation and sediments. Looking northwest.

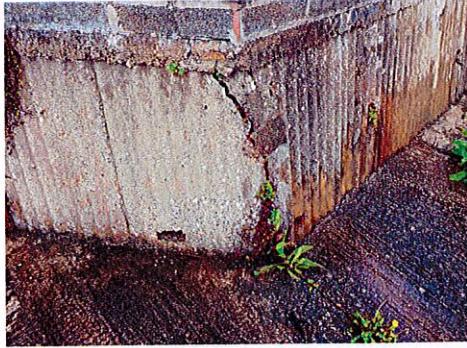
P27: Spa Beach Huts. Detail of vertical crack across the base of the retaining wall comprising prefabricated concrete blocks (above) over concrete with wavy patterns vertically oriented (below). Some of the weep holes are partially blocked with vegetation and sediments. Looking west.

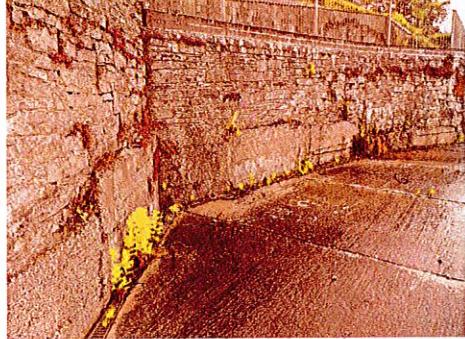
P28: Spa Beach Huts. Retaining wall (≈ 2.5 m high) located in front of the huts. Natural stone blocks forms the main body of the wall with concrete repairs along its lower section. This is indicative of different construction and/or repair stages. Some of the weep holes are partially blocked with vegetation and sediments. Looking northwest.

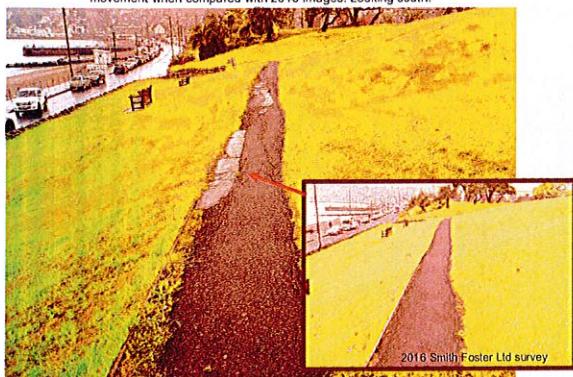
P29: Weathered Station Field. Uneven/hummocky terrain, sloping eastwards. Footpath with extensive cracking along tarmac and recent concrete repairs. This image shows clear evidence of eastwards (probably shallow) ground movement when compared with 2016 images. Looking south.

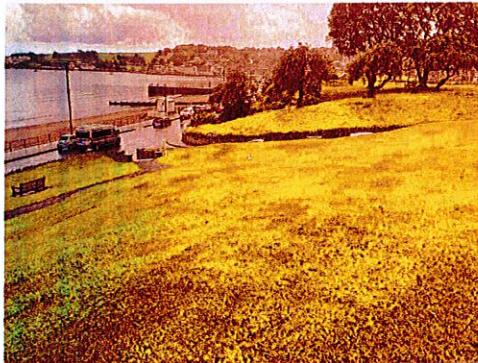
P31: Weathered Station. Uneven/hummocky terrain, sloping eastwards. Sandfield Pit in the background. Looking southeast.

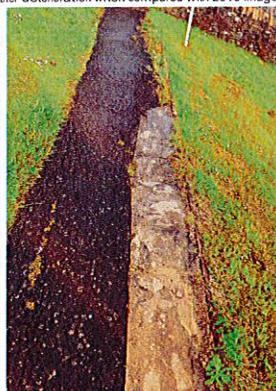
P30: Weathered Station Field. Footpath with extensive cracking along tarmac and recent concrete repairs. Clear evidence of further deterioration when compared with 2016 images. Looking south.

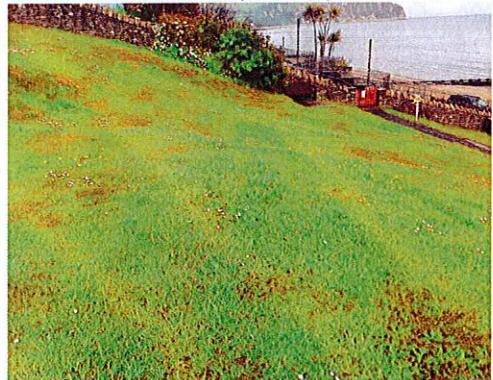
P32: Weathered Station. Uneven/hummocky terrain, sloping eastwards. Looking northeast.

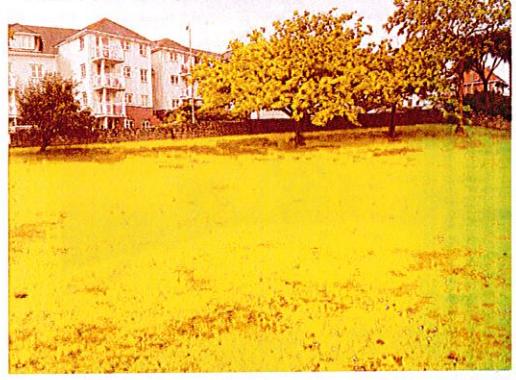
P34: Weathered Station Field. Western retaining wall (=0.5-1.0m high) supporting De Moulham Road. The wall is in fairly good condition although localised minor cracking is present. Looking northwest.

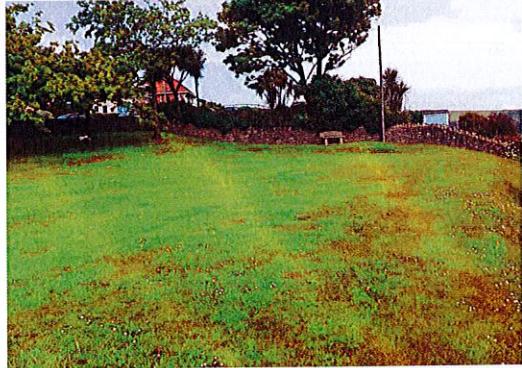
P35: Weathered Station Field. Western area of this section is relatively flat. A retaining wall (=0.5-1m high) with localised cracking defines the northern boundary of the Weather Station Field. Looking north.

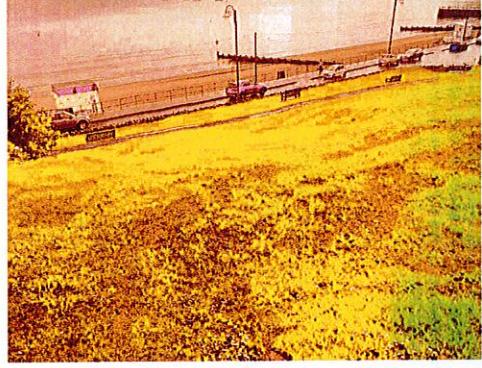
P36: Weathered Station Field. General view of the Weather Station Field slope. Uneven/hummocky terrain, sloping eastwards. Looking southeast.

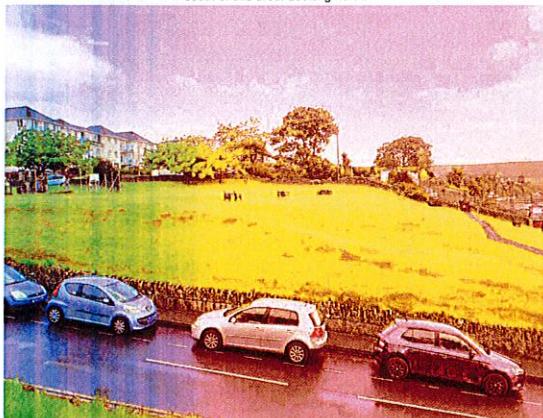
P37: Weathered Station Field. General view of the Weathered Station Field from Sandfield Pit. Uneven/hummocky terrain, sloping eastwards. It shows the flatter western area (left), and the steeper and unstable slopes to the east and south of this area. Looking north.

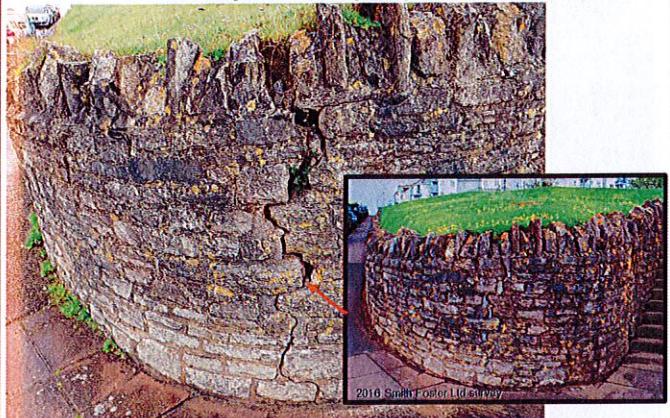
P38: Weathered Station Field. Detail of localised vertical cracking ($\approx 1-15\text{cm}$ s wide) across the eastern retaining wall ($\approx 1.5\text{m}$ high). The defect is located at the southeastern corner of the Weathered Station Field. Various stone blocks along the crack are missing. Looking northwest.

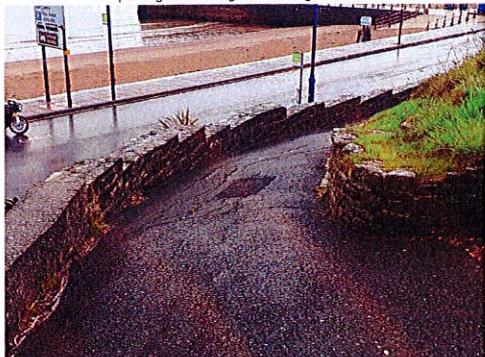
P41: Sandpit Field. Cracking, subsidence and repairs along footpath. Clear evidence of eastwards shallow ground, pushing the retaining wall. Looking southeast.

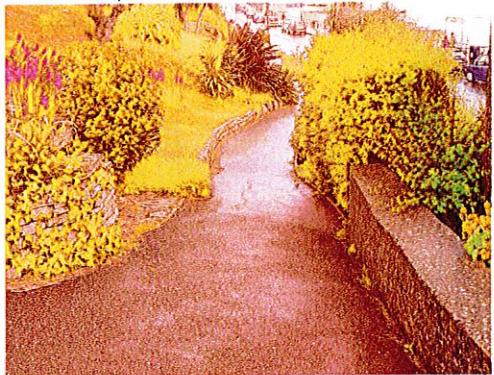
P42: Sandpit Field. Minor cracking along footpath. Looking northeast.

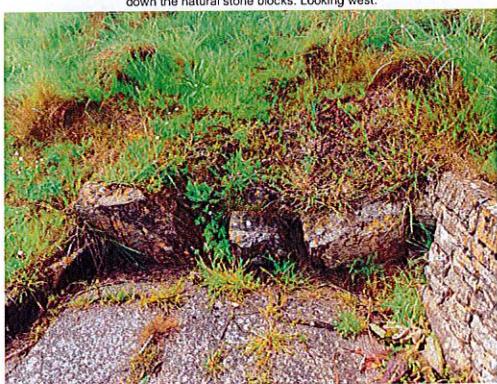
P43: Sandpit Field. Partially collapsed retaining structure (=0.5m high). Backfill pushing eastwards has knocked down the natural stone blocks. Looking west.

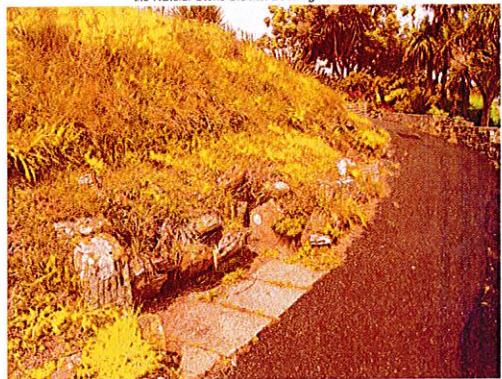
P44: Sandpit Field. Partially collapsed retaining structures (=0.5m high). Backfill pushing eastwards has knocked down the natural stone blocks. Looking northwest.

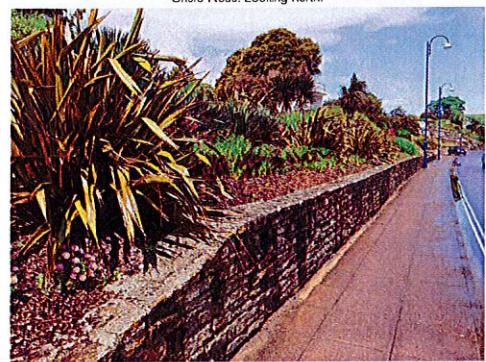
P46: Sandpit Field. Eastern retaining wall (≈1m high) in fairly good condition at this location. Drainage blockage along Shore Road. Looking north.

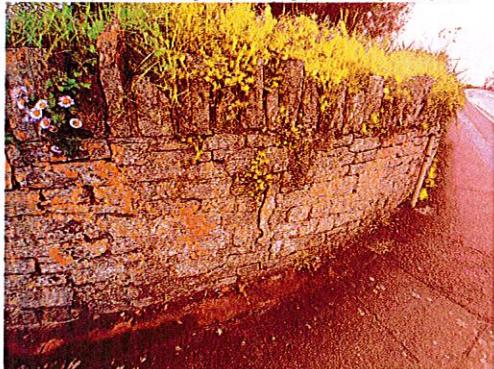
P47: Sandpit Field. Retaining wall (≈1-1.5m high) with cracking. Looking west.

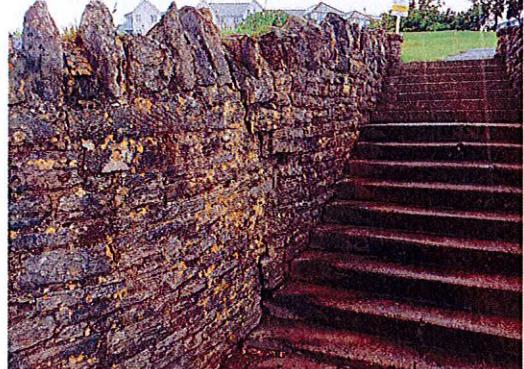
P48: Sandpit Field. Retaining wall (≈1-1.5m high) with localised vertical crack. Looking west.

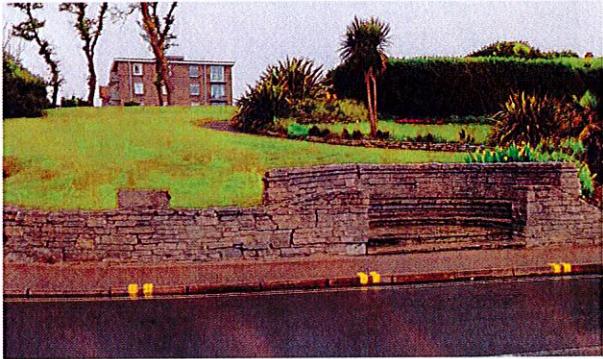
P49: Sandpit Field. General view of Sandpit Field eastern retaining wall with localised cracking. Looking west.

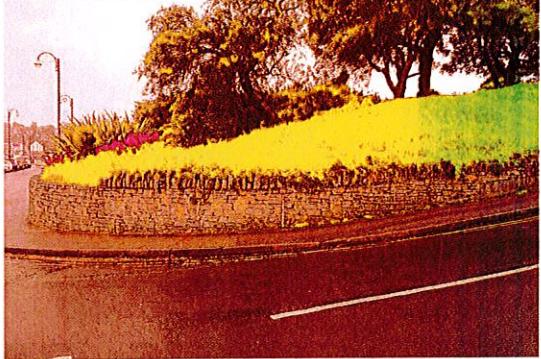
P50: Sandpit Field. General view of Sandpit Field eastern retaining wall with localised cracking. Looking south.
