GEOTECHNICAL ASSESSMENT

Client: Swanage Town Council

Swanage Seafront

Report No. 12660

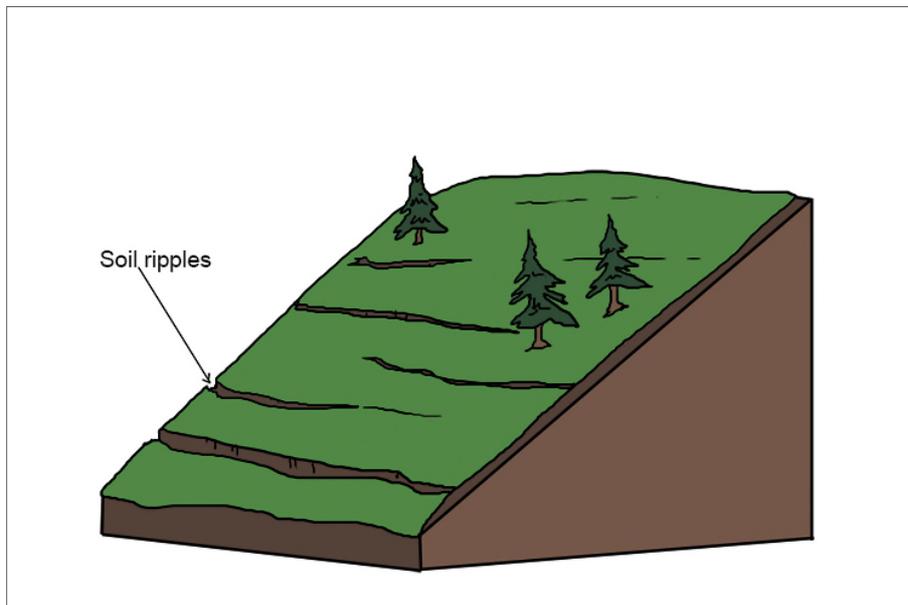
Figure 1: Illustration of Soil Creep Movement

The instability associated with the Weather Station field (Section 2) is generally more translational/creep related (See Figures 1 and 2) with shallow failures affecting the steeper soils on the lower sections of the slope (as observed by the deformed footpath) and associated with the stone wall at the lower level. Large, deep seated failure of the slope, if left in its current state is not expected to occur, although larger failures would occur if the retaining wall at Shore Road level is left to deteriorate/ is removed.

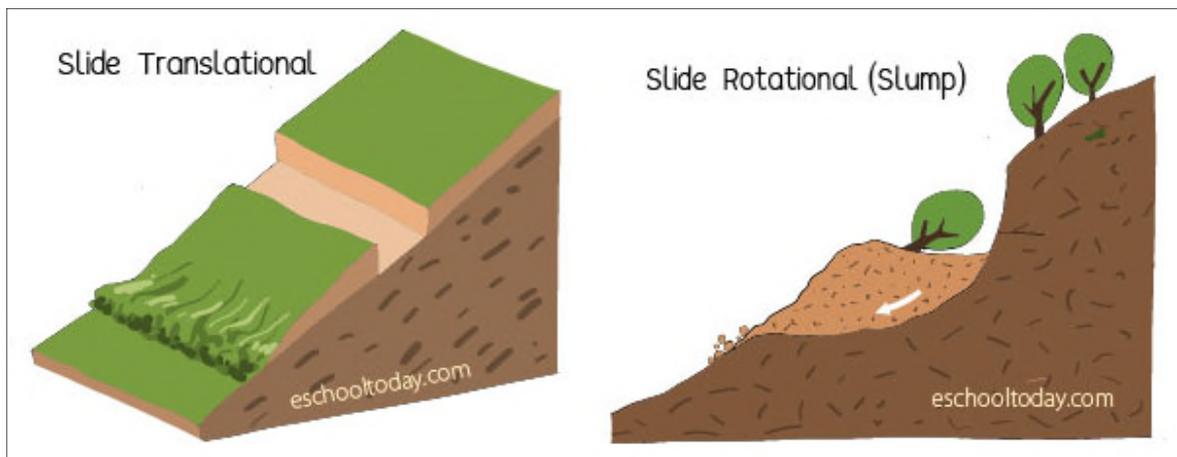
Figure 2: Shallow Translational and Rotational Landslide Illustration

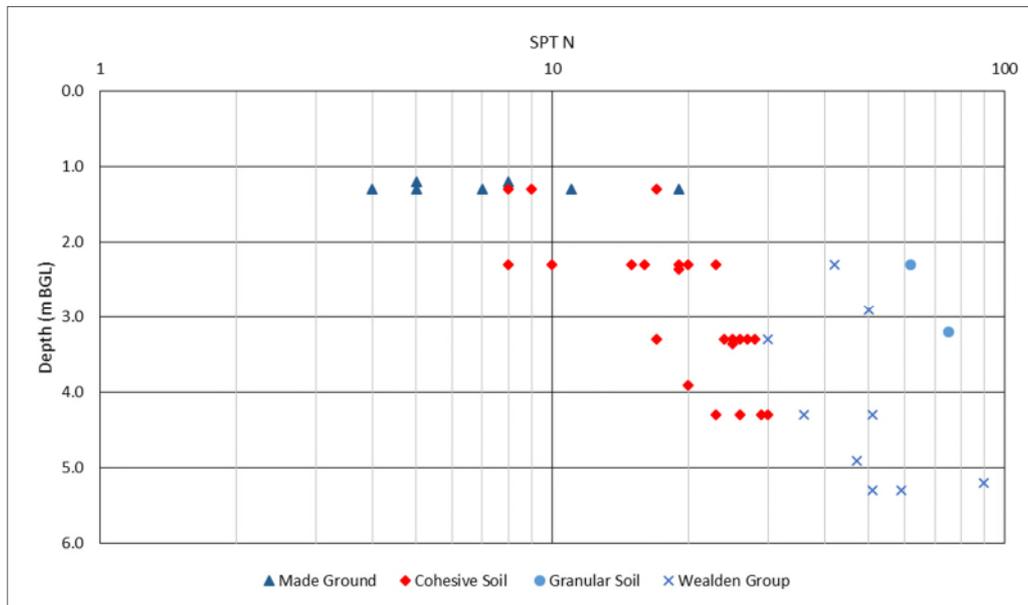
Figure 3: SPT N Vs Depth Plot

The N values show significant scatter near surface which is reflective of the variable nature of the made ground and near surface cohesive soils. Below a depth of approximately 3.0m the scatter decreases.

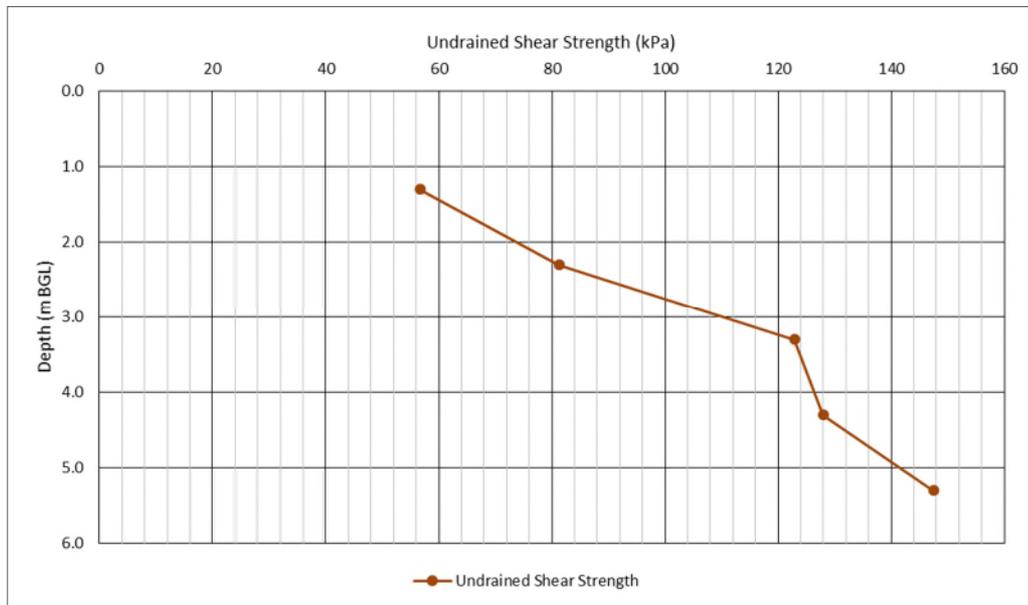
Figure 4: Cohesive Soil - Undrained Shear Strength Vs Depth

Four drained shear box tests undertaken on the cohesive soils gave peak values of cohesion and friction of between 8-14 kPa and 22-27° respectively. Residual drained shear strength parameters of 6-10 kPa and 17-26° were recorded during the tests. The friction values are in line with the value derived from correlations between Plasticity Index and friction angle (25°).

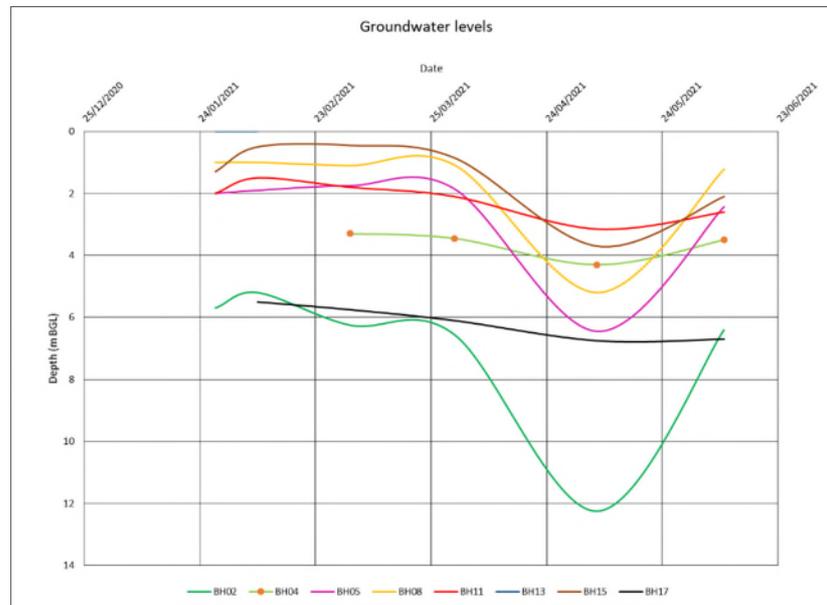
Subsequent monitoring visits have recorded groundwater at various depths in the boreholes, as indicated in Figure 5. The monitoring indicates that the groundwater levels are particularly susceptible to climatic weather conditions with changes in groundwater levels across the site of between 3.0 and 7.0m depending on the recent weather conditions. Figure 5 shows that groundwater levels steadily declined during the dry period of mid-March to early May 2021, with a rapid increase in groundwater levels following the particularly wet May 2021.

Figure 5: Groundwater Monitoring Summary

Groundwater was recorded at ground level in BH13 during the initial visits. Subsequently the protective cover has been damaged and it has not been possible to monitor this borehole since.

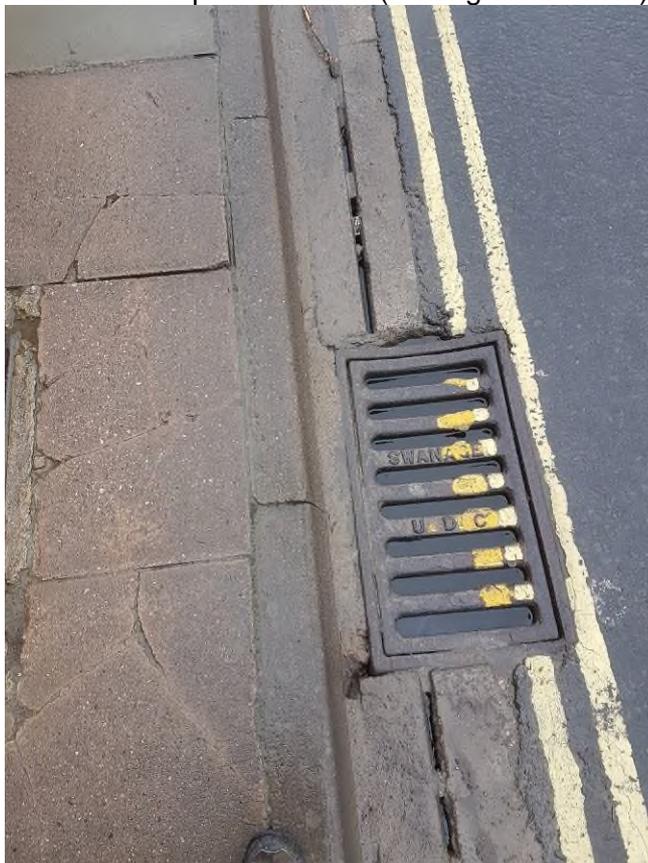
There is also seepage along the retaining wall along the sections eastern boundary (photo 9) and an adjacent blocked drain along Shore Road (photo 4).

The drains along the seafront (Shore Road) and Walrond Road are blocked/ full of water/ sediment (Photos 4, 13 and 18).

Photo 4 – Blocked drain.

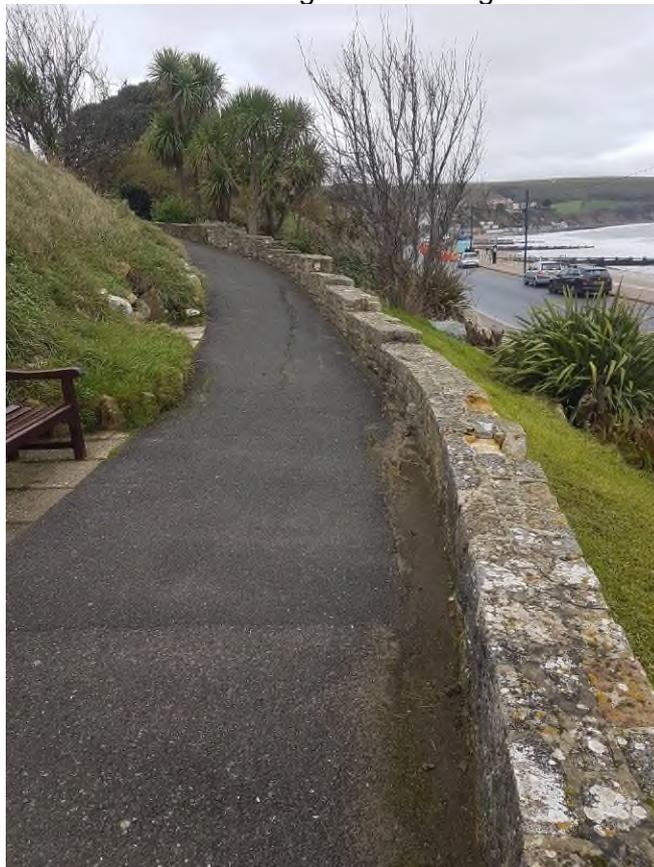
Photo 16 – Tilting path wall. (Looking north.)

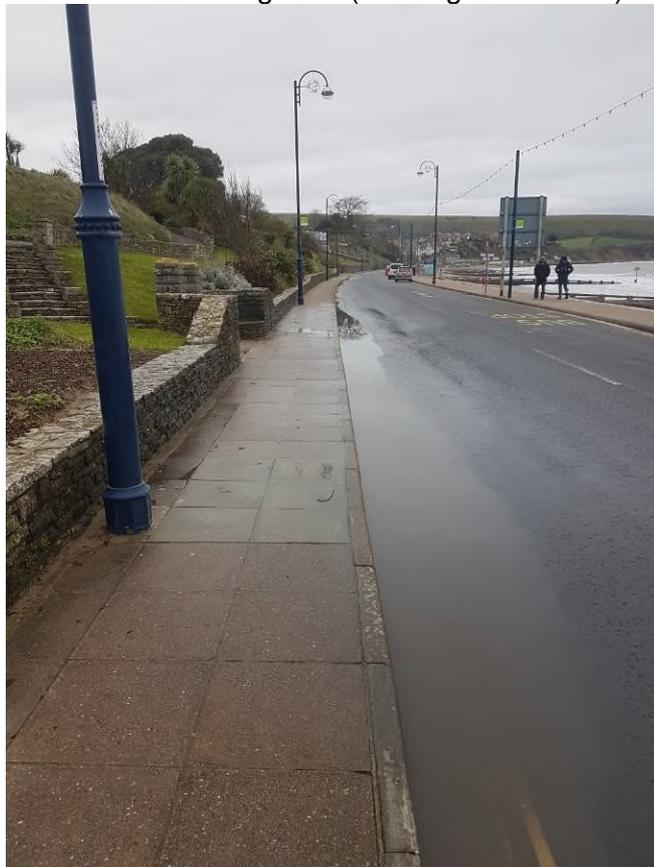
Significant deformation was noted on Shore Road, at the southern end of Sandpit Field (Photos 18 and 23). This may be indicative of a collapsed drain.

Photo 18 – Blocked drain (looking north.)

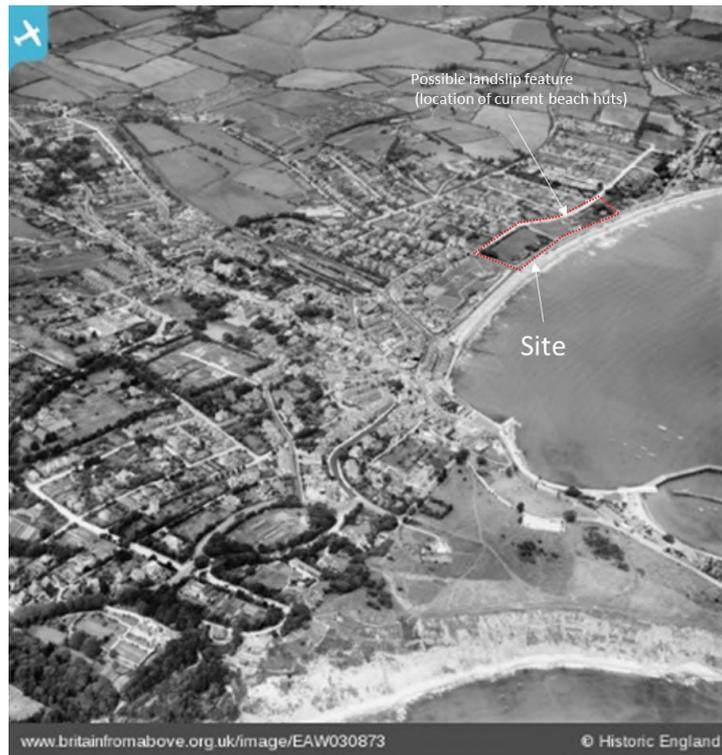
A historic aerial photograph from 1950 (Photo 24) suggests the area of current beach huts may be formed on a historic landslip feature with the associated “tables” created by the landslip used to construct the various terraces on. This is not confirmed, but could explain why there is so much groundwater and has been so much historic movement (evidenced by the rebuilds of multiple walls) in this area.

Photo 24 – Aerial Photo 1950
