SWANAGE SEAFRONT

Ground Stabilisation Feasibility Study

OUR REF. NO. 70094760-GEO-REV001

DATE: SEPTEMBER 2022

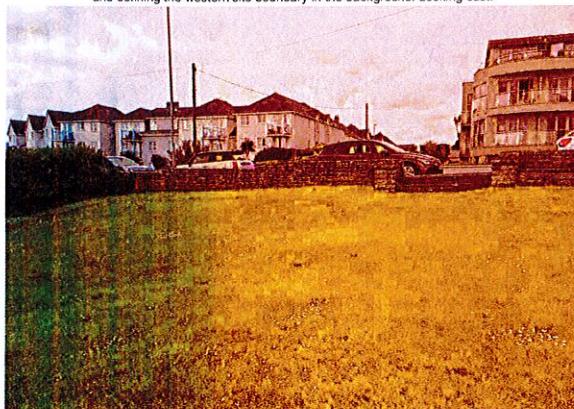
P16: The Spa. Grassed slope gently sloping eastwards. Retaining wall supporting De Moulham Road and defining the western site boundary. Pavement (left) is uneven. Looking north.

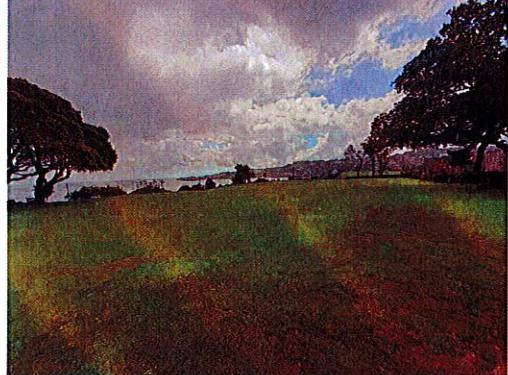
P41: Sandpit Field. Cracking, subsidence and repairs along footpath. Clear evidence of eastwards shallow ground, pushing the retaining wall. Looking southeast.

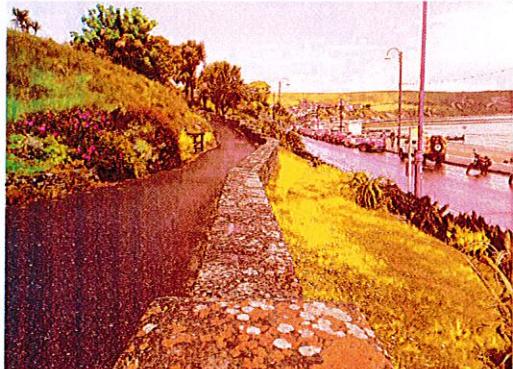
P46: Sandpit Field. Eastern retaining wall (≈1m high) in fairly good condition at this location. Drainage blockage along Shore Road. Looking north.
