SWANAGE TOWN COUNCIL

SEYMER ROAD DRYSTONE WALL REBUILD

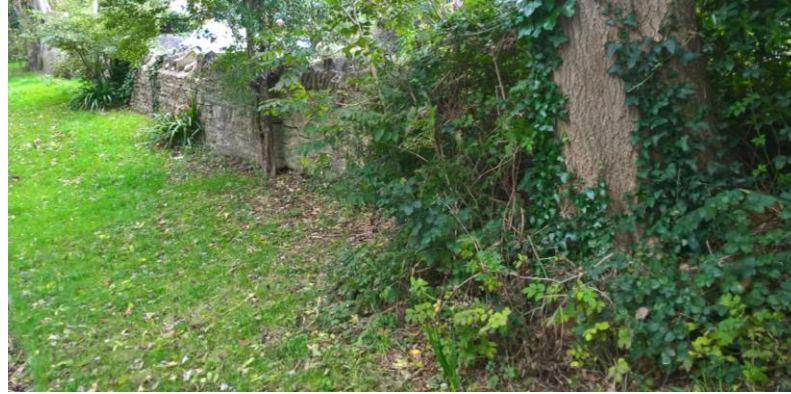
Work is commencing in November 2020 to rebuild the drystone wall adjacent to Seymer Road. Parts of it have become unstable due partly to the trees that were growing just inside the wall and partly because earth is banked up inside the wall which the wall is not strong enough to support. To avoid any part of the wall collapsing unexpectedly into the highway the entire wall is to be rebuilt mostly reusing the existing stone.

The work is expected to take 14 weeks as the wall is dismantled and rebuilt largely by hand. It will be rebuilt in the same style with the “cock and hen” coping.
