**Re : Swanage Seafront Gun Emplacement - Geotechnical Review by WSP**

**From:** martinkenned [REDACTED]  
**Sent:** 01 July 2025 08:44  
**To:** [REDACTED]  
**Cc:** [REDACTED]  
**Subject:** RE : 3912 / 009 - WWII Gun emplacement - Sandpit Field, Swanage

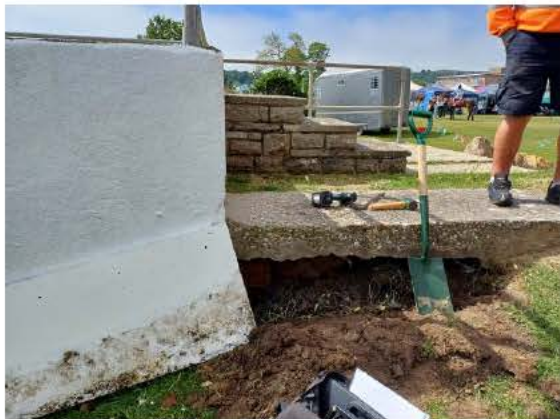
I confirm our visit to Sandpit Field on Friday 30 May to look at the WWII Gun emplacement on the southern side of the field, and in particular at a section of concrete slab adjacent to the main access pathway that allows visitors to step up onto the top of the gun emplacement (see photo below). That platform area is then used by a large number of members of the public as a viewing point for most of the events held on Swanage Seafront throughout the year, particularly in the summer months.

You commented that following the current Swanage Green Seafront Consultation, and as part of the works that are planned to commence in autumn 2026, the gun emplacement will be removed, together with the concrete slab that we were inspecting. Any works to support the slab will therefore only be needed in the short term. For this reason, I proposed that the subsoil beneath the corner of the slab be levelled off, parallel to the underside of the slab, so that the corner of the slab can be 'propped' using a stack of three or four concrete blocks laid flat set out to enable some slate packing to then be wedged in tight along the top of the blocks to provide a continuous support to the corner of the slab. Any loose and soft topsoil material should be dug out and then the new excavation can be levelled off with an almost dry bed of sand and cement onto which the three or four concrete blocks can be dry laid, finishing with the slate packing. If the depth does not accommodate dry laid 100mm thick blocks, then a row of offcuts from a 65mm thick x 100mm wide PC lintel could be combined with the blockwork to suit the height required.

Following this 'propping' of the outer corner of the concrete slab, it should be fairly easy to monitor the level of the top of the slab against the white paint to the rear of the gun emplacement, so that the board covering over the current gap beneath the slab need not be regularly removed - perhaps annually in September as visitor numbers and events reduce.

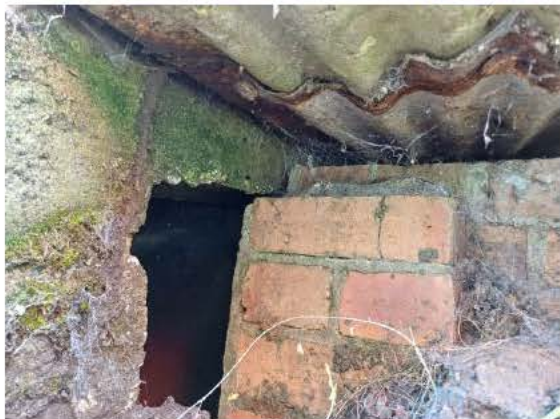
As highlighted in your email below, and as can be seen in the second photo above, there is a brick wall that may have previously provided some support near to the edge of the concrete slab, but which has now moved and tilted inwards, thereby dropping away from the underside of the slab and leaving the edge unsupported. The slab is likely to have been poured on the profiled sheeting that spanned between the brickwork and an inner wall - measured on site as about 780mm in from the outer edge of the slab. You said that the inner support is likely to be the side wall of the passageway that runs from the front of the gun emplacement to a room beneath the mound of earth behind the gun emplacement. The short edge of the concrete slab looks to have just been poured up against the rear face of the gun emplacement and may currently be held in place due to the friction between the two surfaces, despite the movement of the brick wall.

However, this leads to a small risk that, when fully loaded with people watching an event from behind the viewing platform, the slab could move downwards until it 'settles' back onto the brick wall, a drop of about 40mm.
